# **Modelli e tecniche nei progetti di intervento**

**Gaetano Manfredi**

# L'Aquila Earthquake: Structural damages

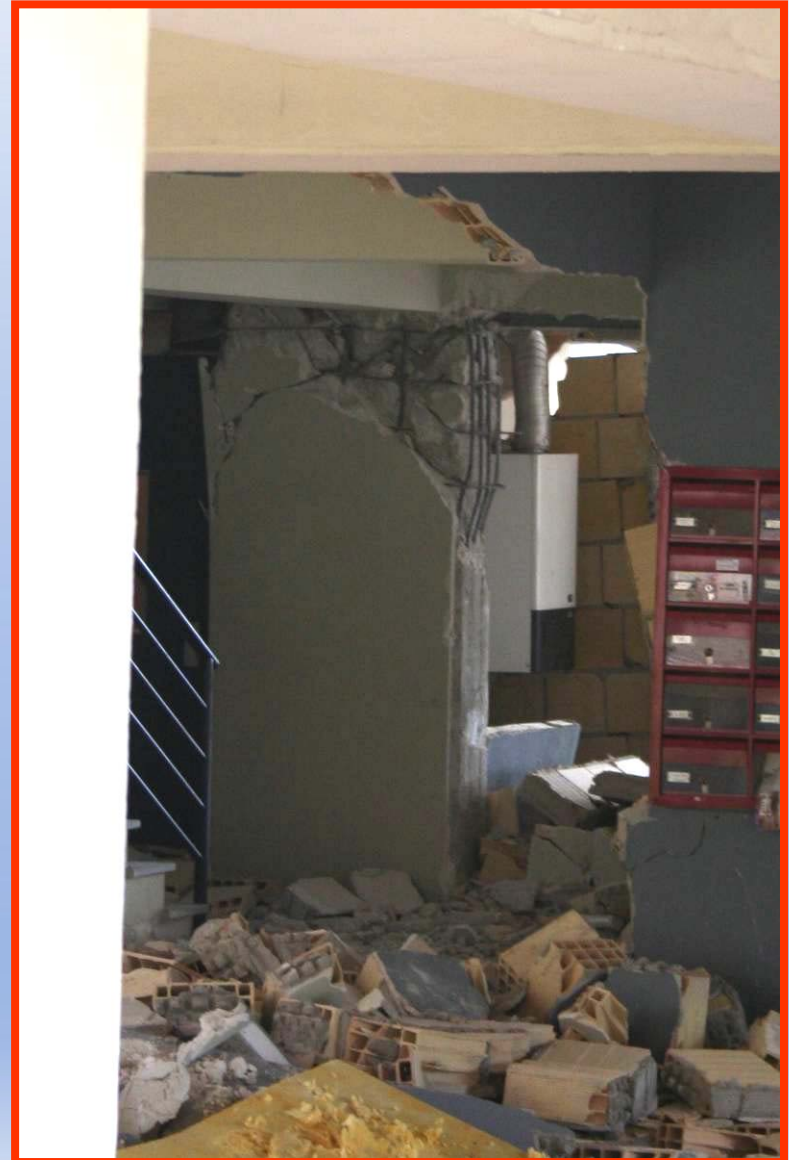
Shear Failure at the rectangular column end.

The stirrups spacing seems to be higher than 200mm.

Poor concrete quality

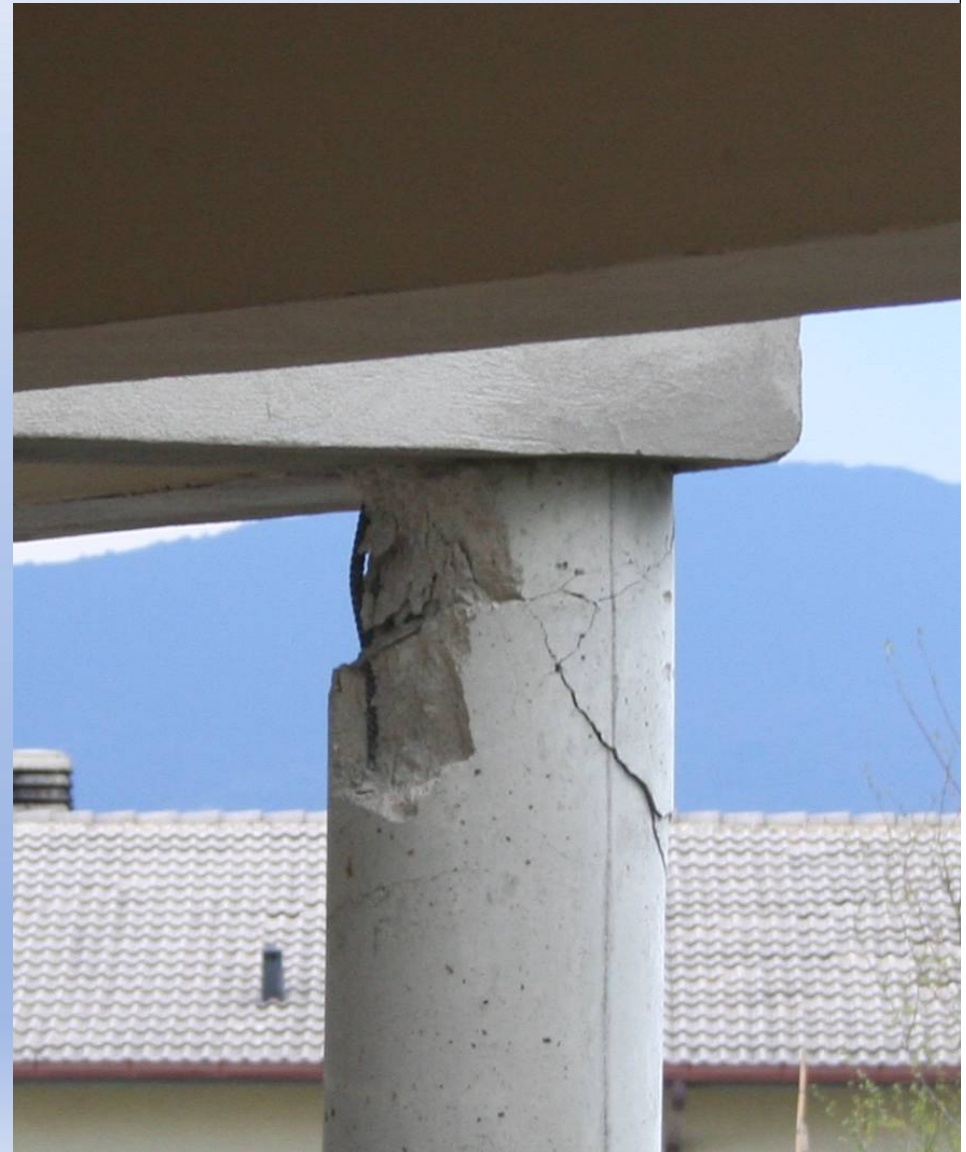
Shear Failure

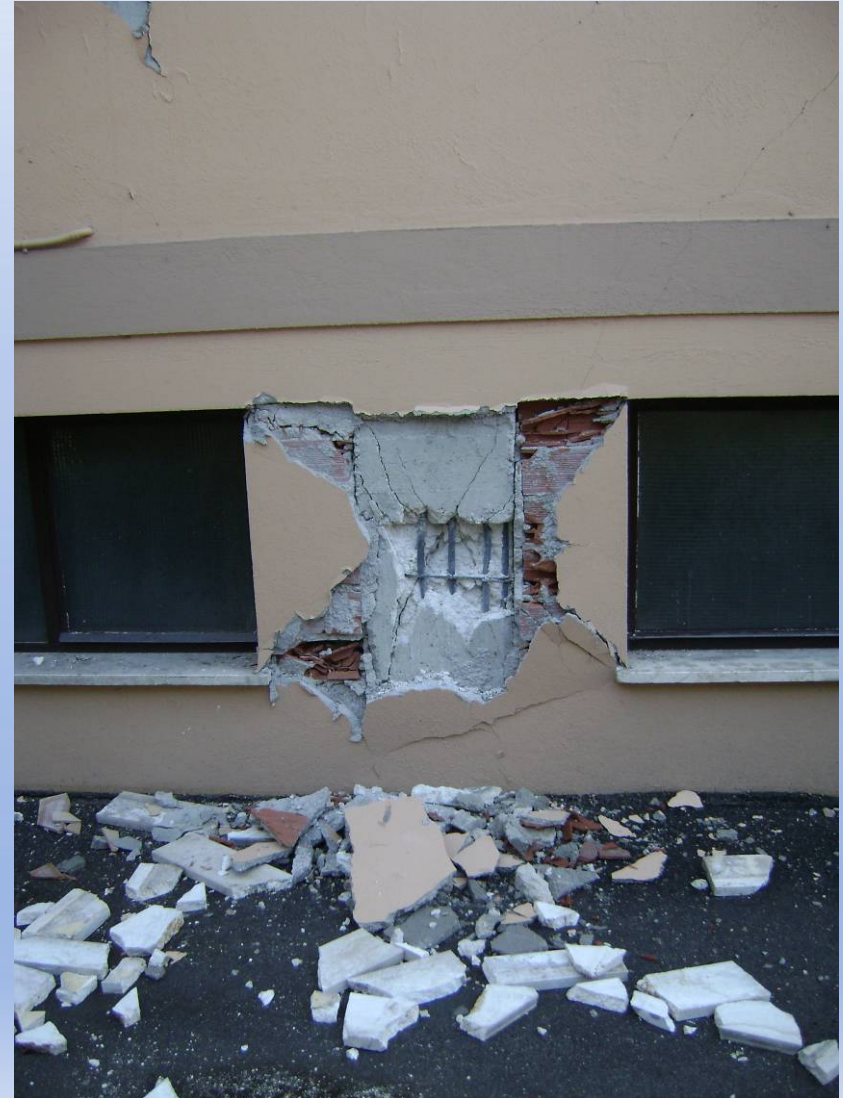
Shear Failure on the short columns due to the basement wall

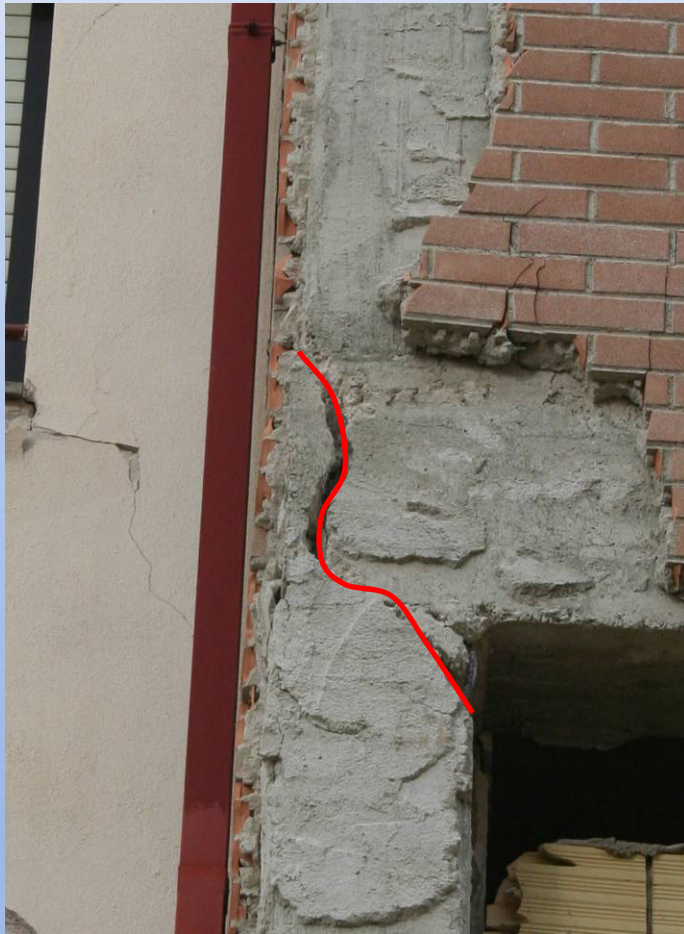
Lack of stirrups in the joint

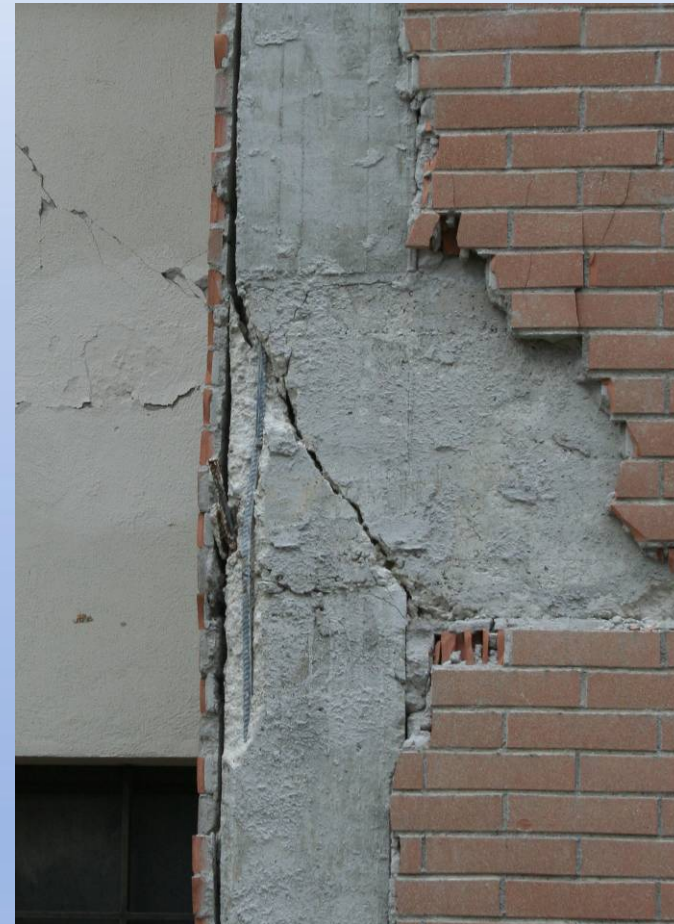
Buckling of longitudinal rebar from column to the joint

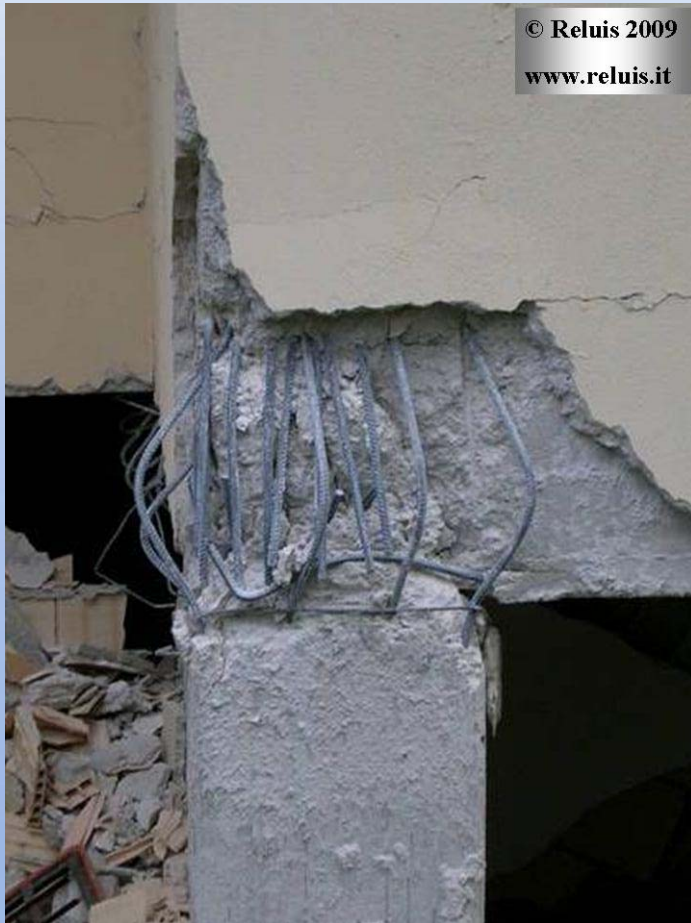
No stirrups in the joint

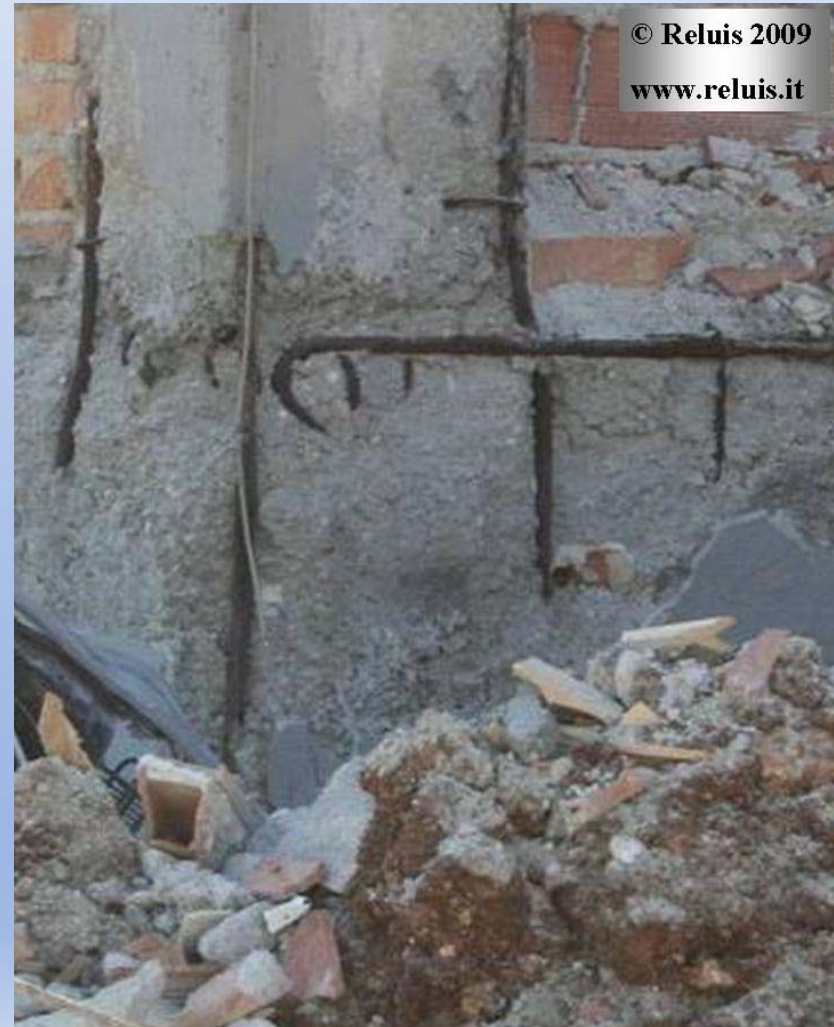
Poor concrete quality

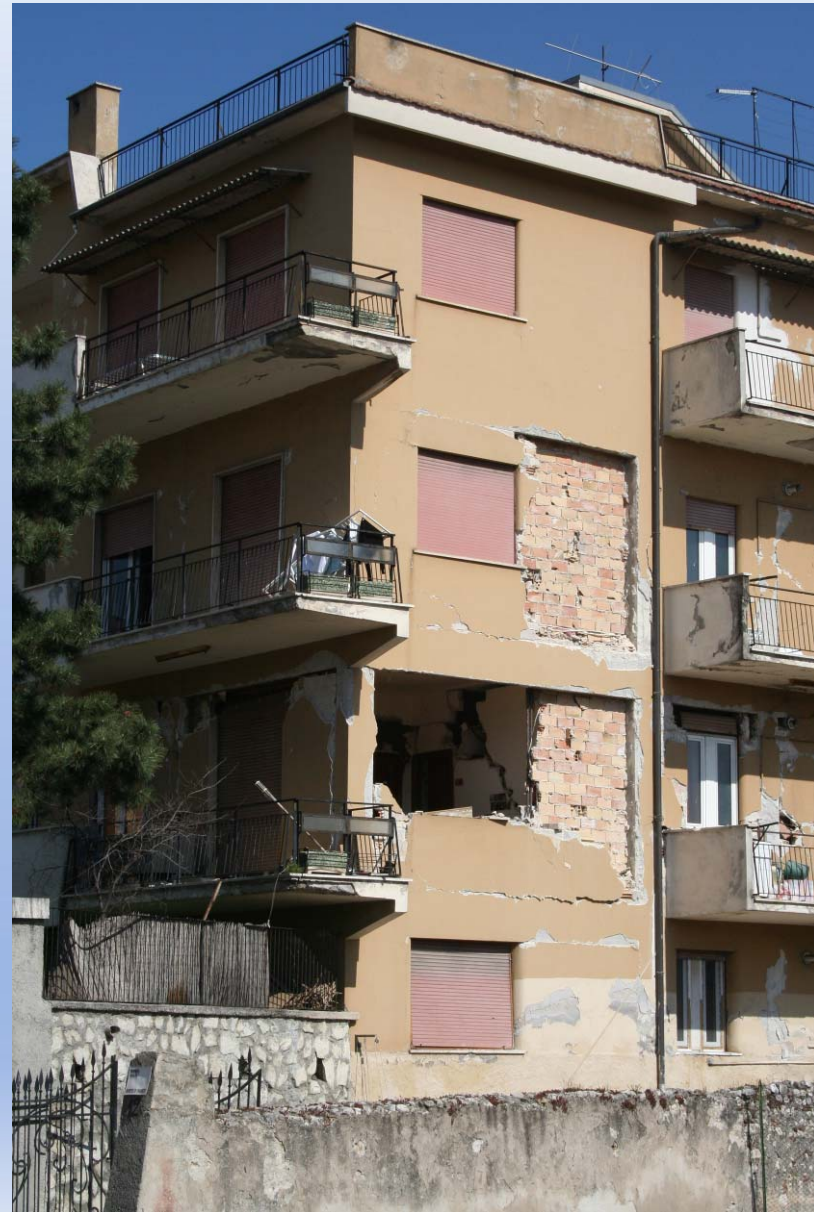
Discontinuity due to openings

Overturning of external partition's panel

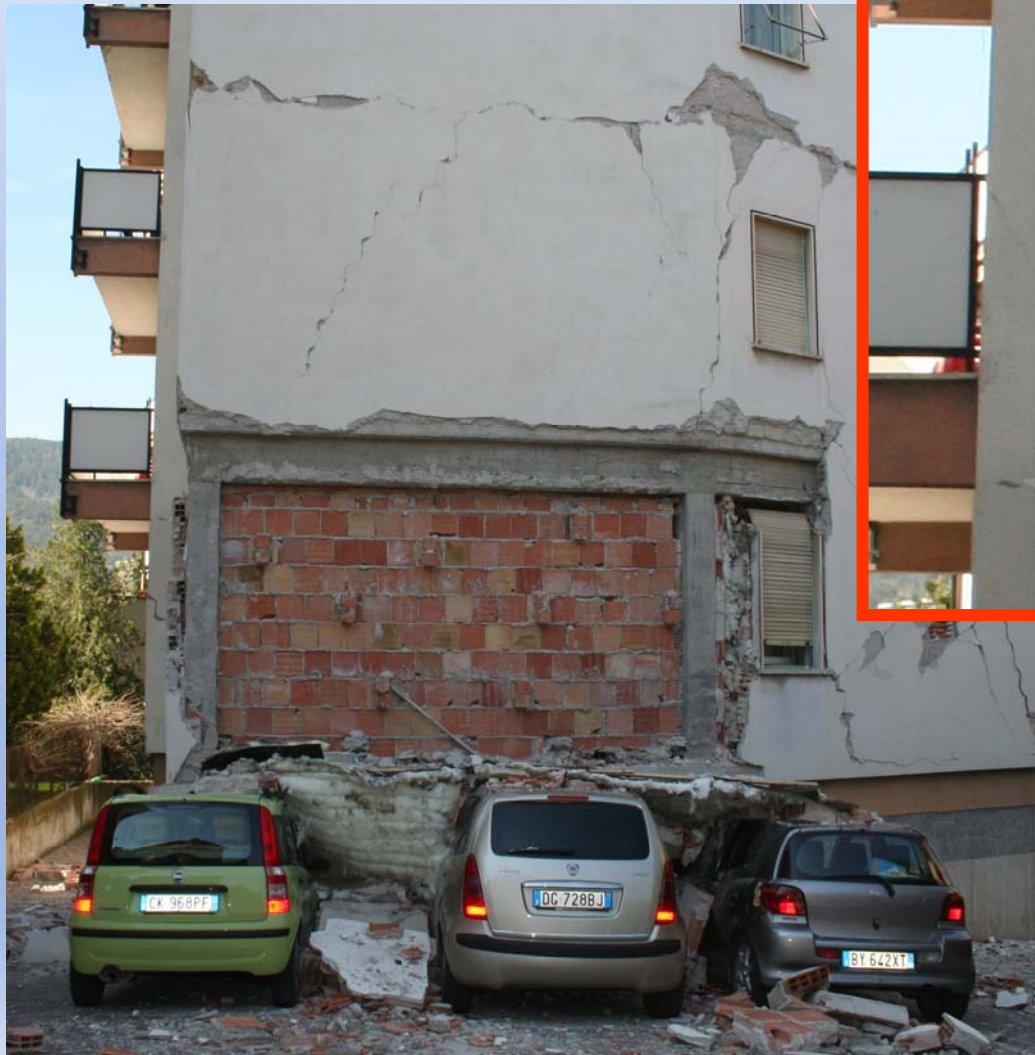
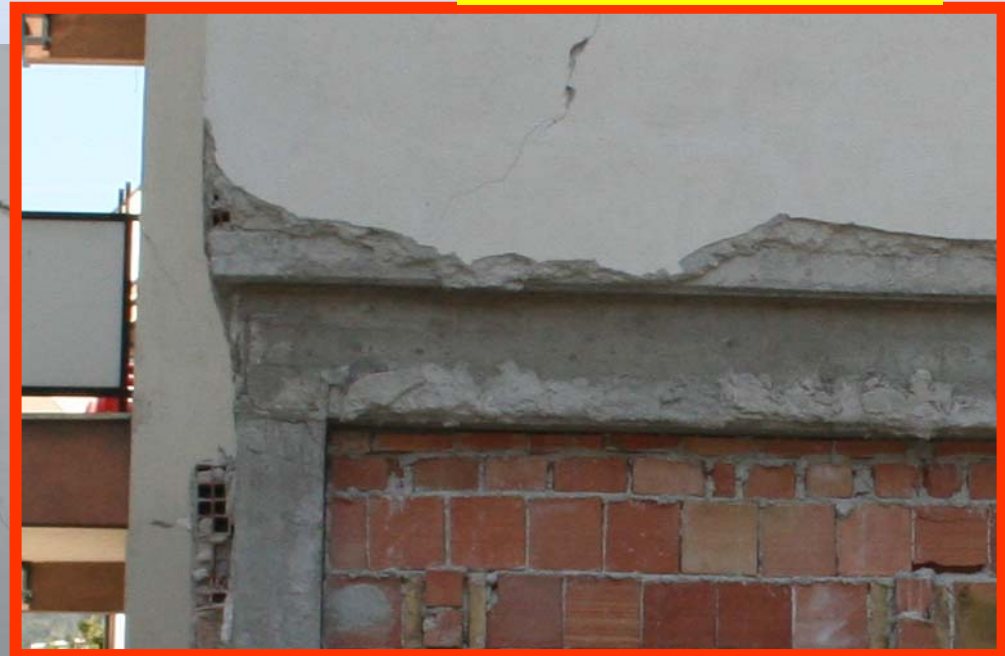
**Overturning of external  
partiton's panel**

*High slenderness*

*No lateral restrains*

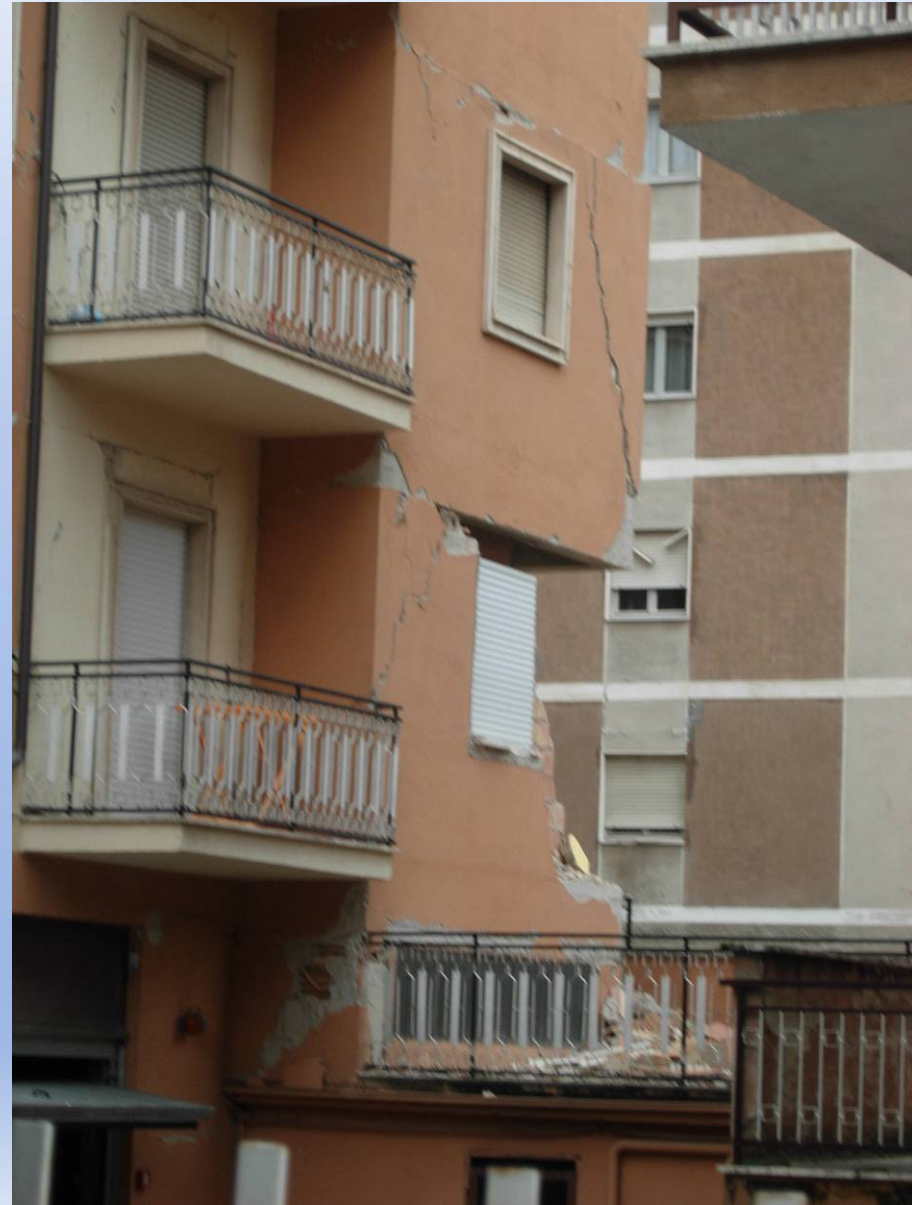
*No lateral restrain.*

Failure of external corner with damage of two sides.

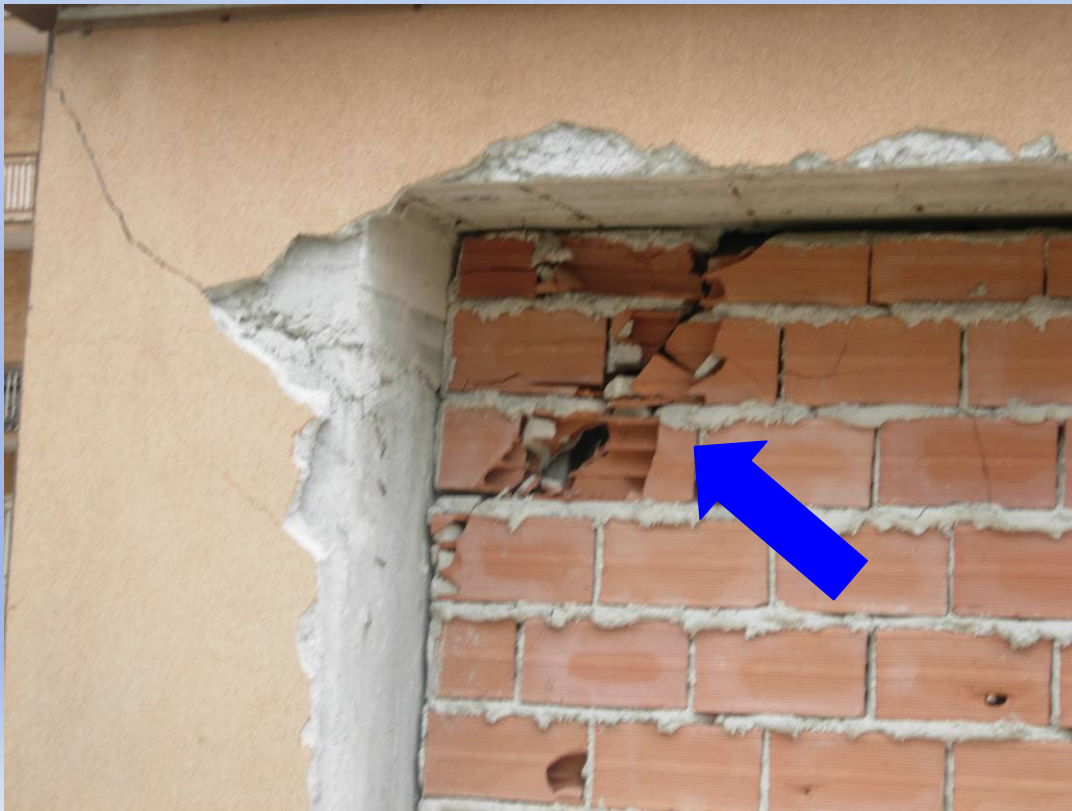
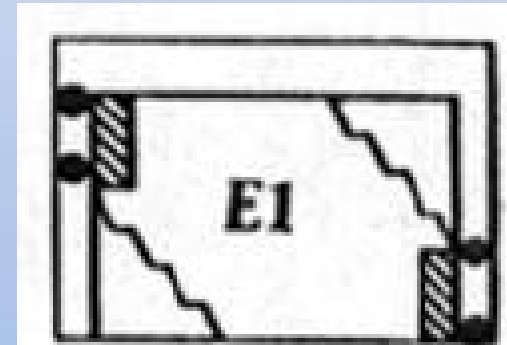
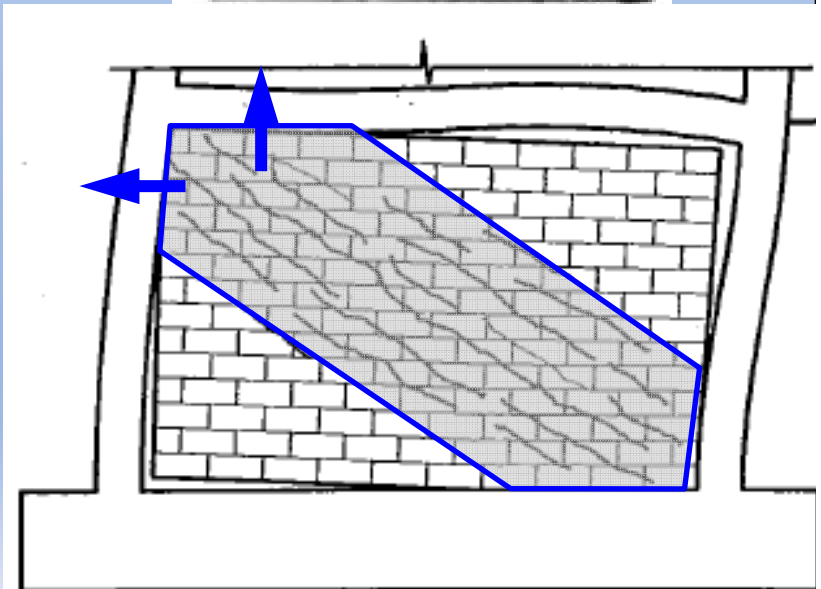
Typical partition crushing on corners due to the compressive stresses.

Diagonal flexural crack on the columns' end

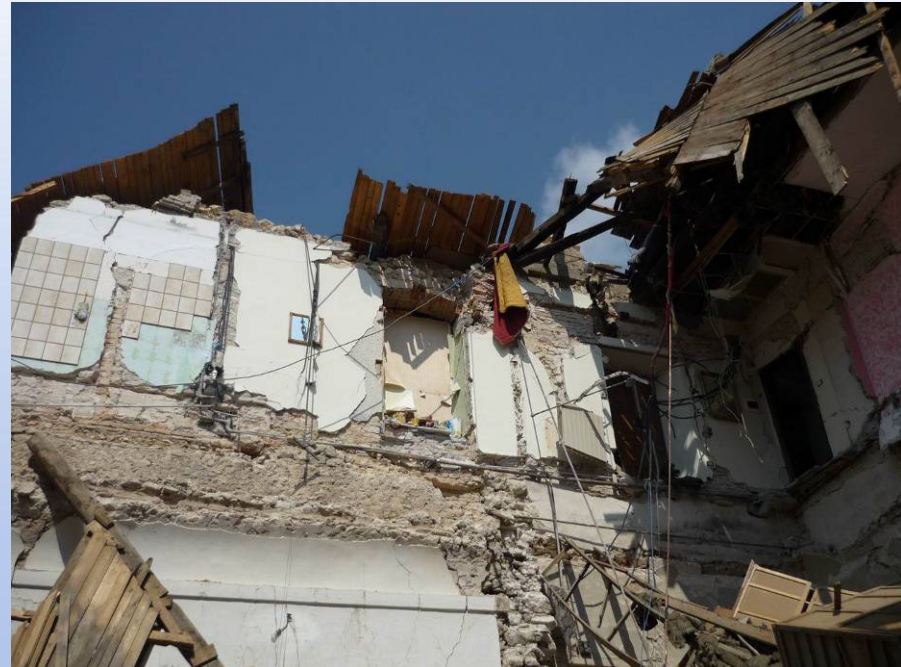
L'Aquila: lack of transversal wall at the upper level of the building

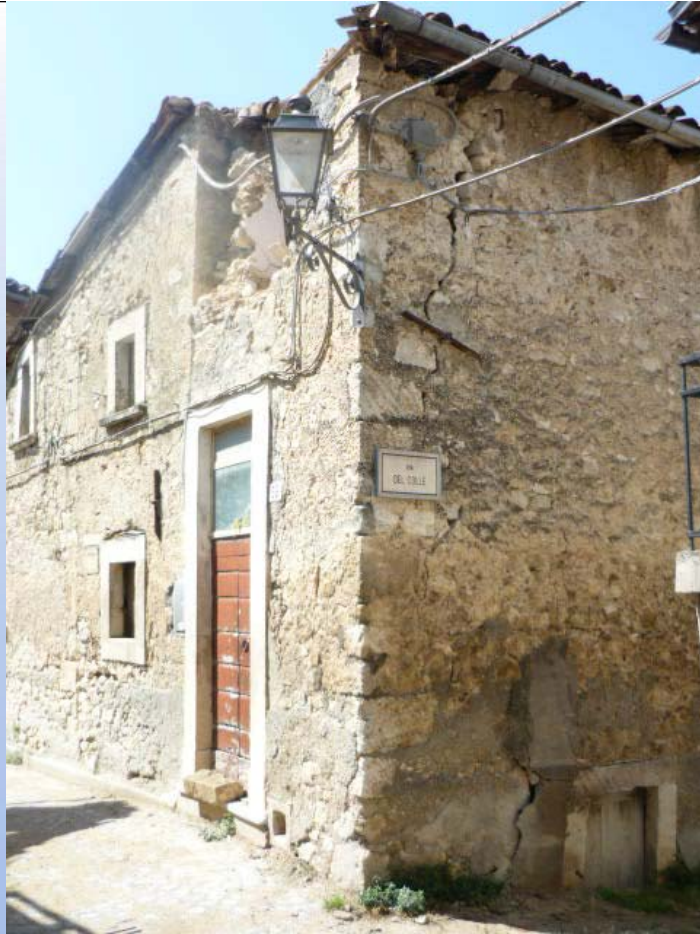
Poggio Picenze: Local collapse due to a wall discontinuity

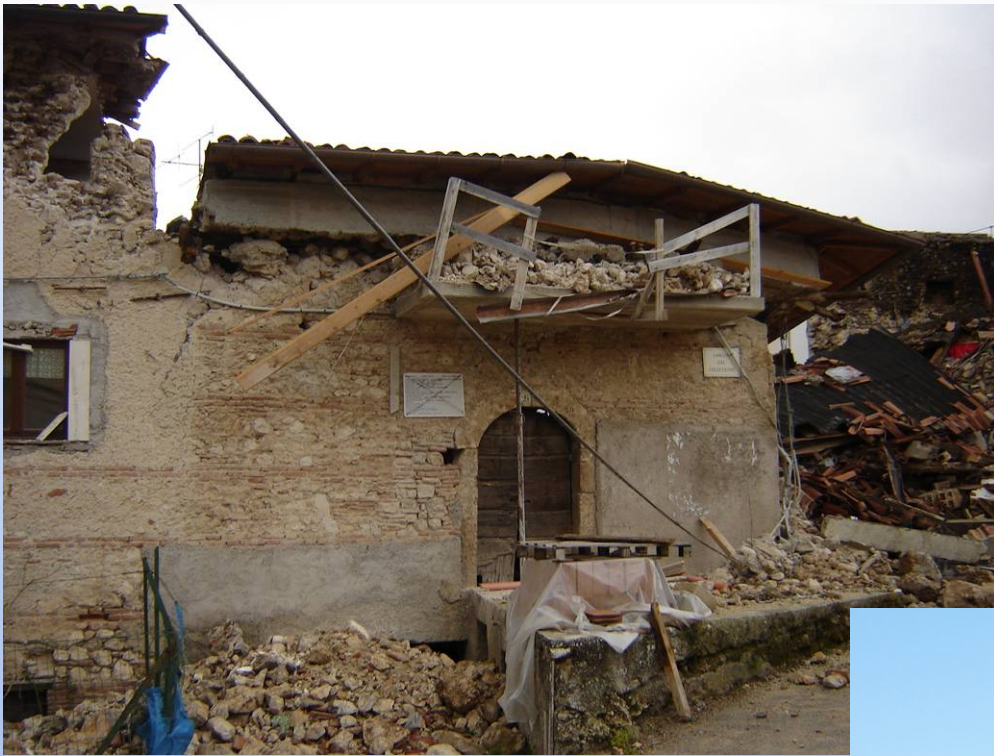
Tempera: the heavy roof caused the collapse of masonry walls

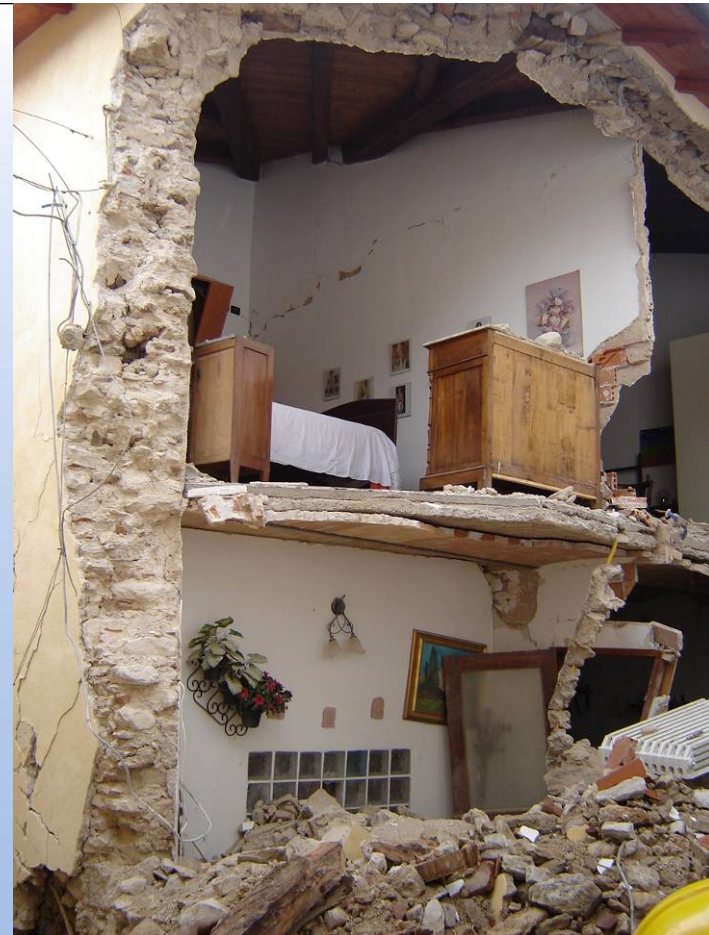
Paganica: insertion of a deep r.c. slab

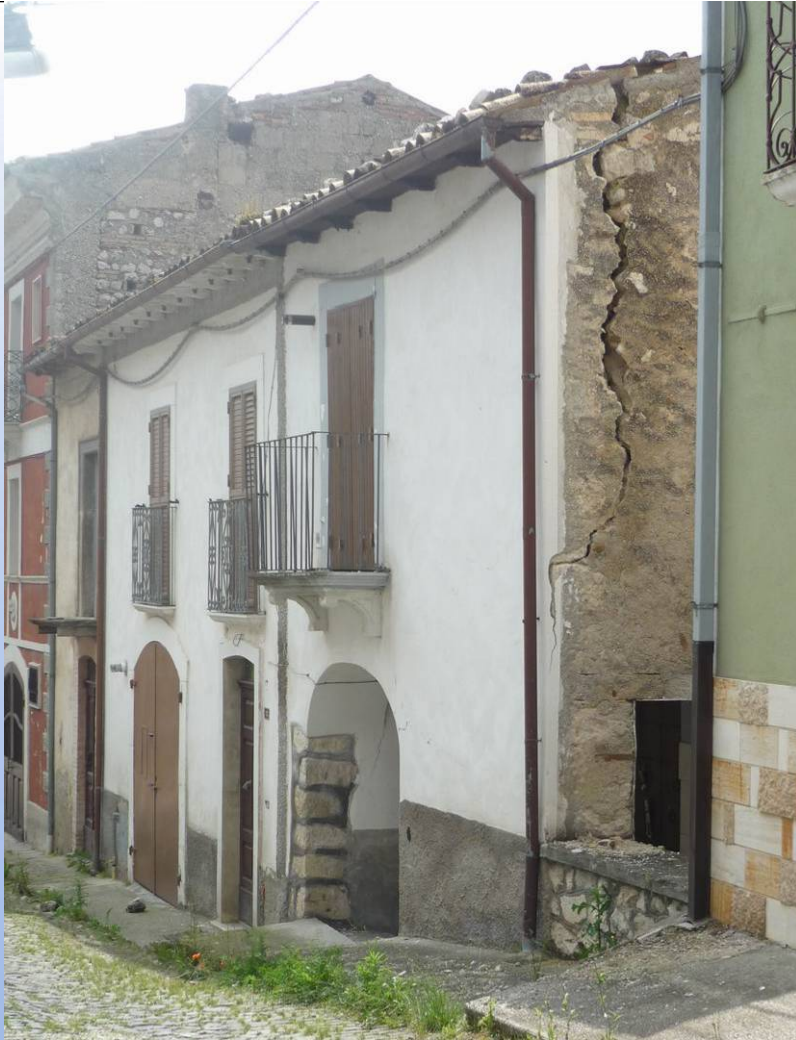
Castelnuovo: poor connection between masonry walls.

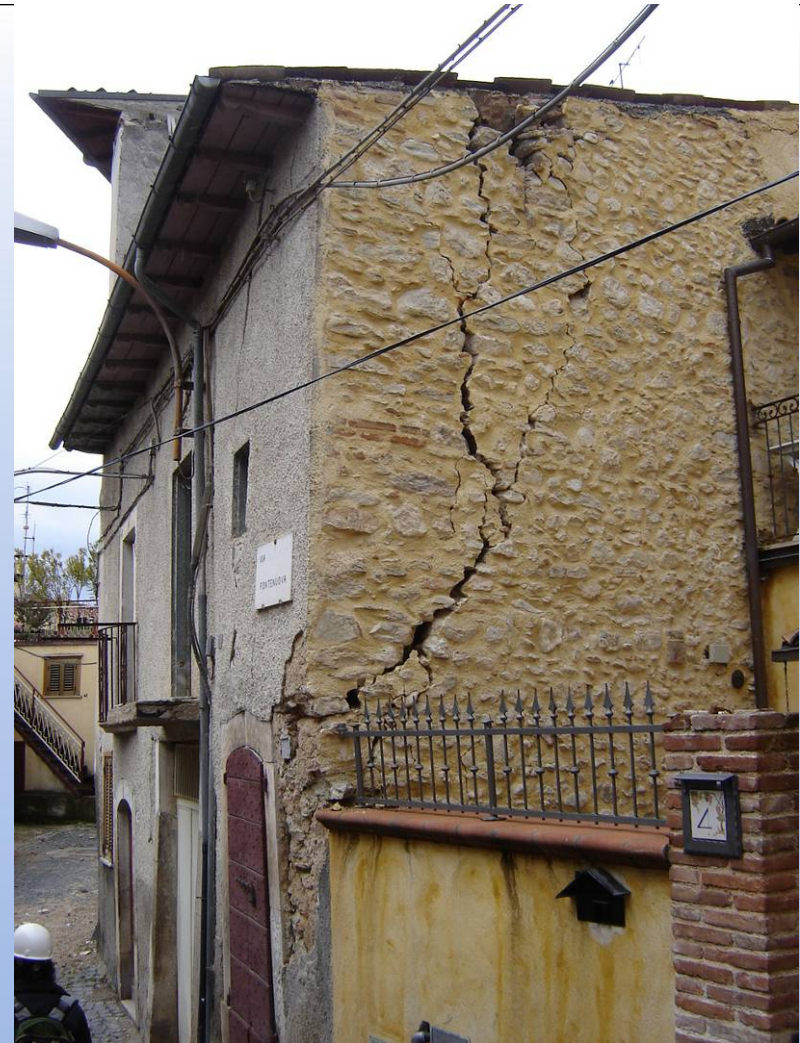
Paganica: overturning crack involving a portion of masonry wall.

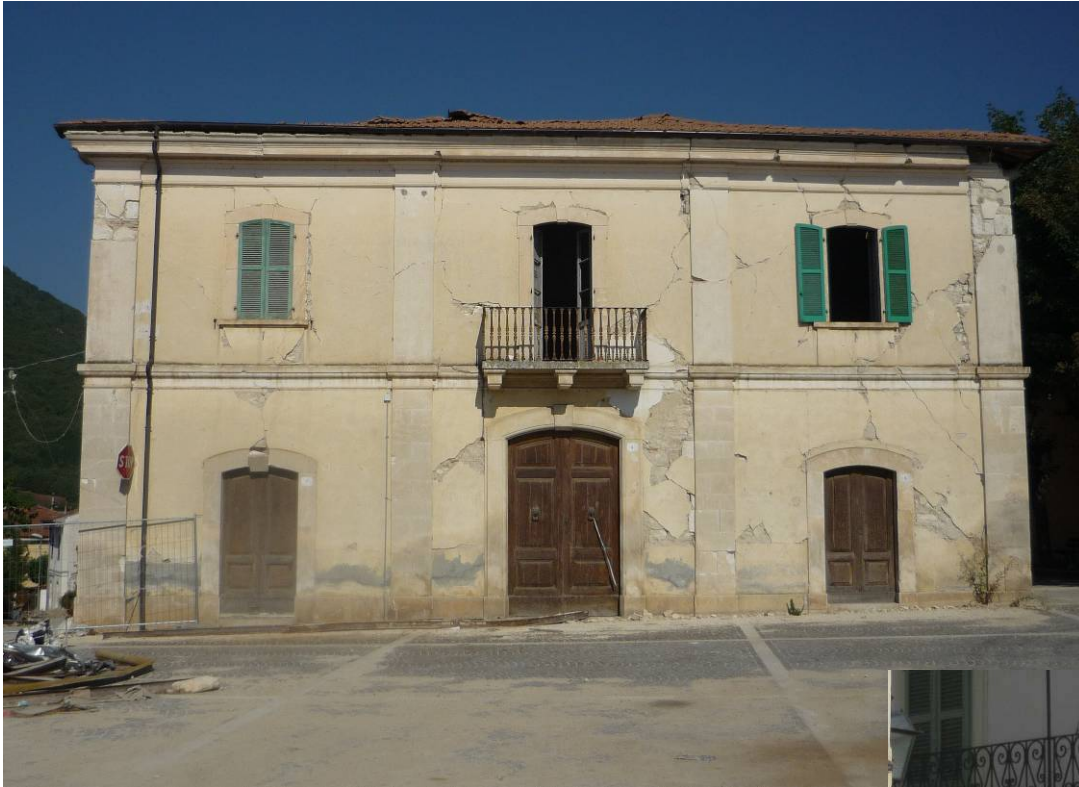
Villa Sant'Angelo: in-plane shear cracks on the whole facade wall.

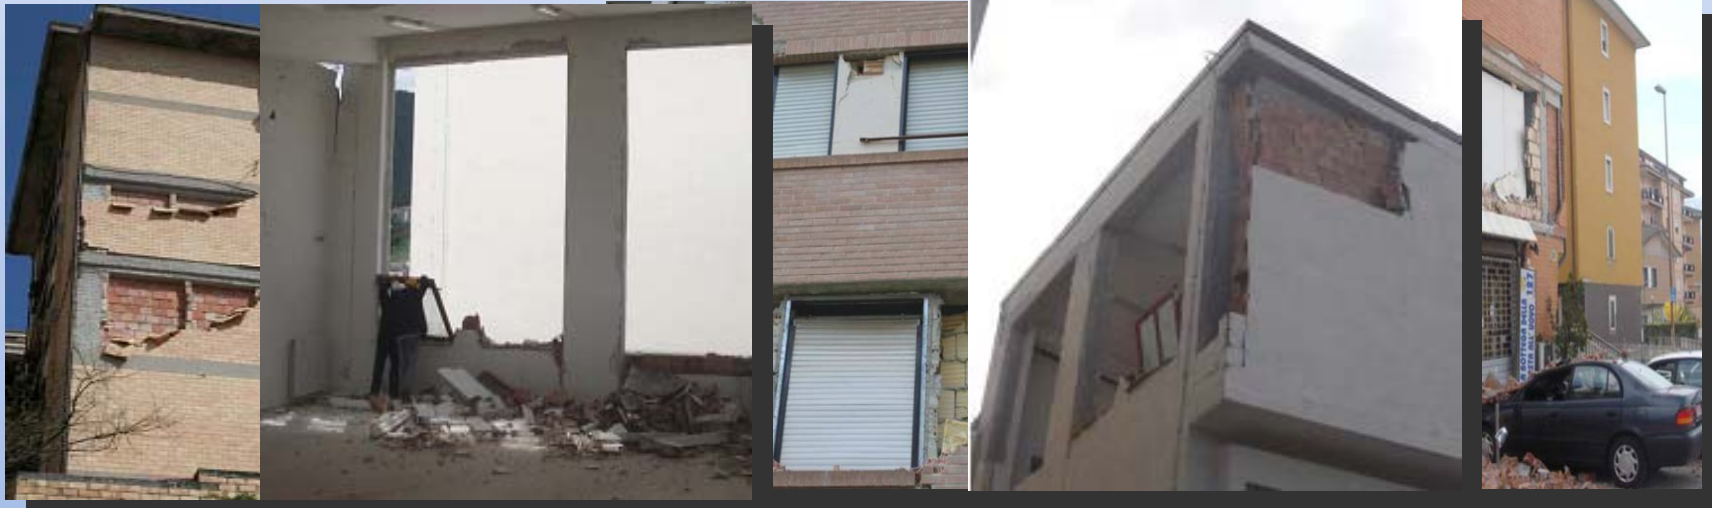
1. External panel of partition collapse;
2. Partition overturning:
3. Cracks on partitions.

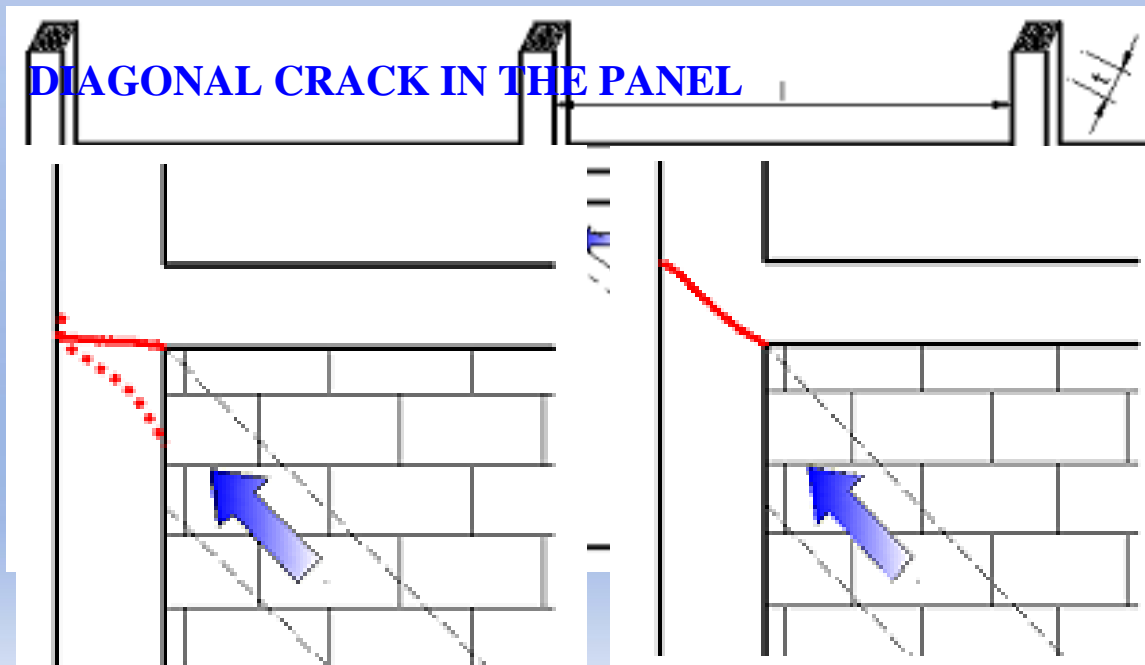
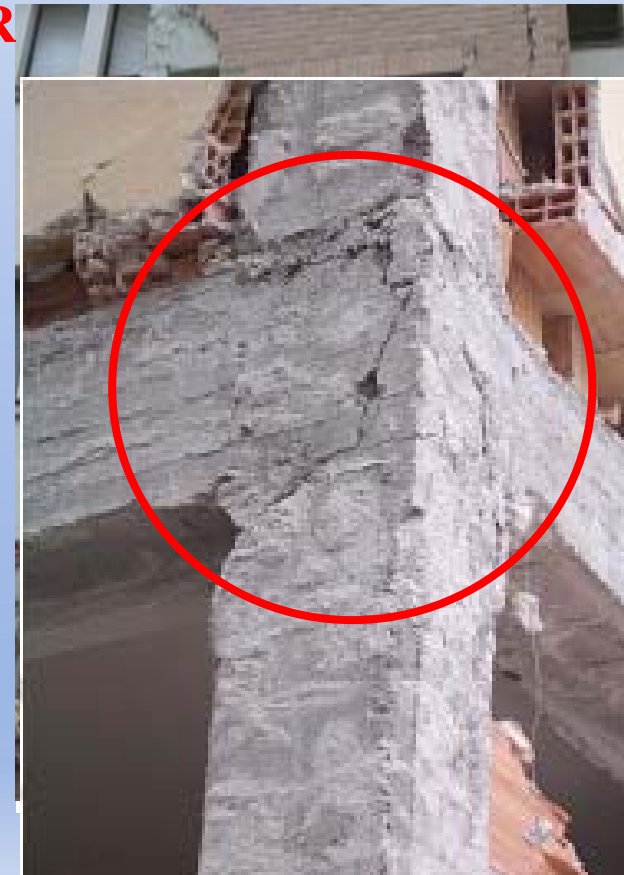
**DAMAGE OF STRUCTURAL MEMBER**  
**JOINT FAILURE:**

Cracks due to the actions provided by partition.  
**PSEUDO-HORIZONTAL CRACK** at column-joint panel interface.

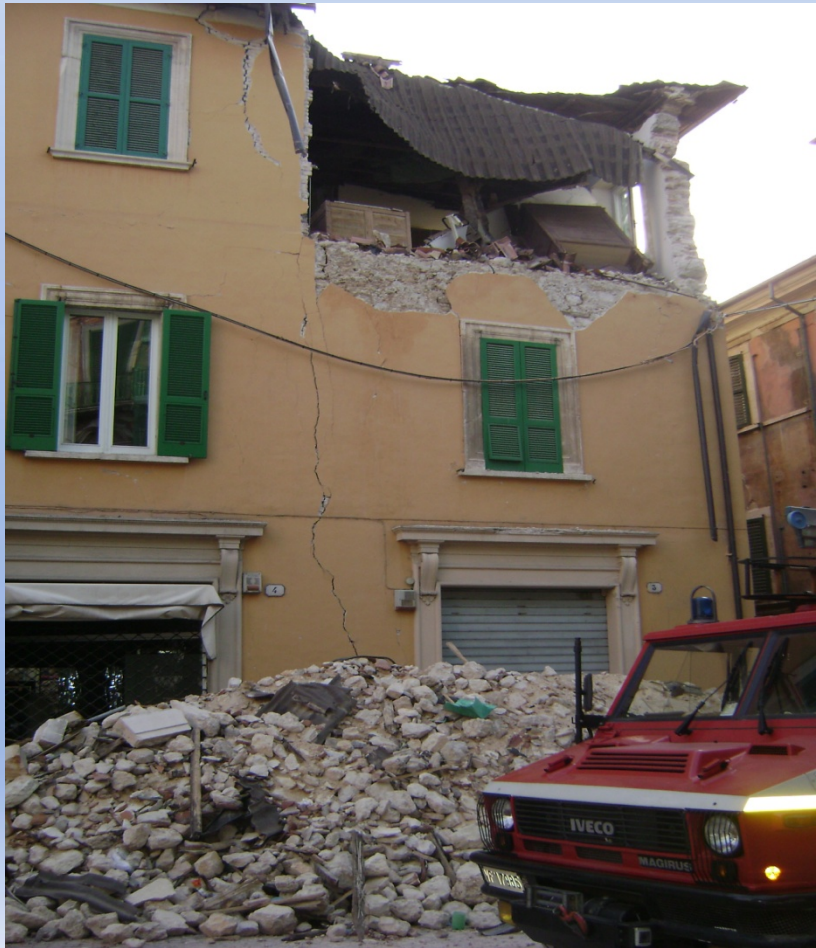
**DAMAGES**  
**OVERTURNING**
