# GEOTECHNICAL ENGINEERING RECONNAISSANCE OF THE 2010 HAITI EARTHQUAKE

Version 1: February 22, 2010

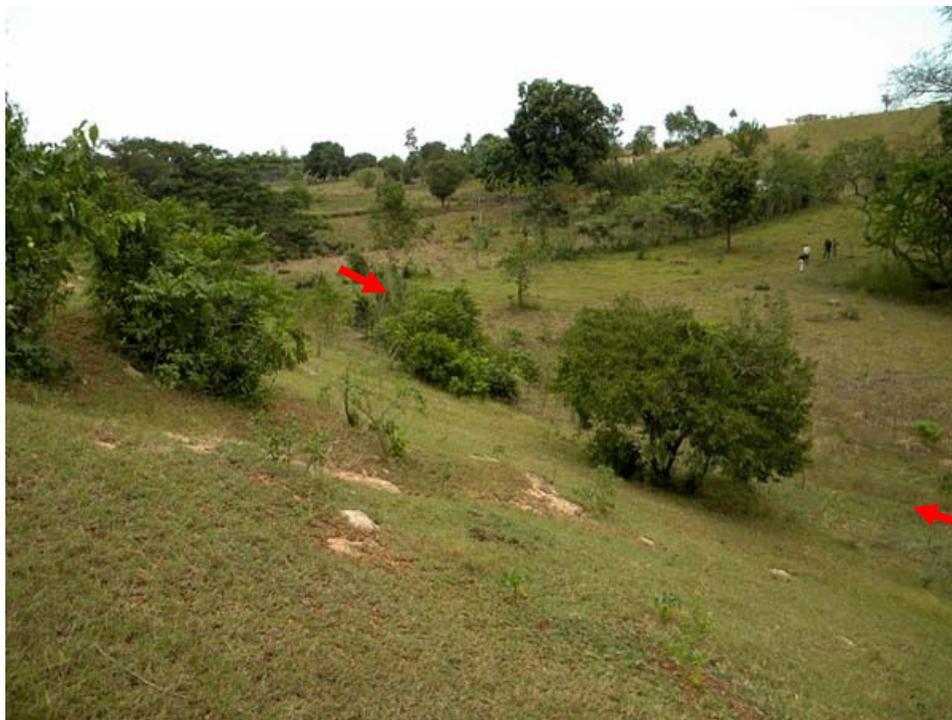
**Figure 4.4.** View west along trace of EPG fault at linear valley southwest of Dufort (west of Road 204). Fault trace likely between base of slope (between red arrows) and center of linear valley. No fractures or other evidence for fault rupture observed at this site (N18.444306, W72.643722,).

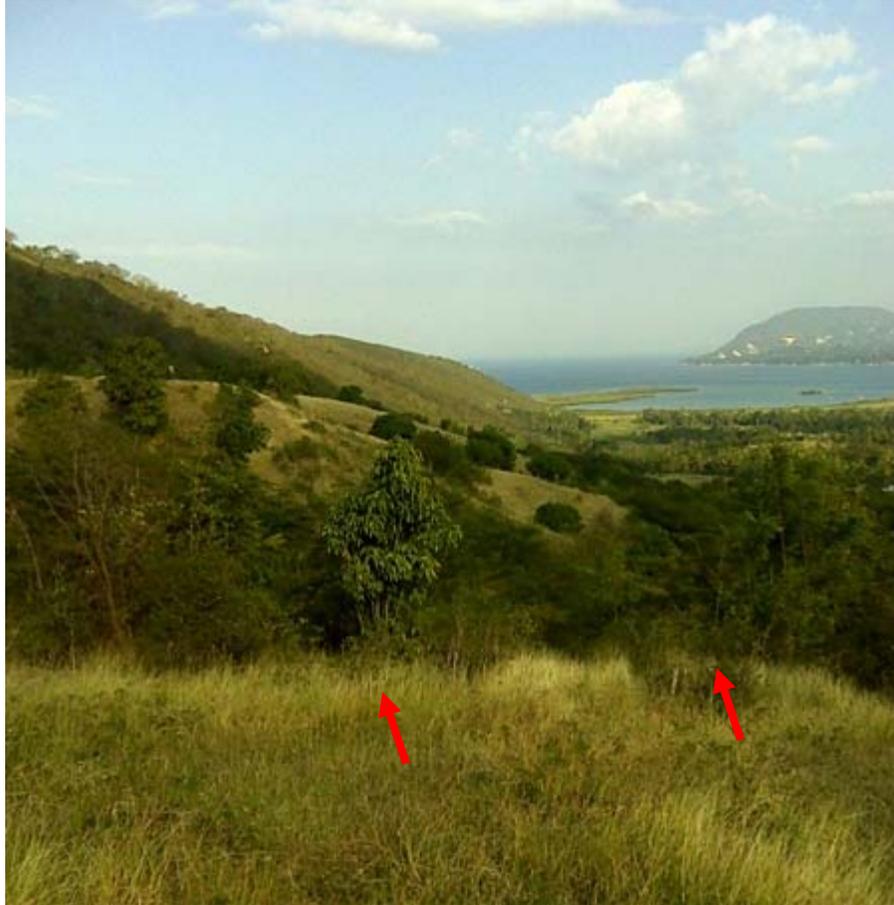
**Figure 4.9.** View east-northeast along fault west of Port Royal. Side-hill bench bounded by two fault traces at left and center of photo (above red arrows). No fractures or other evidence for fault rupture observed at this site (N18.440027, W72.923304).

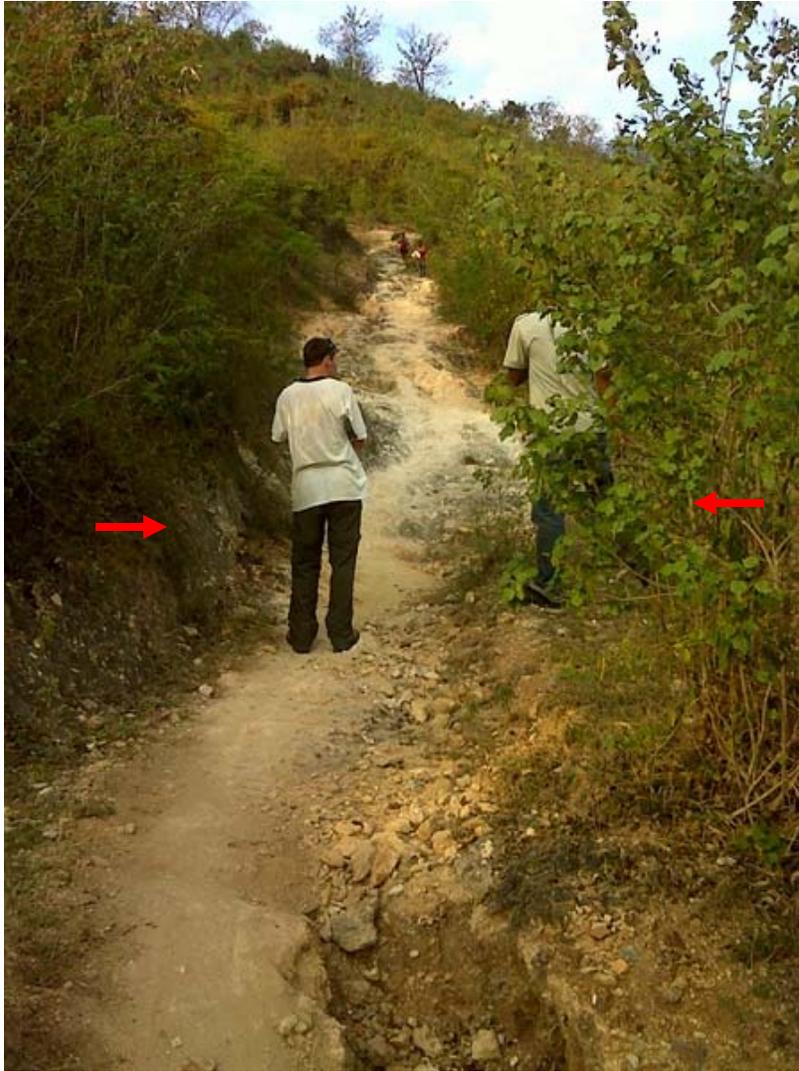
**Figure 4.11.** View north across fault at west of Port Royal. Fault passes perpendicular to track in middle of photograph at colluvium-bedrock contact (at red arrows upslope from team members). No fractures or other evidence for fault rupture observed at this site (N18.44150, W72.916389).

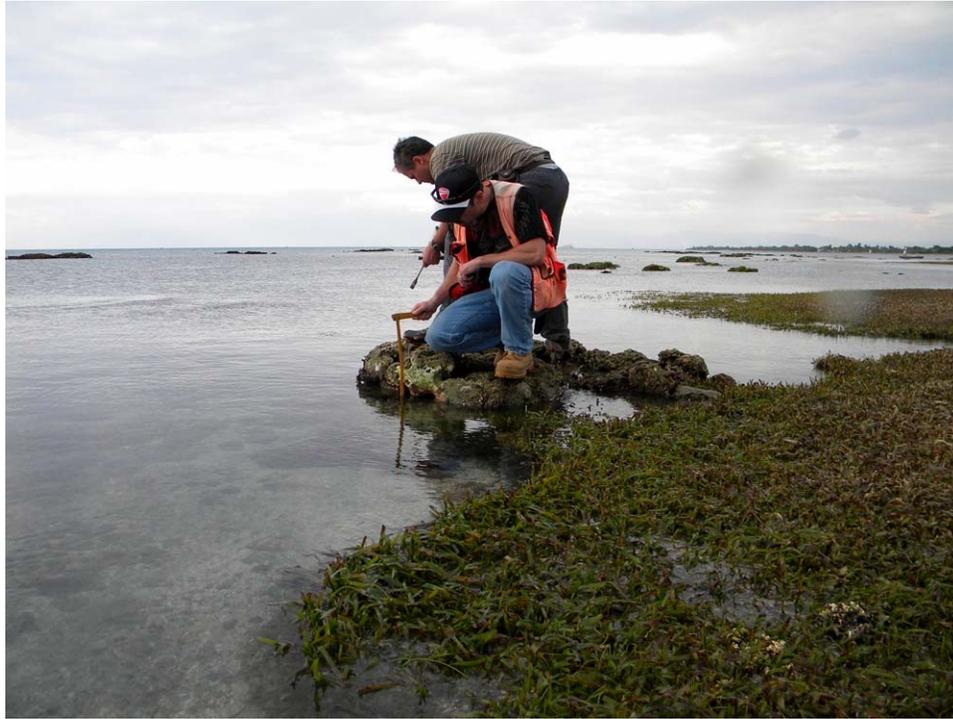
**Figure 4.17.** Exposed coral head at Ca Ira, Léogâne. Team members measuring uplift of coral head. (N18.525333, W72.652008)

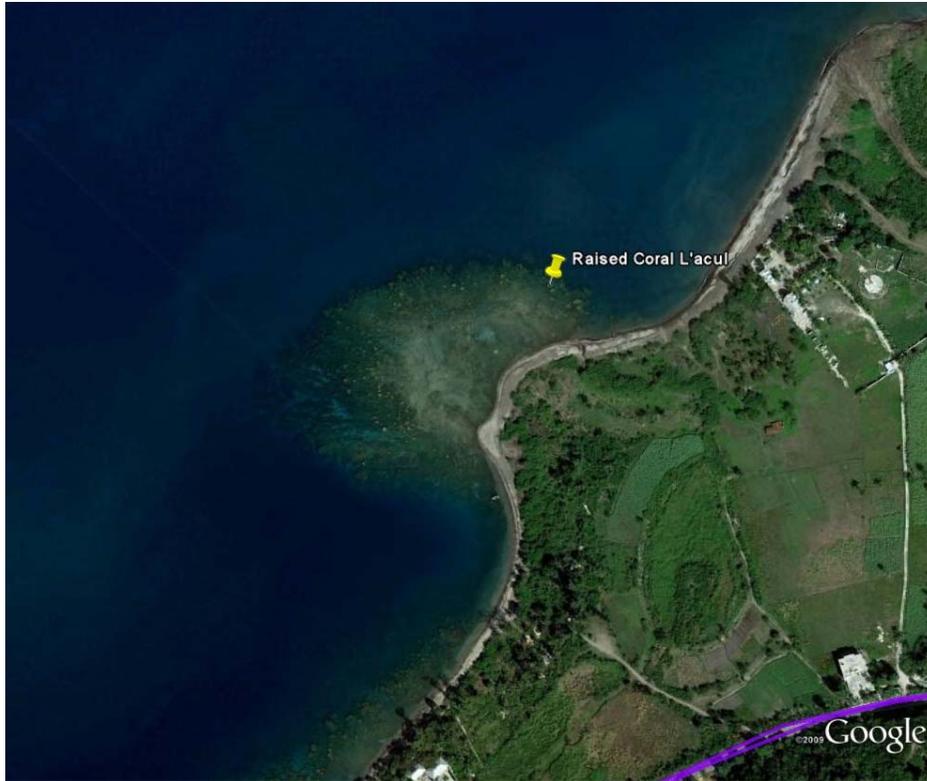
**Figure 4.18** Aerial view of coral uplift near L'acul.  
(See GEER Haiti Report.kmz for location)

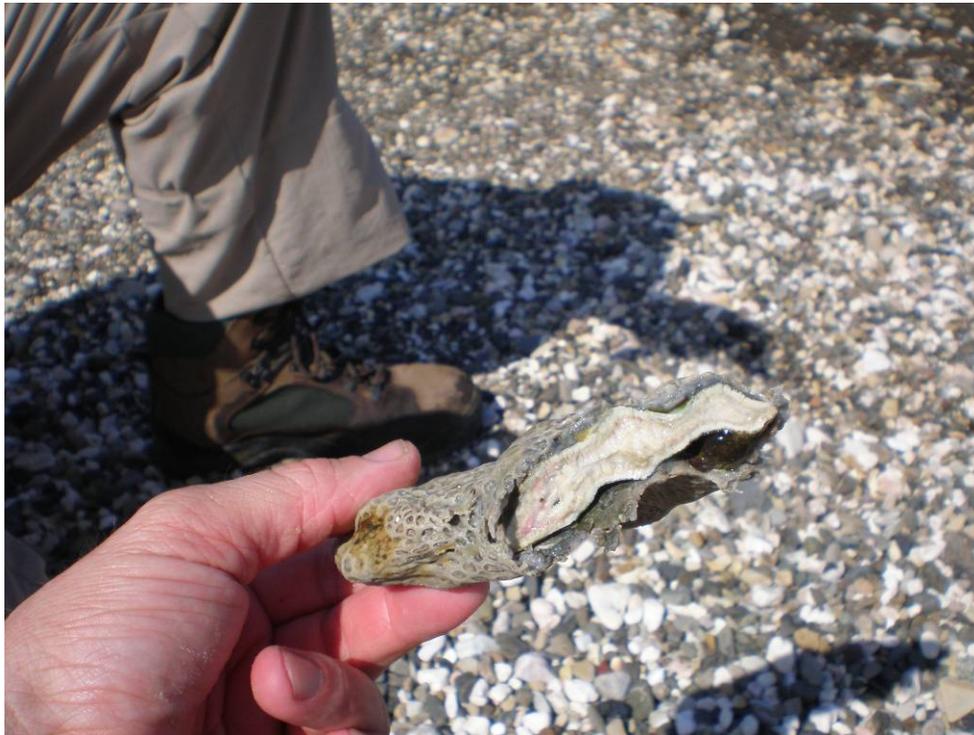
**Figure 4.20** Fleshy living, or recently living, coral collected from the top of a coral spire projecting about 3 to 5 cm above water level at the time of the GEER field visit. (N18.446463, W72.688354)

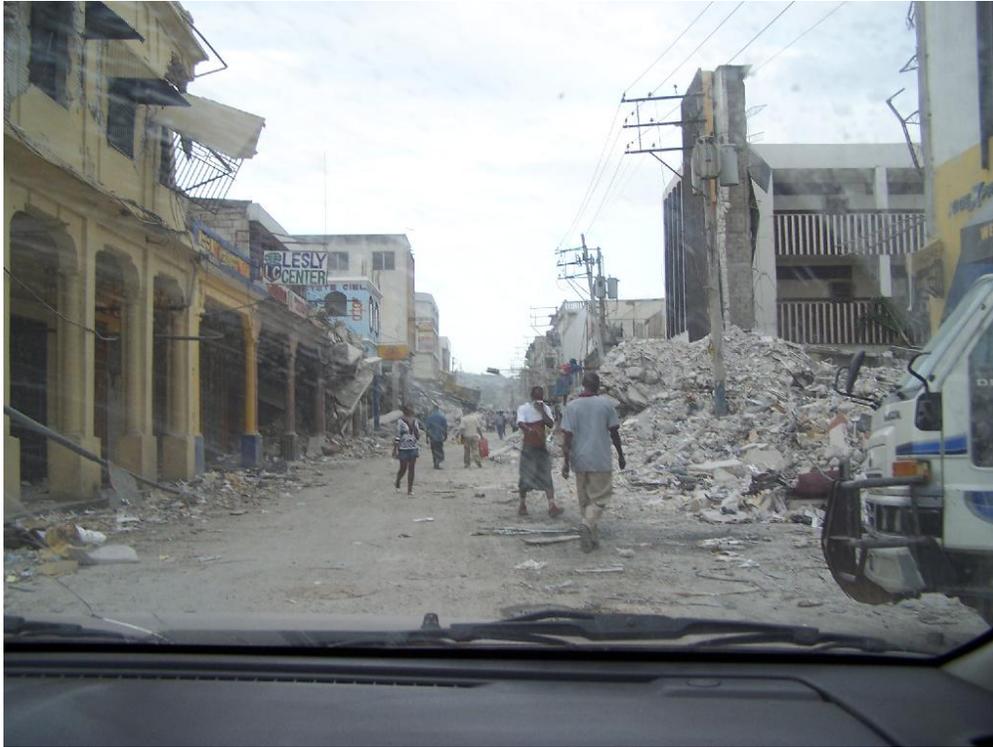
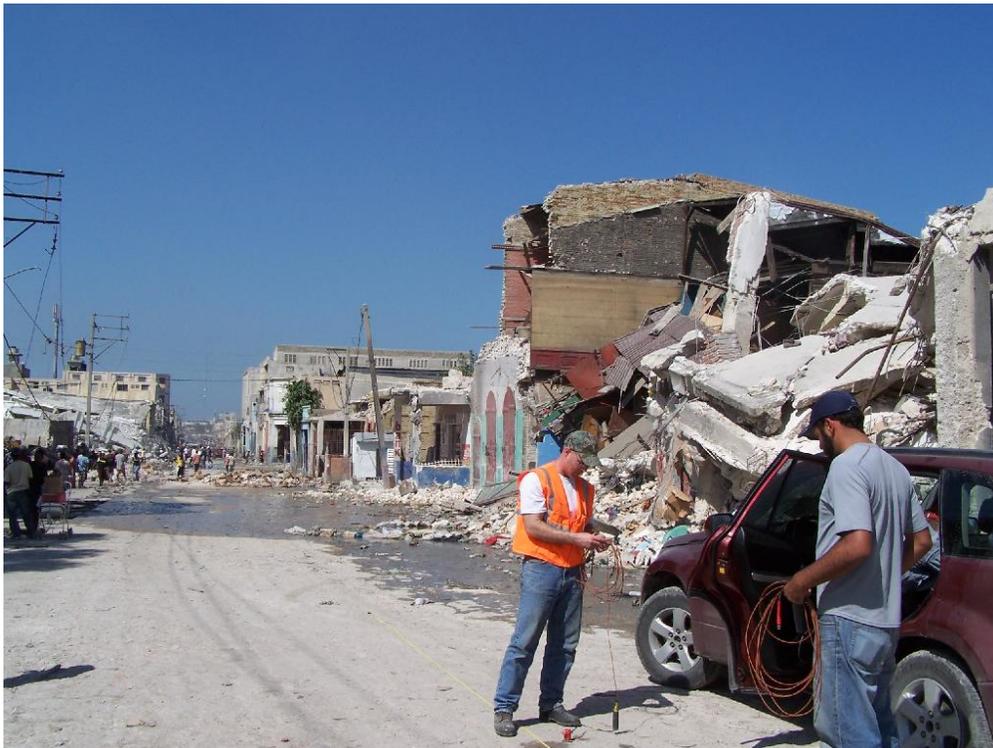
**Figure 5.8** Typical types of structures and damage found within the heavily damaged zone near SASW 8 (N18.550210°, W -72.339638°).

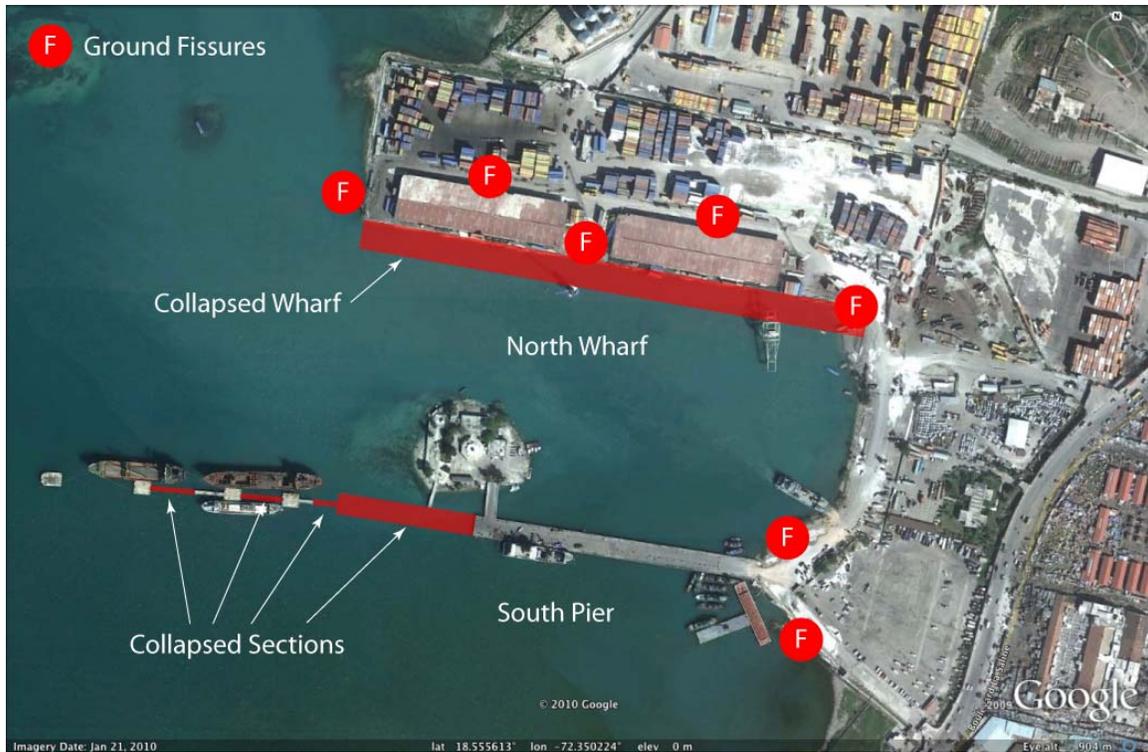
**Figure 6.5** Annotated aerial image of Port de Port-au-Prince showing locations of damage due to the earthquake. Imagery courtesy of Google Earth. (N18.555058°, W72.351144°)

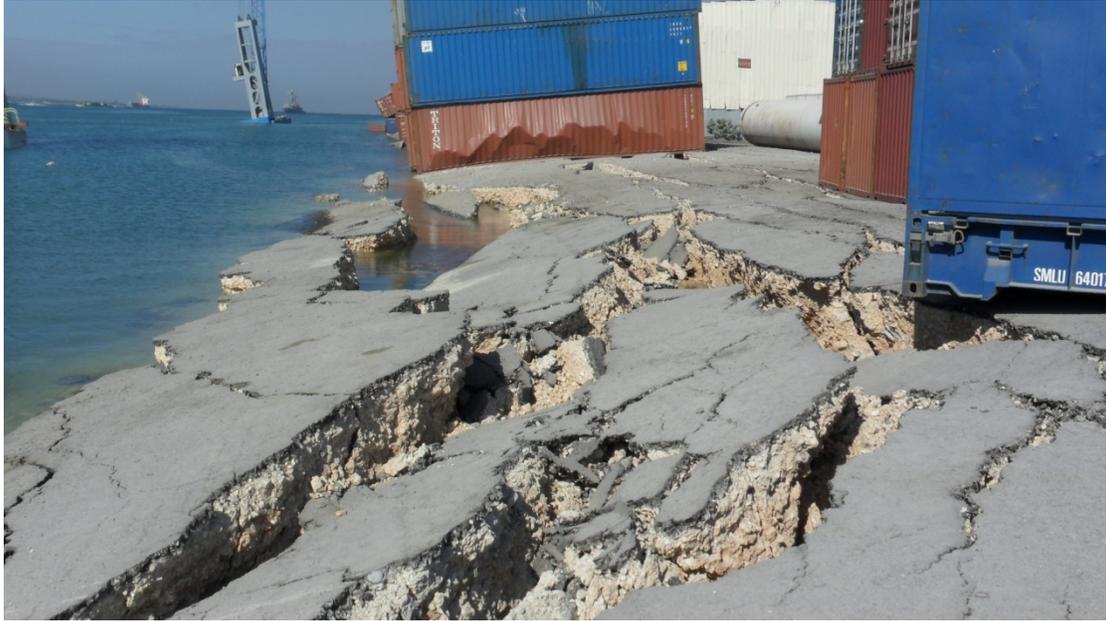
**Figure 6.6** Lateral spreading adjacent to the collapsed North wharf. Note the crane in the water in the background and the metal warehouses on the right. (N18.55622, W72.34787)

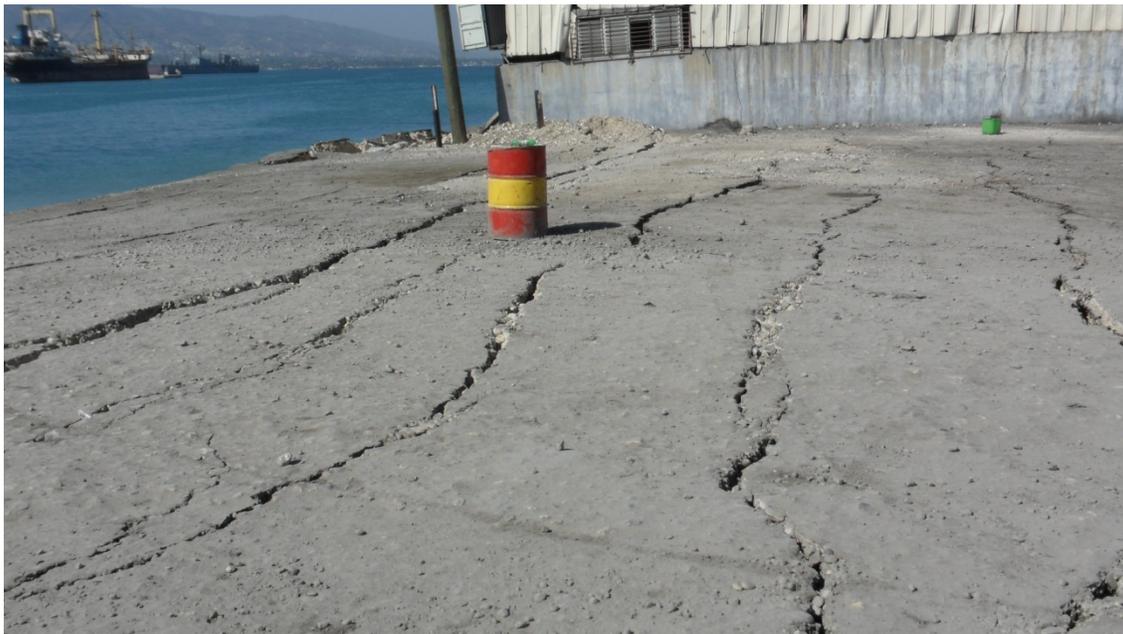
**Figure 6.7** Lateral spreading between the two metal warehouses, adjacent to the collapsed North wharf (left). A cumulative total of 89 cm of horizontal movement (determined by crack width) was measured in a zone extending inland approximately 30 m from the post-earthquake shoreline. Post-earthquake imagery indicates lateral spread cracking extended 50 m inland. (N18.556696, W72.34787)

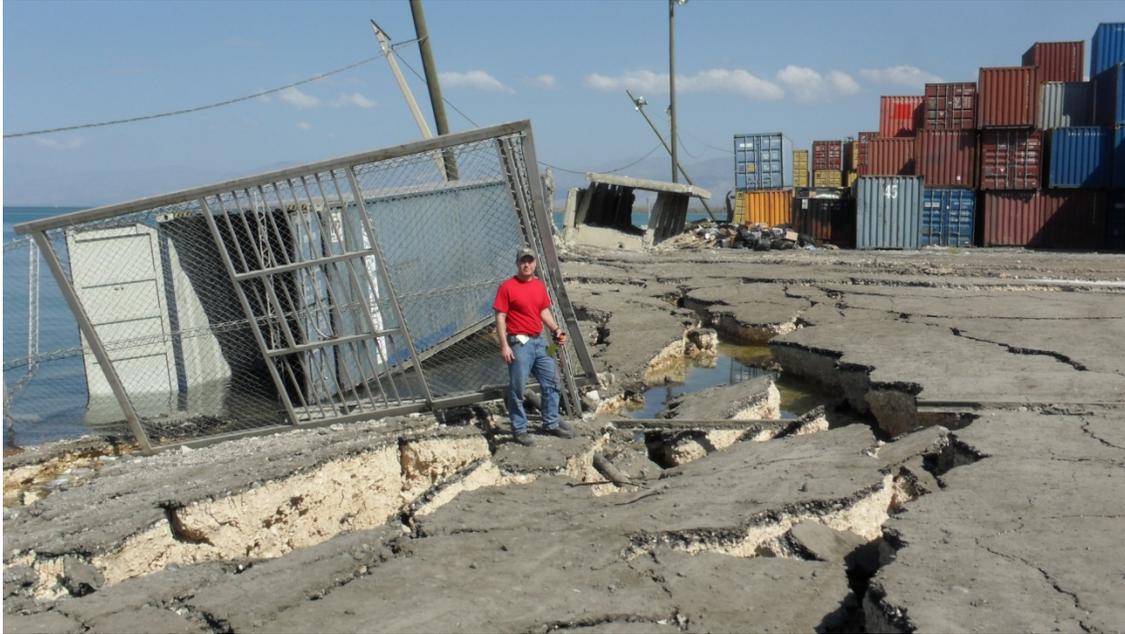
**Figure 6.8** Lateral spreading west of the two metal warehouses. Photo taken facing north with the metal warehouses to the right. (N18.557075, W72.352045)

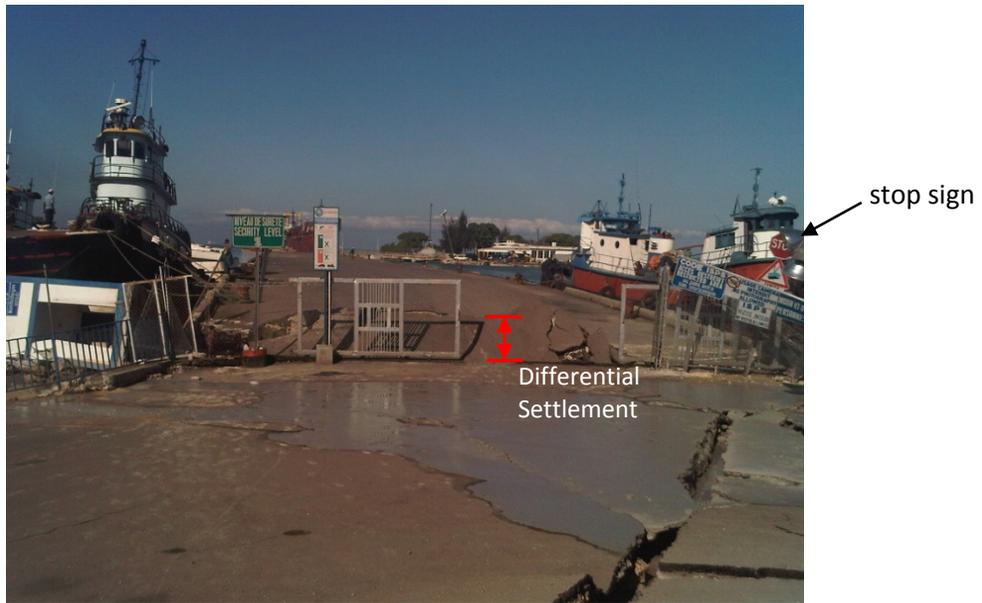
**Figure 6.15** Approach to the South Pier immediately after the earthquake (top photo: Source unknown; photo taken facing South-East) and after approximately 1 m of fill was placed (bottom photo: photo taken facing West). (N18.554028, W72.348658)

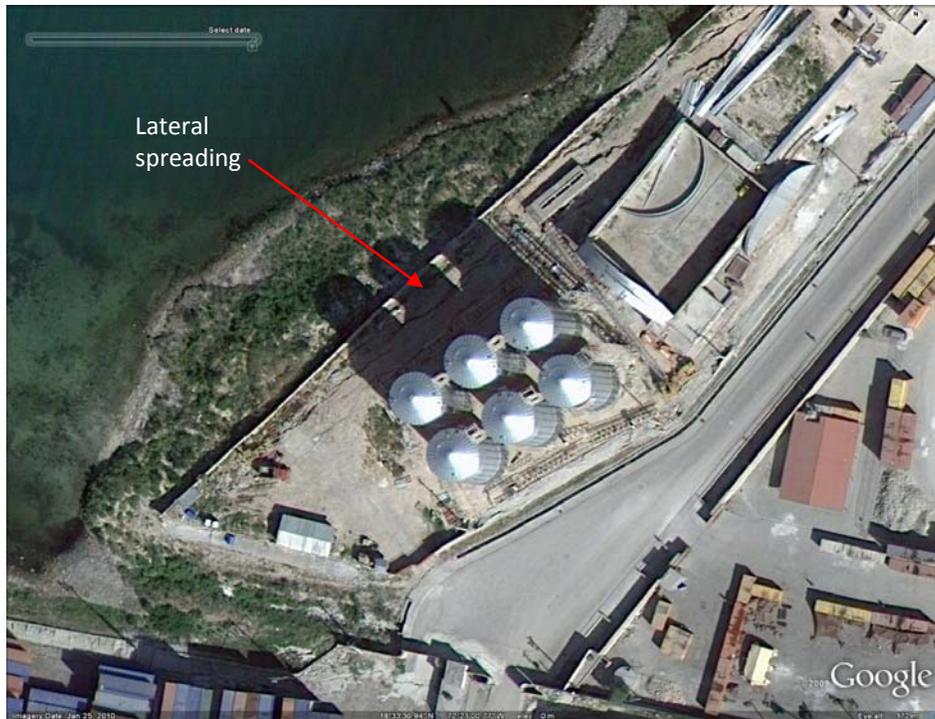
**Figure 6.18** Lateral spreading behind (westward side) steel grain hopper silos. However, the foundation system for the silos showed no visible signs of distress.  
Imagery courtesy of Google Earth.

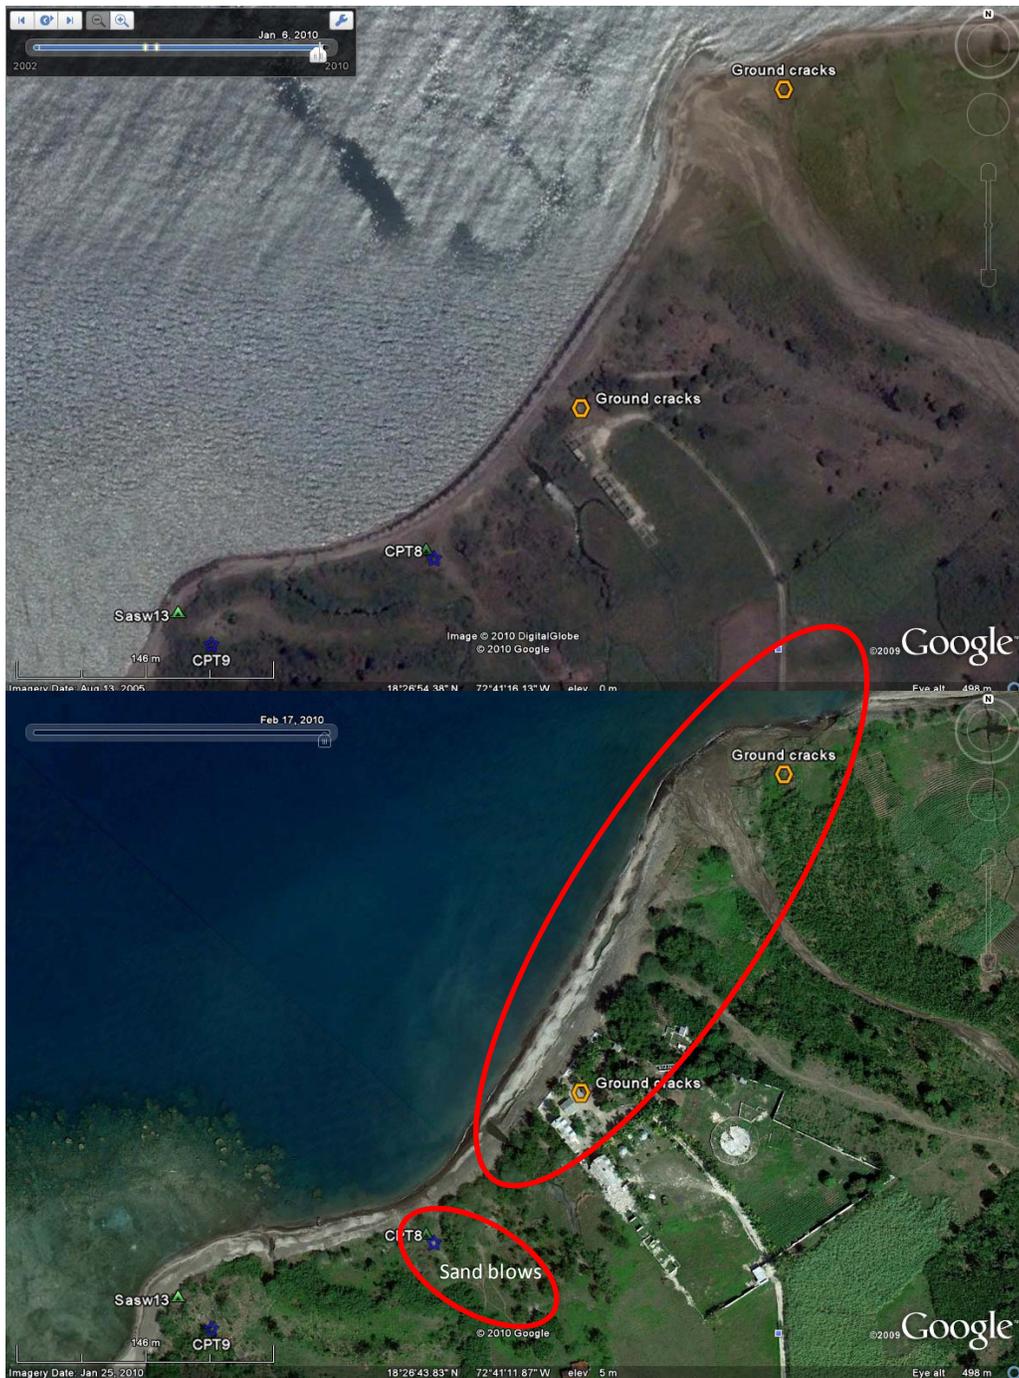
**Figure 7.3.** Pre- and post-earthquake images of coastline near village of L'Acuil. Note in the lower, post-earthquake image the significant cracking subparallel to the coast and the arcuate slump in the northern end of the failure. SASW and DCPT testing was performed near several large sand blows located near the south end of the failure zone, as well as farther south outside of the failed reach. Imagery courtesy of Google Earth. Approximate center of image at 18°26'51.17"N, 72°41'11.06"W.

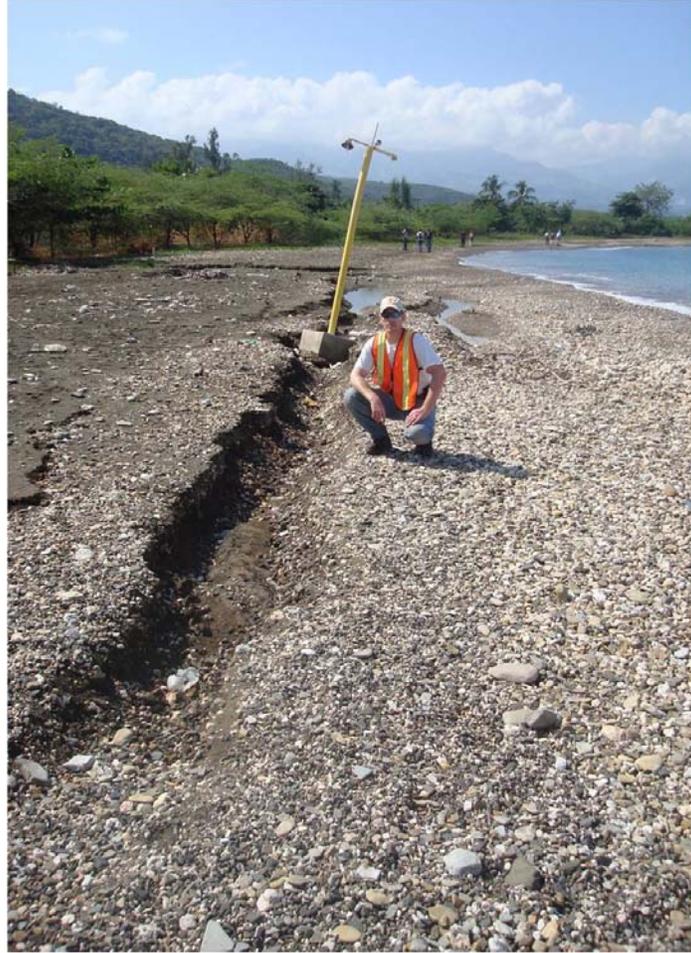
**Figure 7.4.** Cracking and lateral spread along coastline near village of L'Acul. (18°26'48.81"N, 72°41'11.92"W looking west).

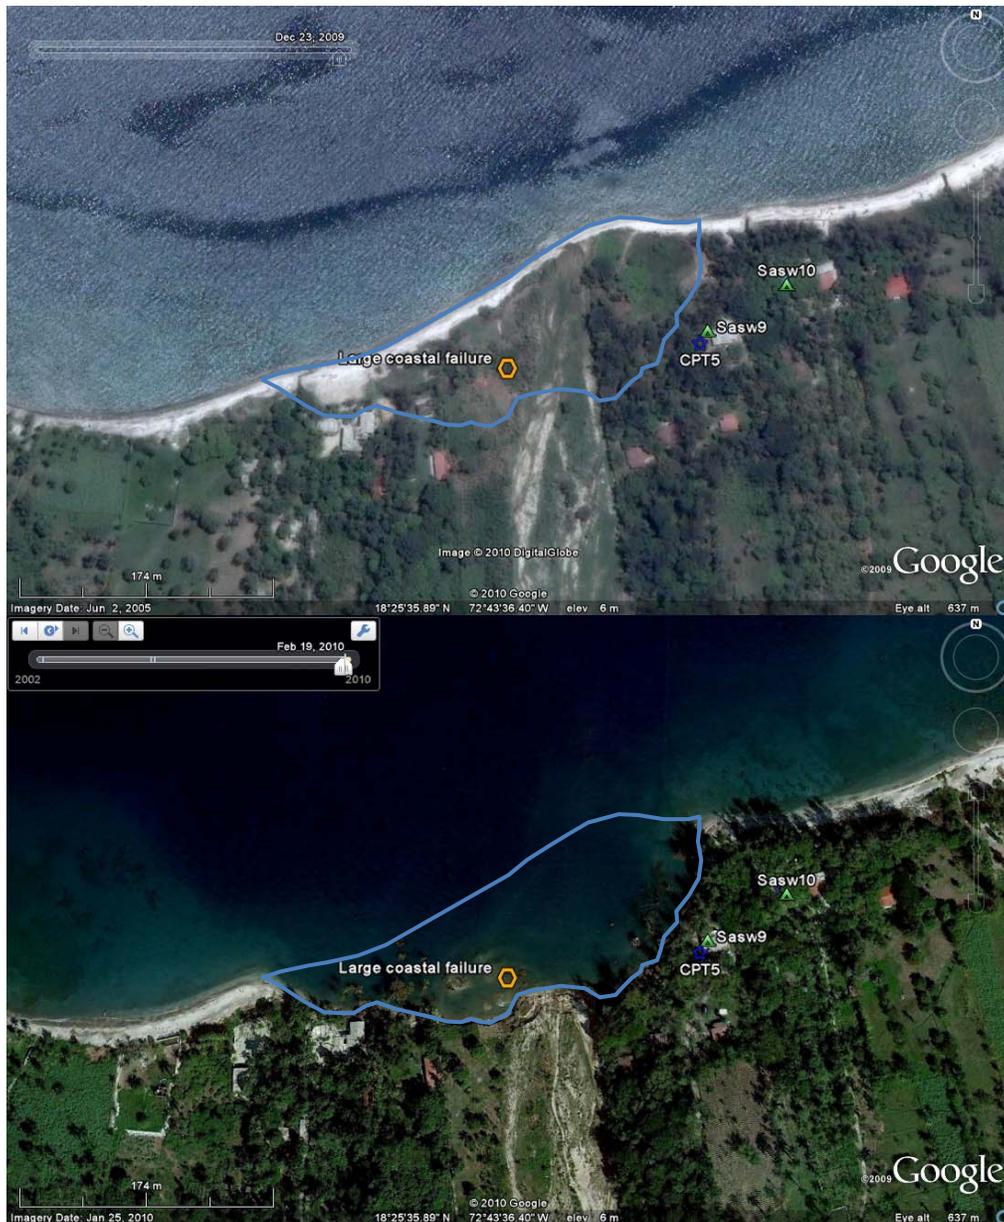
**Figure 7.8.** Pre- and post-earthquake images of coastline near village of Fouche. Note in the lower, post-earthquake image the significant loss of coast as outlined in blue. SASW-9 and DCPT-6 were performed near several moderate-sized sand blows located near the southeast end of the failure zone, while SASW-10 was performed outside of the failure zone. Imagery courtesy of Google Earth.

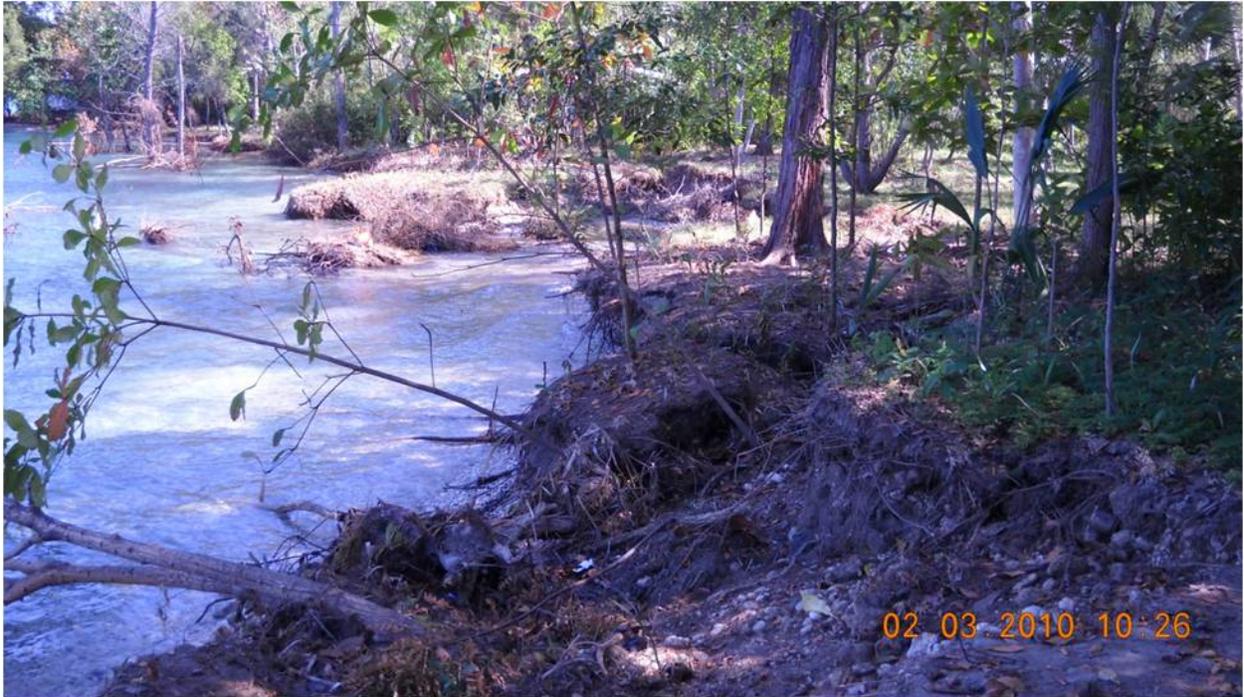
**Figure 7.9.** Scarp of coastal landslide near village of Fouche.  
( $18^{\circ}25'34.23''\text{N}$ ,  $72^{\circ}43'33.61''\text{W}$  looking northeastward)

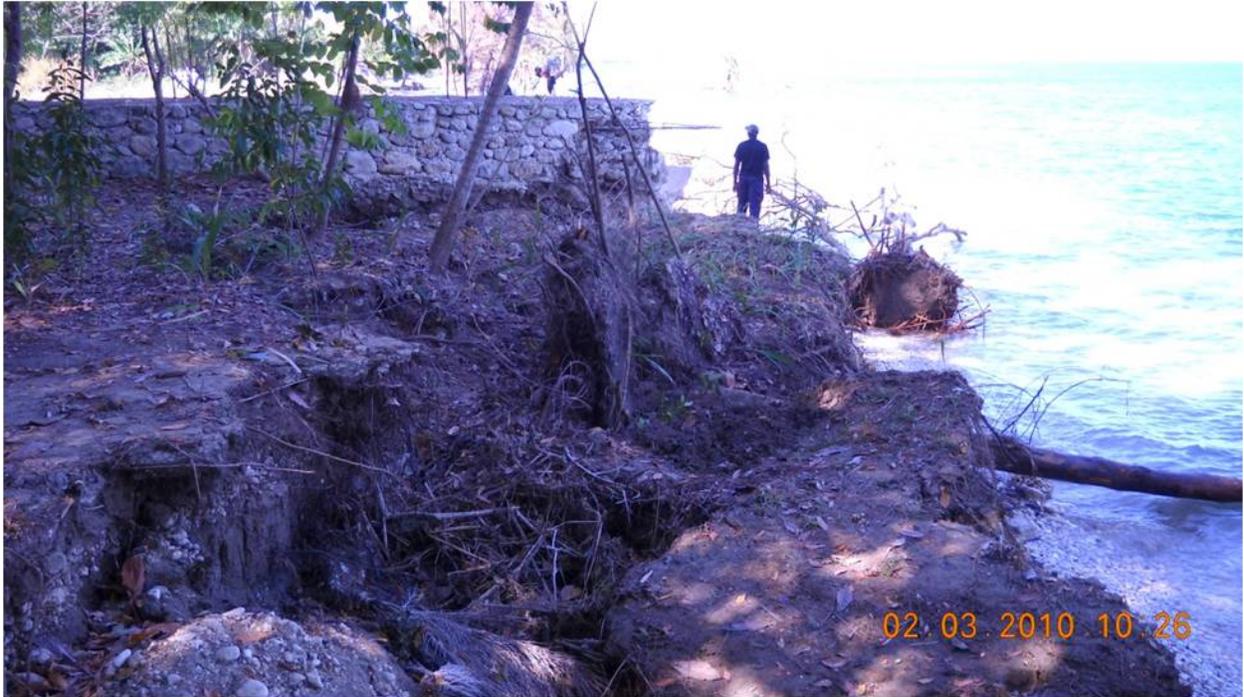
**Figure 7.11.** Damage to stone wall resulting from coastal failure and lateral spreading. (18°25'33.94"N, 72°43'34.27"W looking westward).

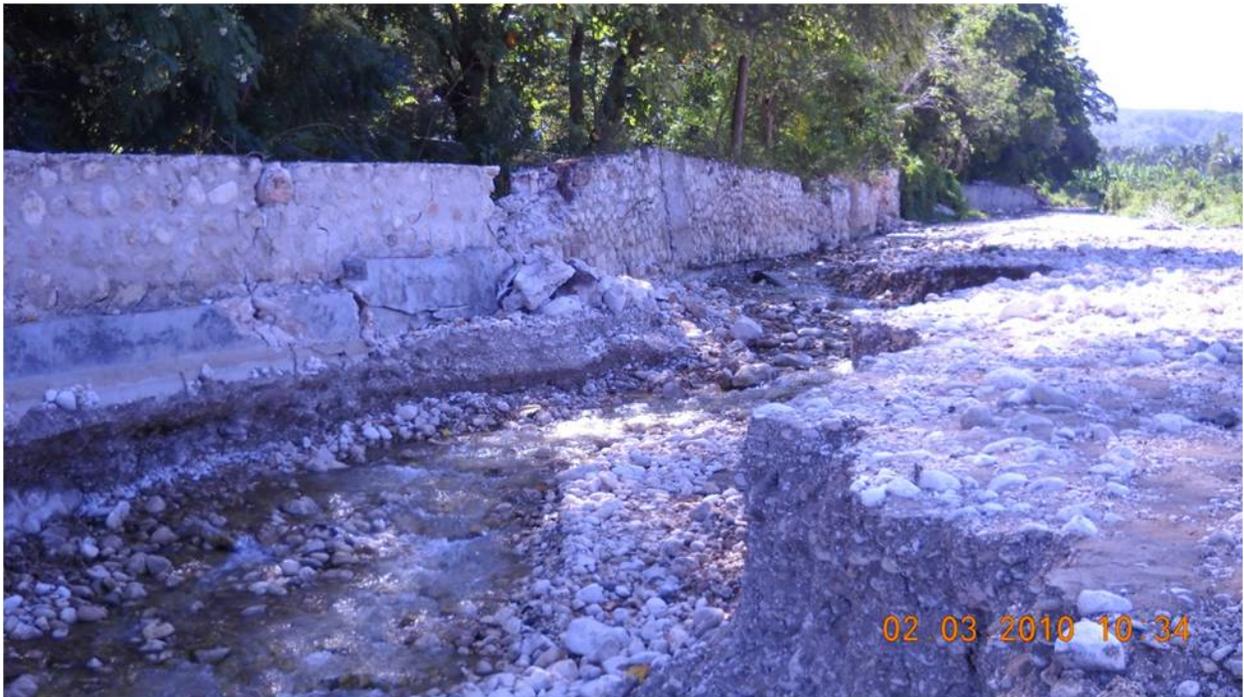
**Figure 7.12.** Damage to stone wall resulting from lateral spreading. Note the surficial cobbly material revealed by the failure scarp in the foreground. (18°25'33.31"N, 72°43'34.58"W looking southward away from coast).

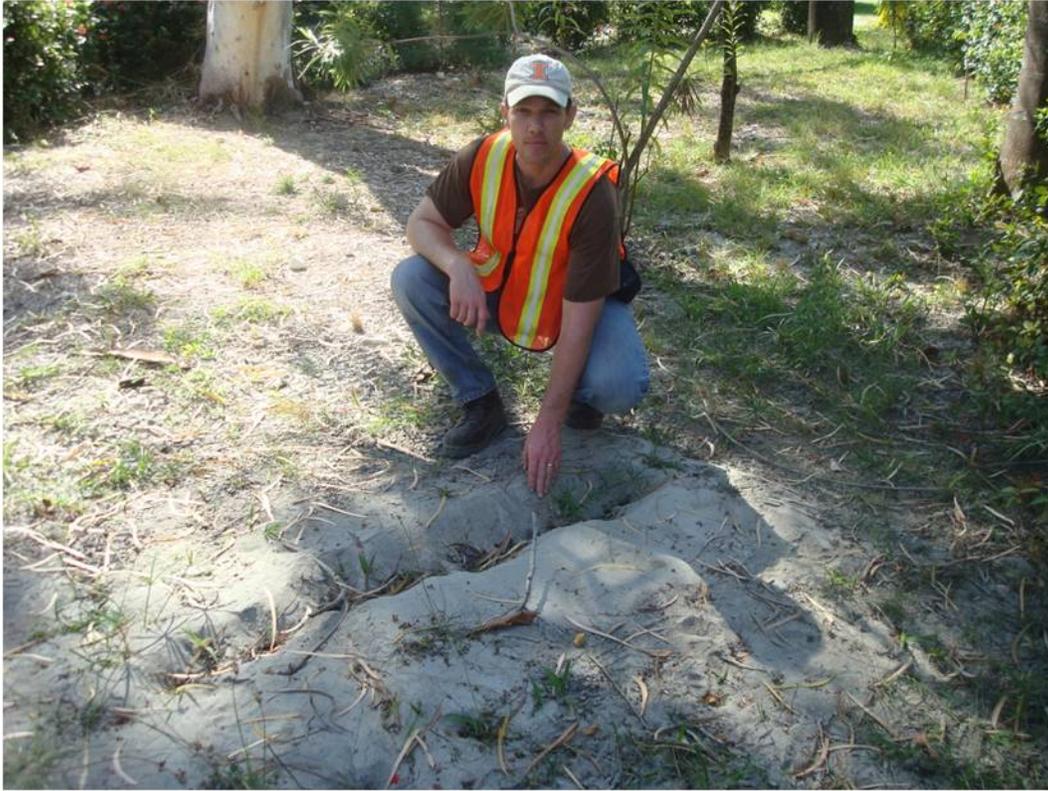
**Figure 7.13.** Sand blow and ejecta formed at coastal failure site near village of Fouche. Approximate image coordinates: 18°25'35.08"N, 72°43'31.70"W.

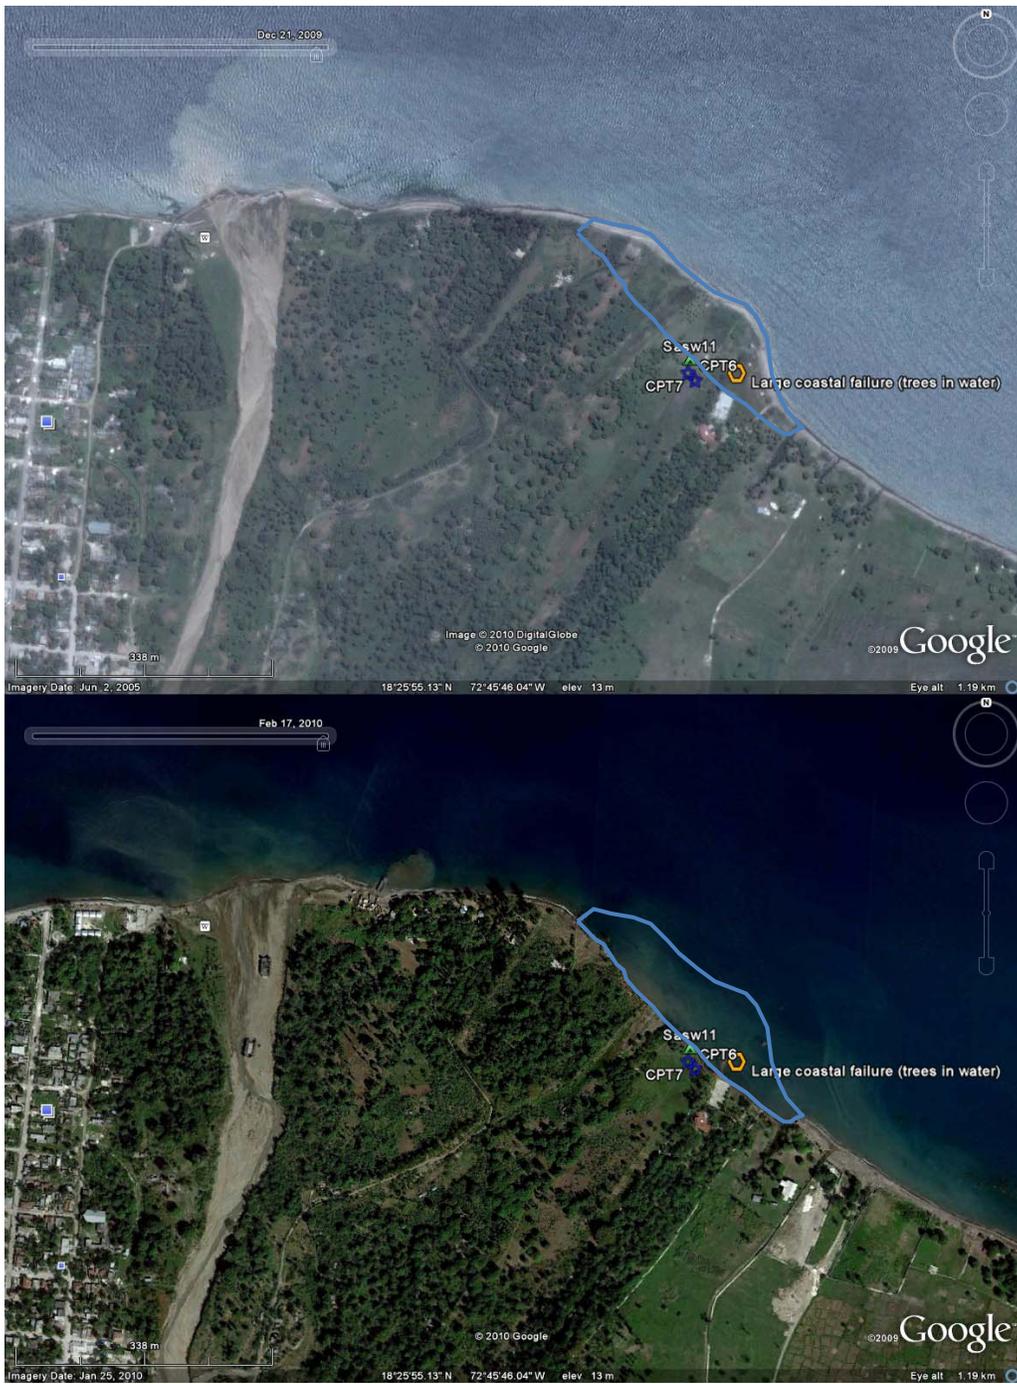
**Figure 7.16.** Pre- and post-earthquake images of coastline near village of Grand Goâve. Note in the lower, post-earthquake image the significant loss of coast as outlined in blue. SASW-11, DCPT-7, and DCPT-8 were performed just inland of the backscarp of the failed zone. Imagery courtesy of Google Earth.

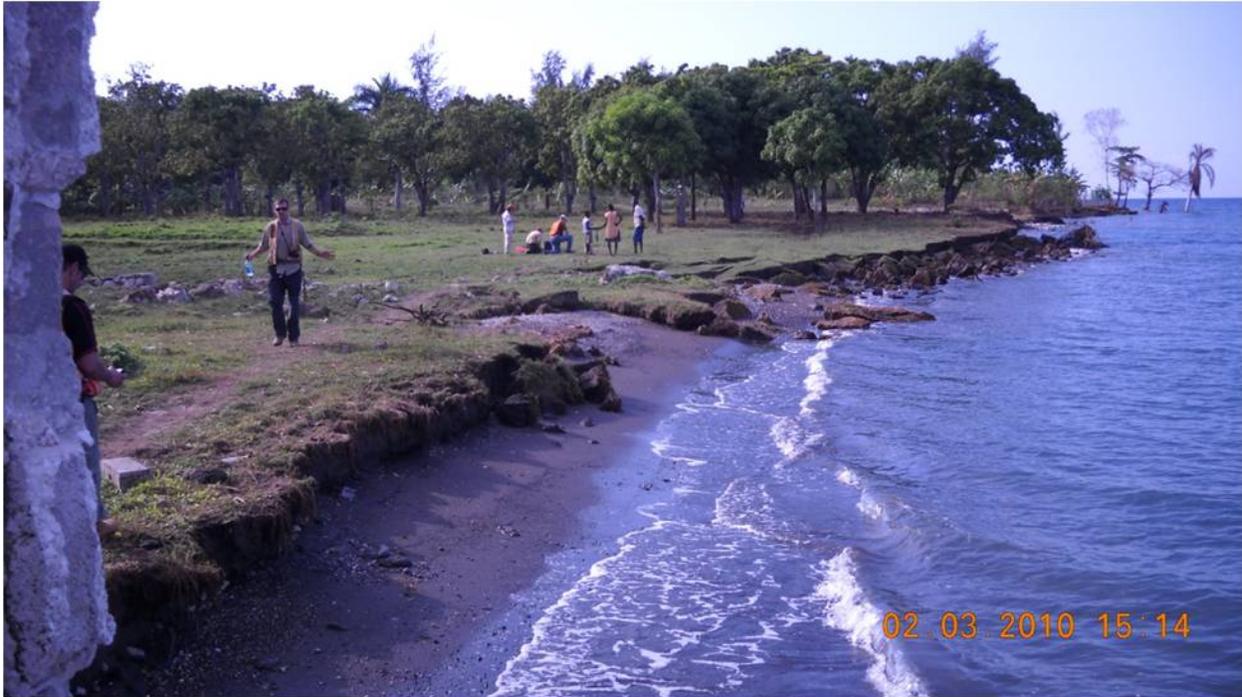
**Figure 7.17.** Scarp formed along northern portion of coastal failure near village of Grand Goave. ( $18^{\circ}25'53.82''\text{N}$ ,  $72^{\circ}45'37.16''\text{W}$  looking northwest).

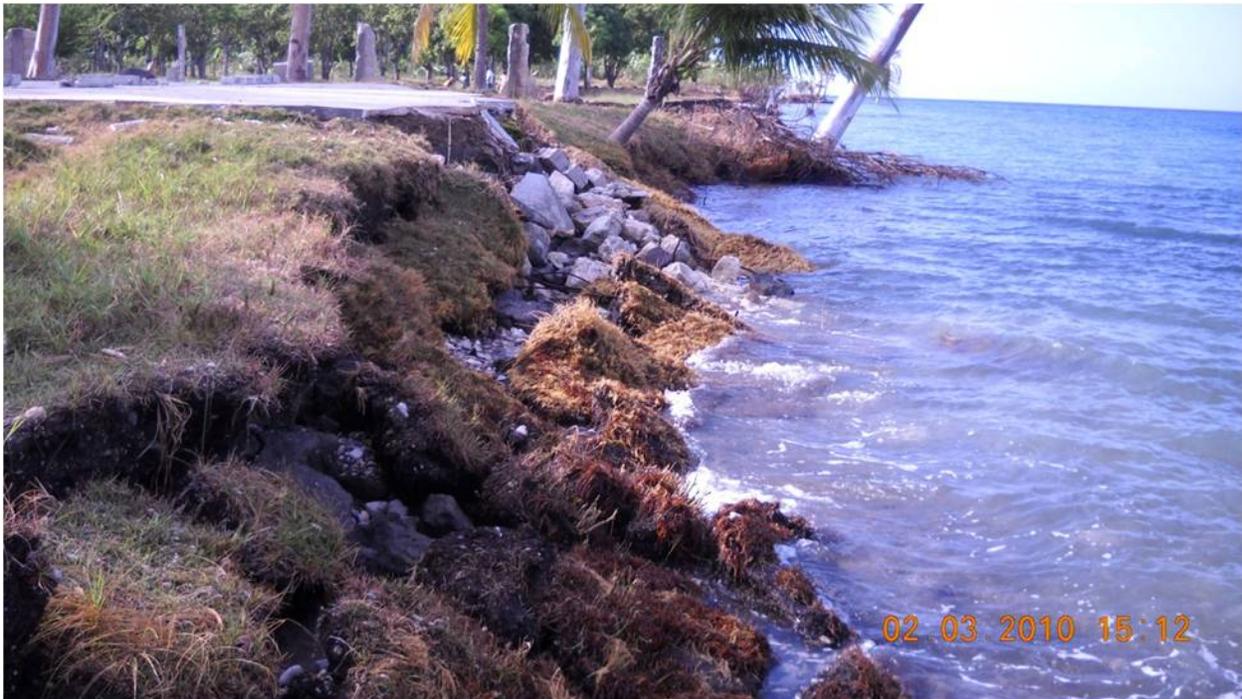
**Figure 7.18.** Scarp formed along southern portion of coastal failure near village of Grand Goave. ( $18^{\circ}25'52.91''\text{N}$ ,  $72^{\circ}45'35.92''\text{W}$  looking northwest)

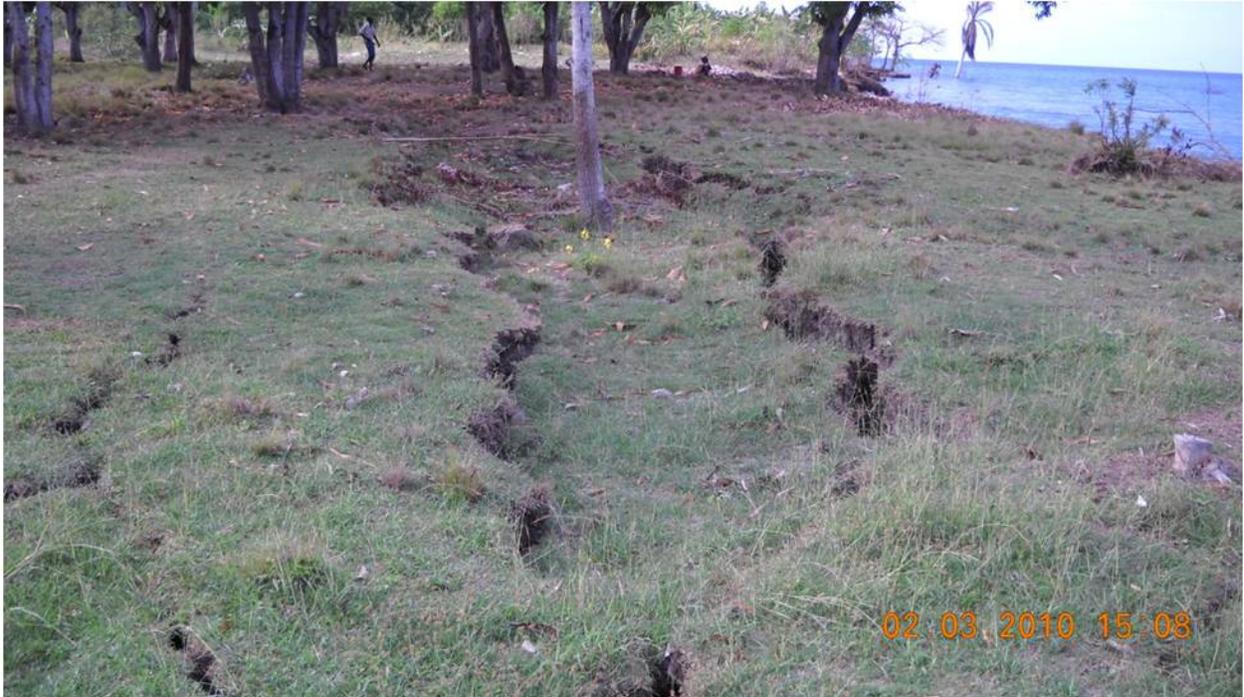
**Figure 7.19.** Graben formation subparallel to coastline at coastal failure near village of Grand Goâve. ( $18^{\circ}25'54.43''\text{N}$ ,  $72^{\circ}45'37.99''\text{W}$  looking northwest).
