# GEOTECHNICAL ENGINEERING RECONNAISSANCE OF THE 2010 HAITI EARTHQUAKE

Version 1: February 22, 2010

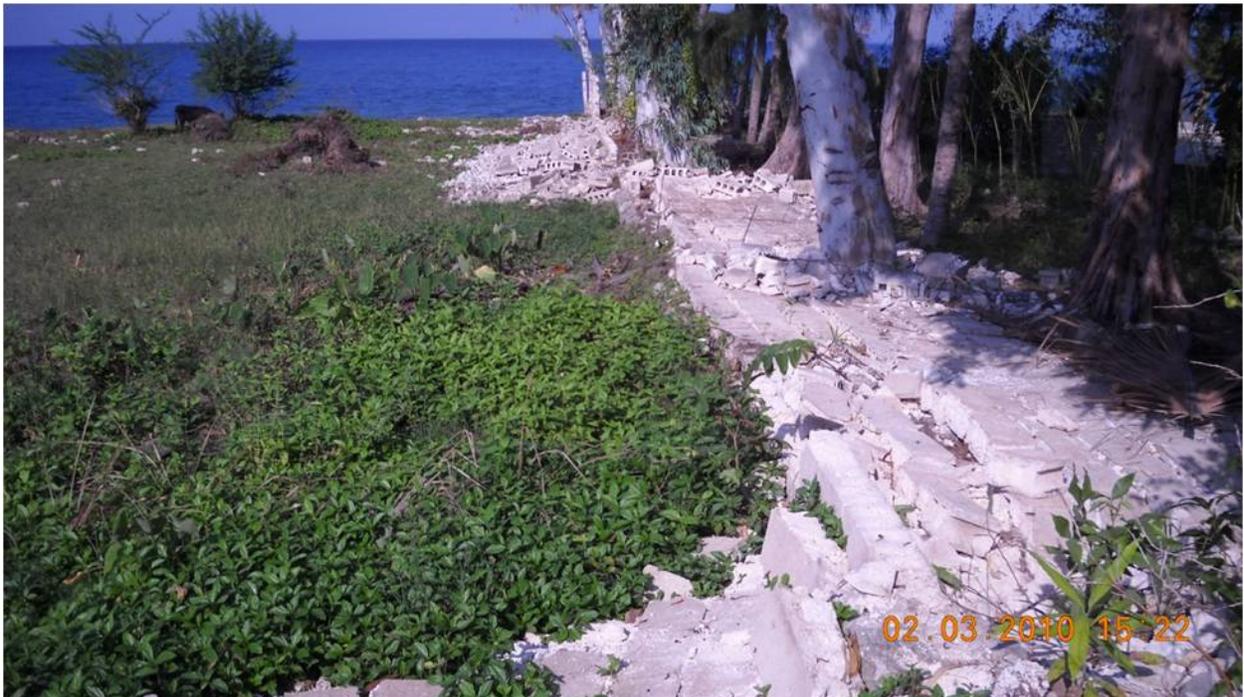
**Figure 7.20.** Damage to unreinforced block wall running perpendicular to coast near village of Grand Goâve. ( $18^{\circ}25'51.84''\text{N}$ ,  $72^{\circ}45'38.06''\text{W}$  looking northeast).

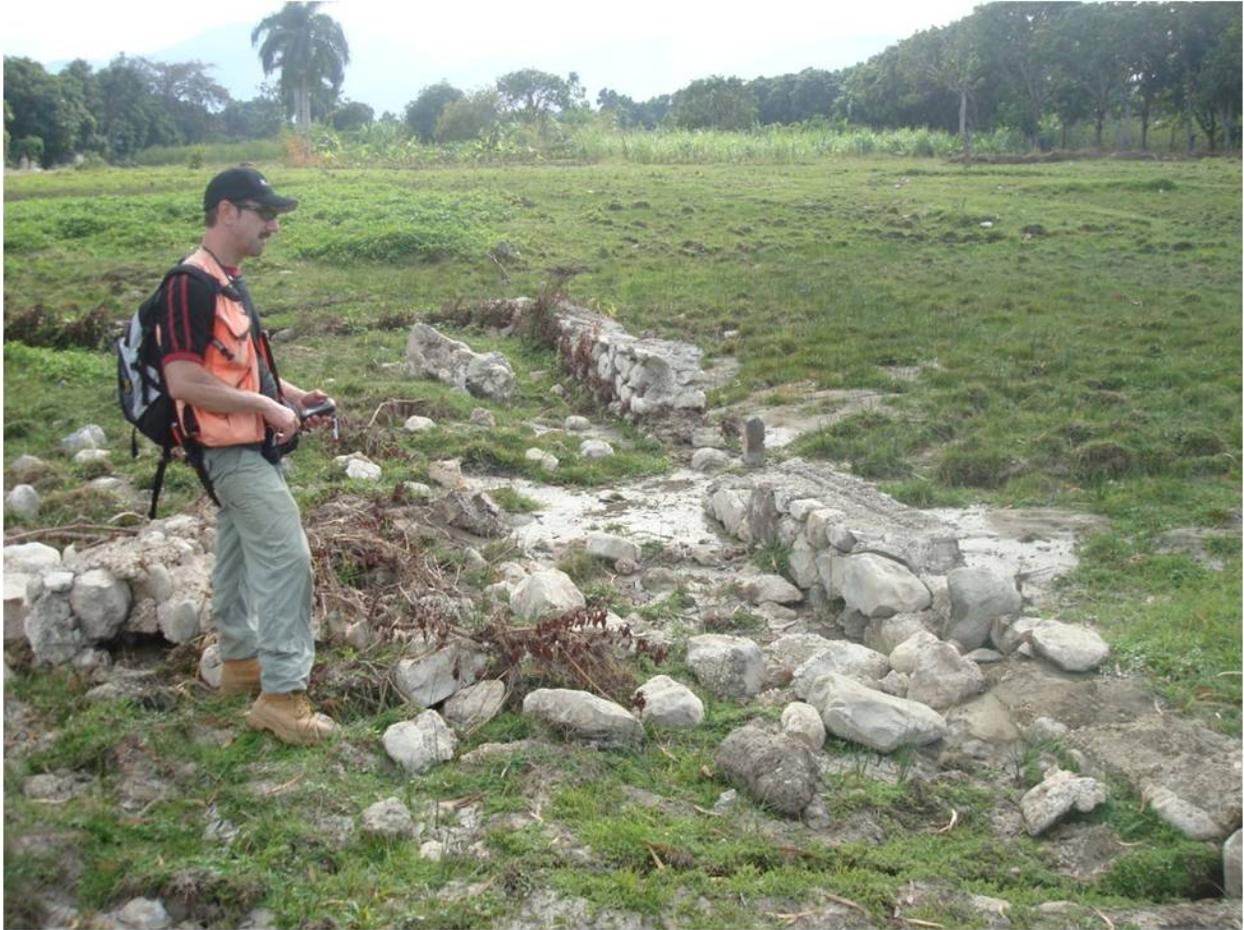
**Figure 7.21.** Sand blow formation along inland extent of coastal failure near village of Grand Goâve. ( $18^{\circ}25'53.73''\text{N}$ ,  $72^{\circ}45'37.65''\text{W}$ )

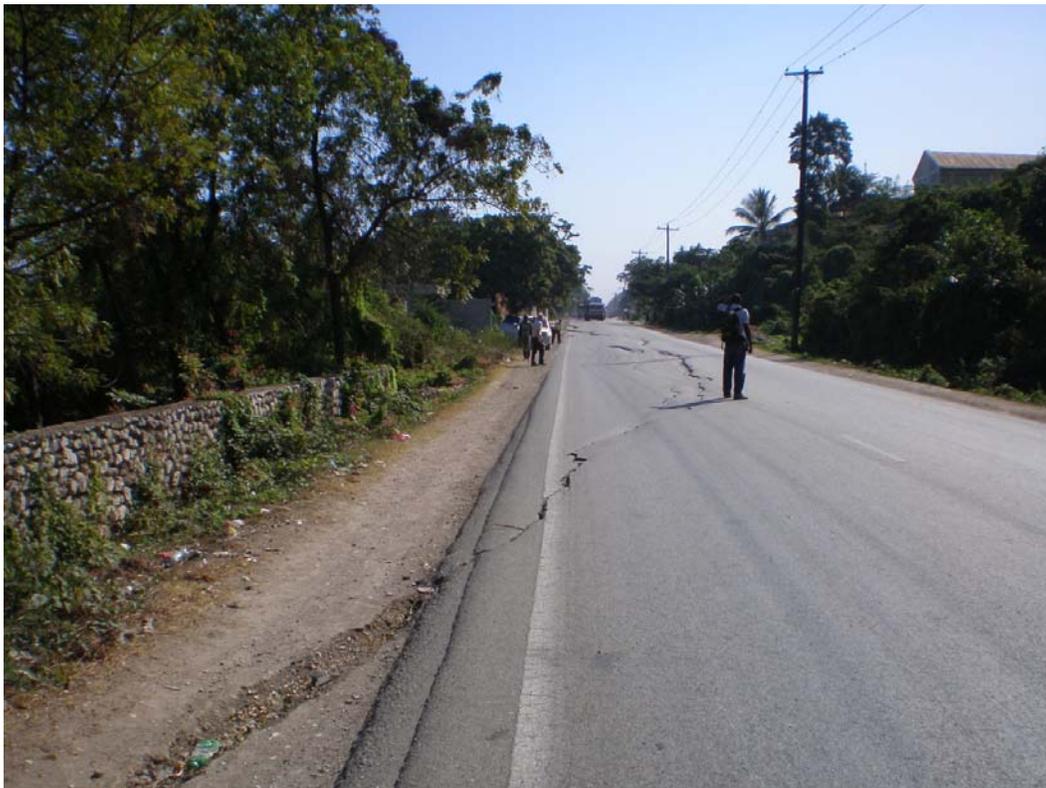
**Figure 8.4** Typical arcuate road cracks at road failure site RCA west of Carrefour.

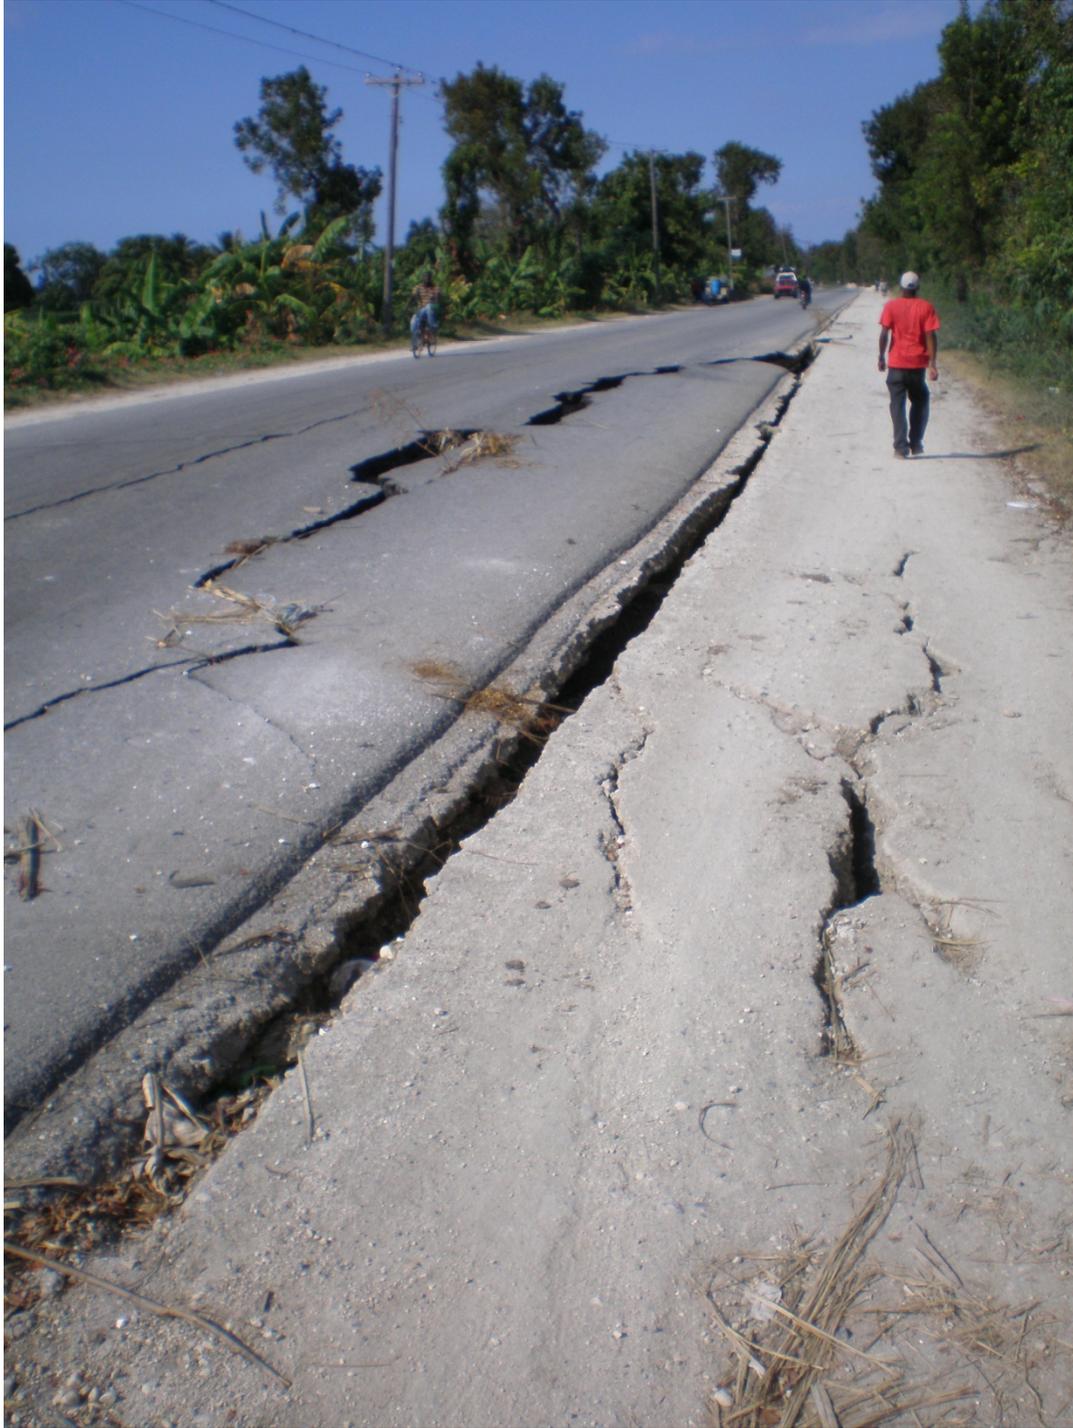
**Figure 8.5** Cracks induced by fill slope slumping at road damage site BOXCLVTA.

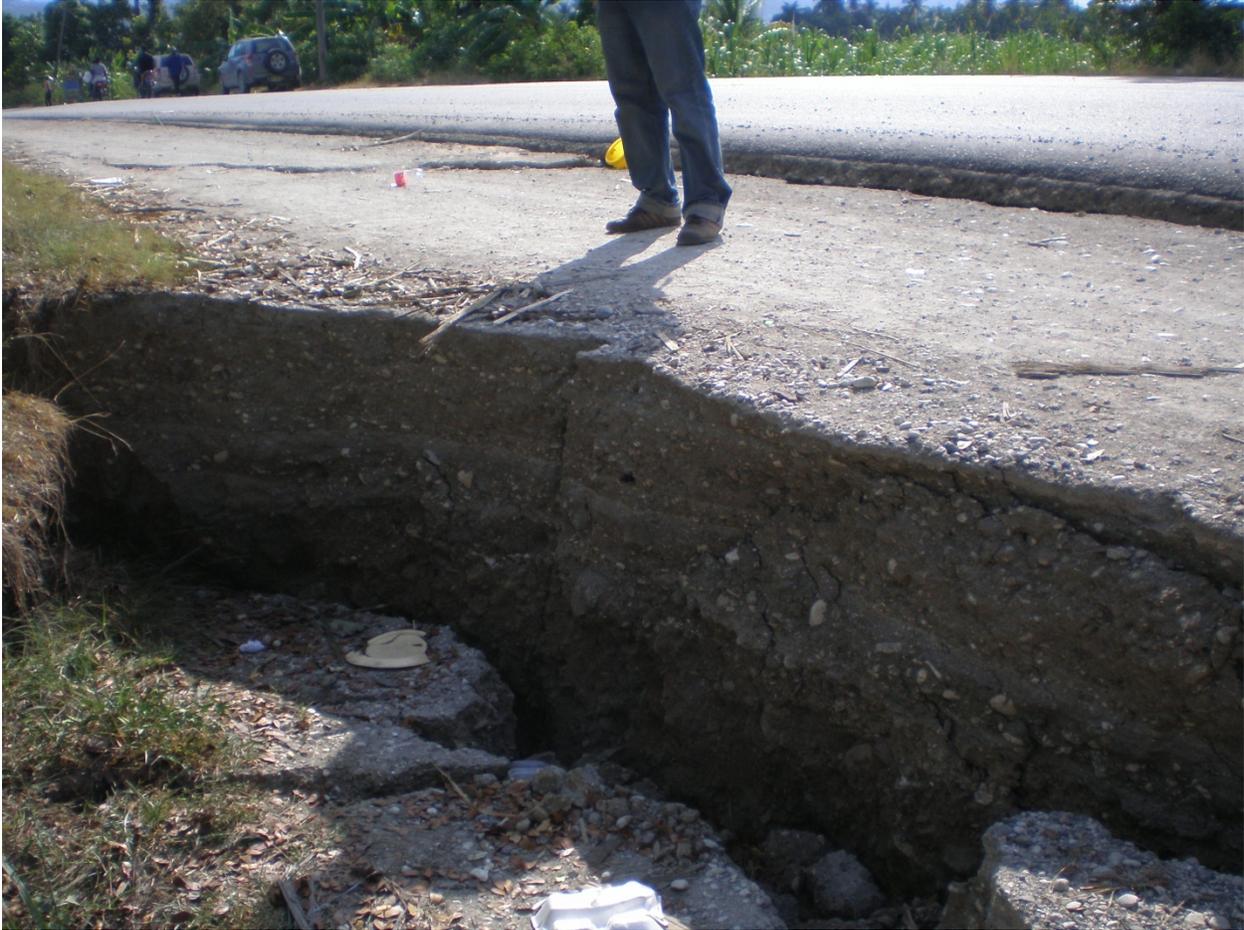
**Figure 8.6** Well-compacted granular fill at road damage site BOXCLVTA.

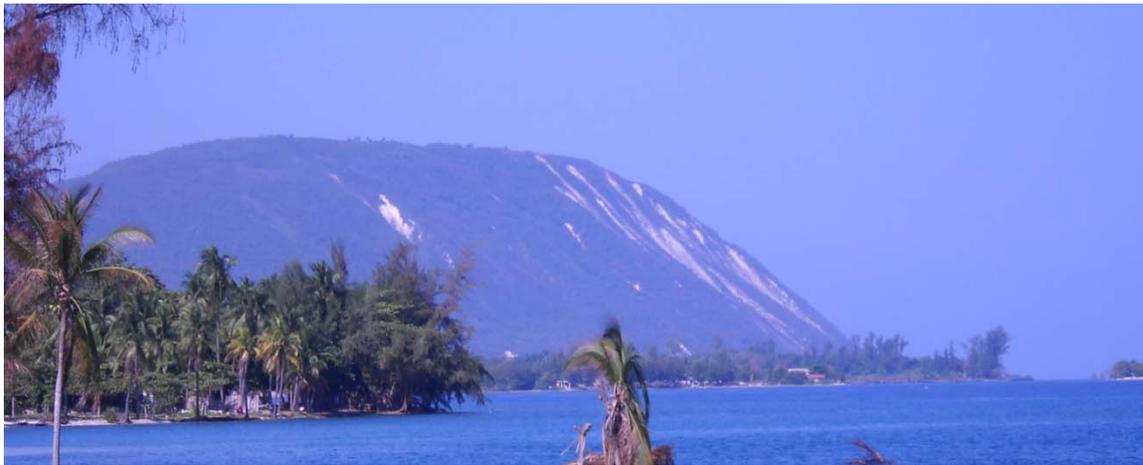
**Figure 9.3** Landslide scars near Provence in distance. (18.426166°N, 72.725825°E).

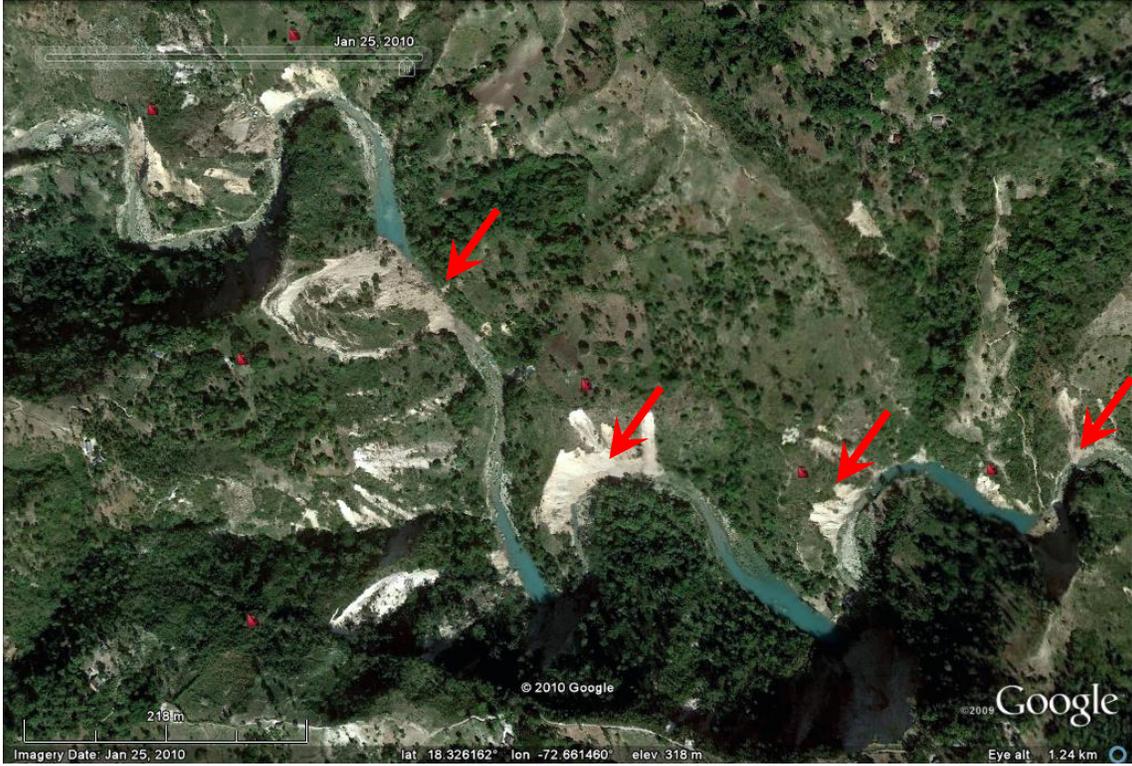
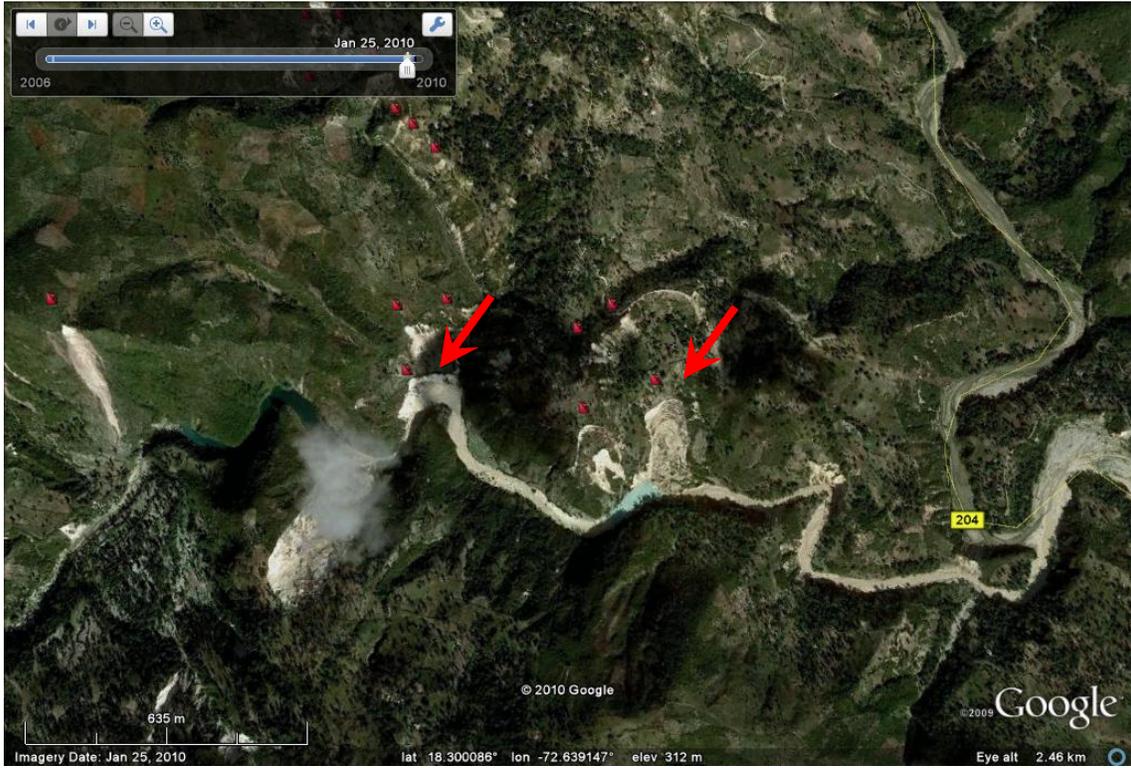
**Figure 9.4** Landslide dams (red arrows) and retained lakes west of Route 204 and approximately 15 km northwest of Jacmel (top: N18.326162, W72.66146, bottom: N18.300086, W72.639147).
