# **Modelli e tecniche nei progetti di intervento**

**Gaetano Manfredi**

# L'Aquila Earthquake: Structural damages

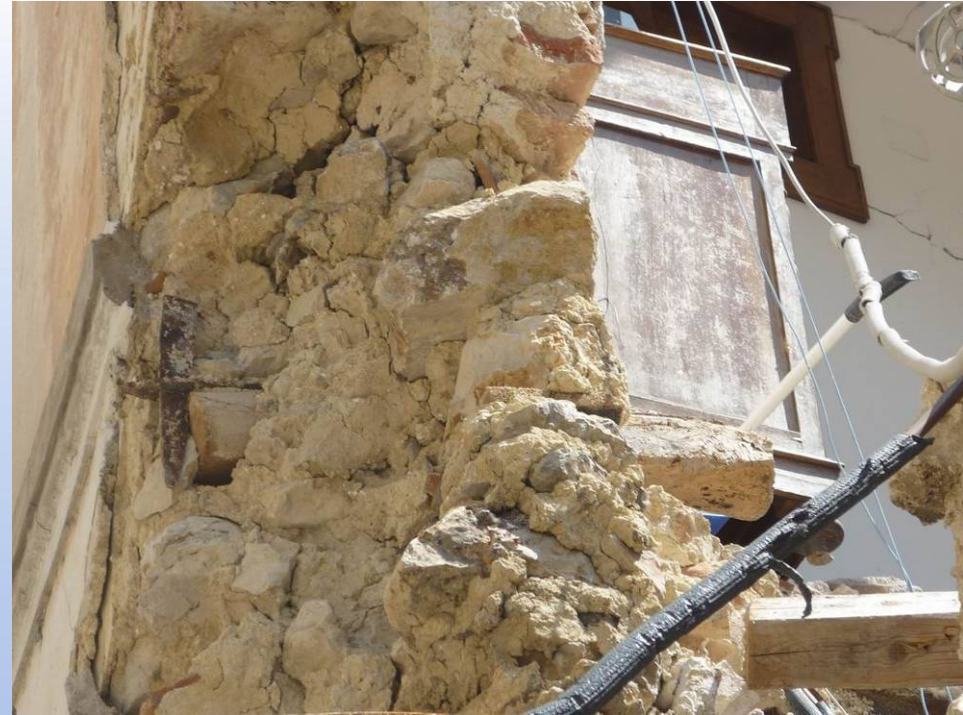
Villa Sant'Angelo: alteration of the original structural configuration: wooden tie, originally well connected to the external wall by means of an iron device, has been cut during an heavy refurbishment

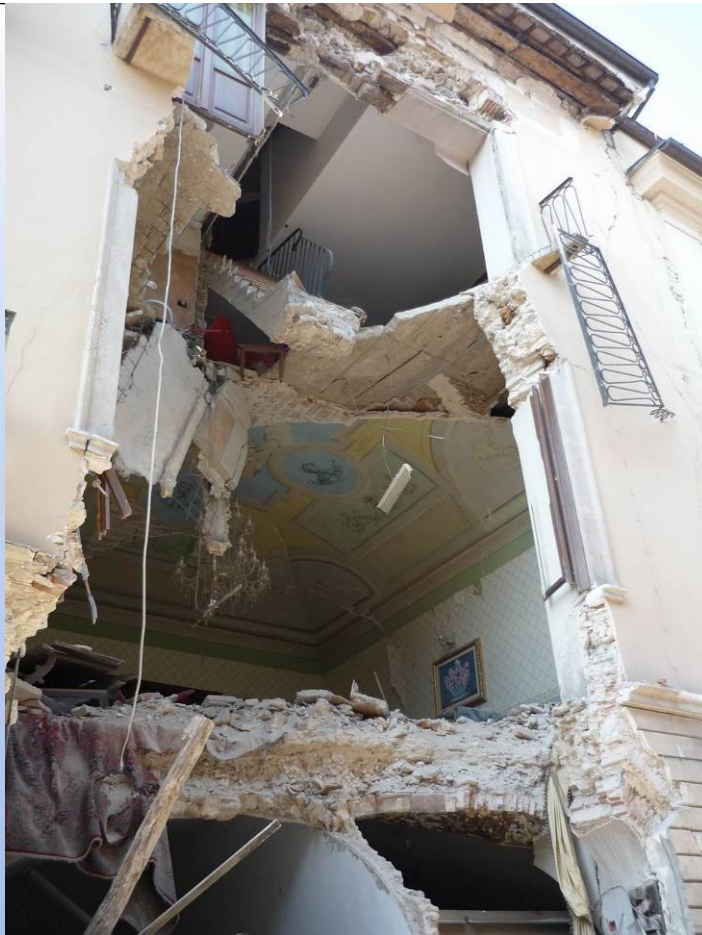
L'Aquila: at second floor it was inserted a r.c. stair.
