# GEOTECHNICAL ENGINEERING RECONNAISSANCE OF THE 2010 HAITI EARTHQUAKE

Version 1: February 22, 2010

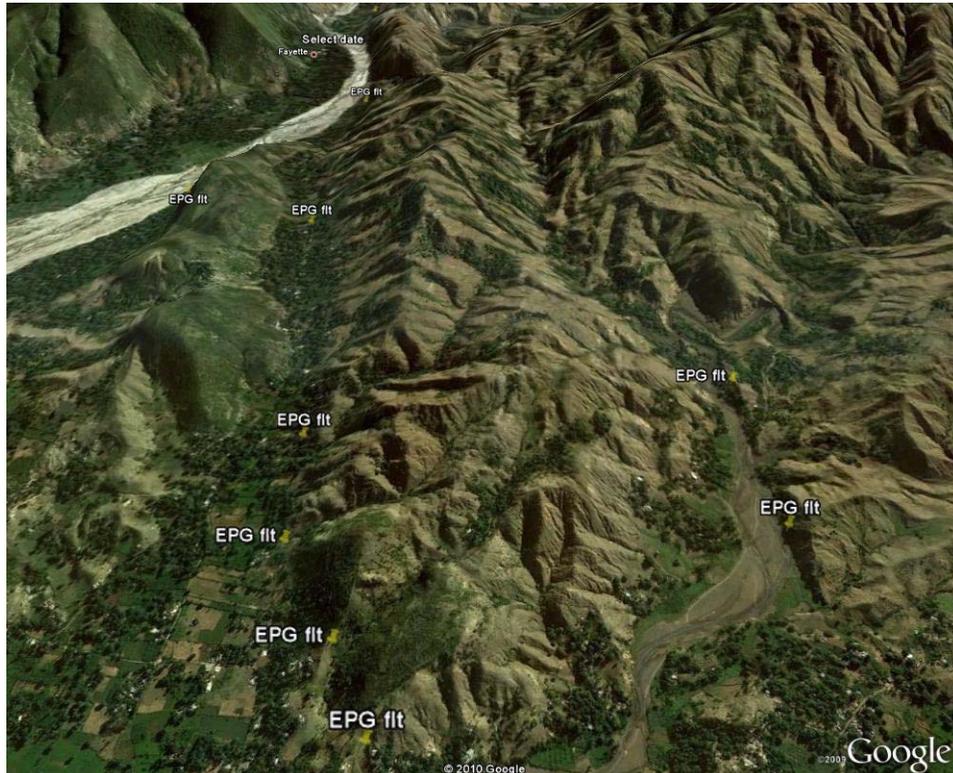
**Figure 4.1.** View east towards Fayette and Leogane along parallel east-northeast trending traces of Enriquillo Plantain Garden fault. Fault trace marked by push-pins labeled “EPG flt”. Fault trace at right (left offset of river along prominent north-facing scarps) apparently steps north to linear valley of Momance River at top left of picture.

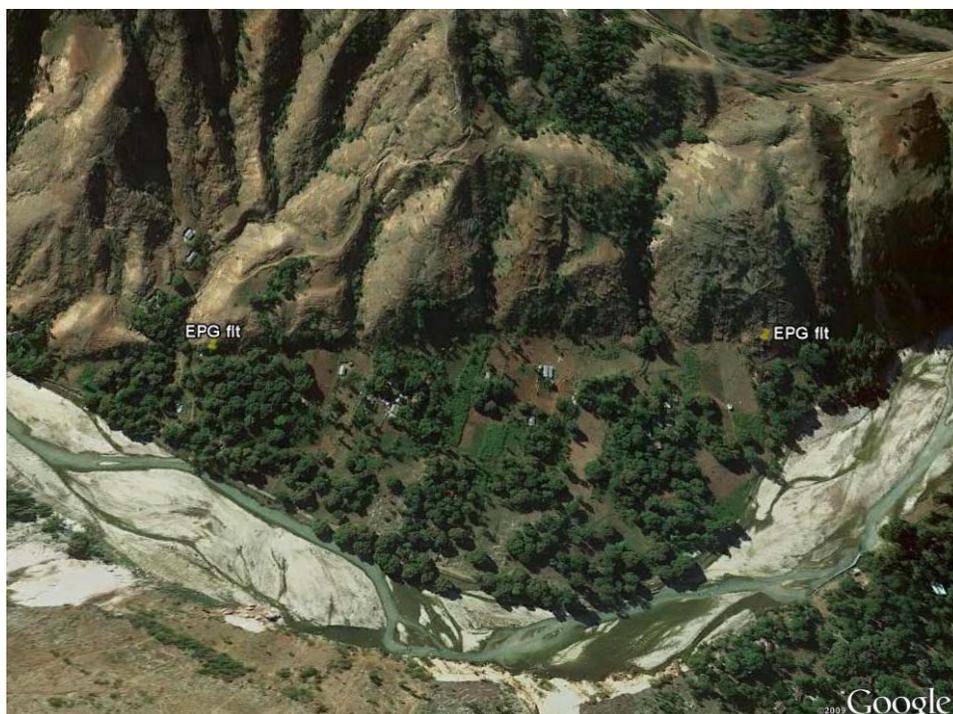
**Figure 4.2.** View south of prominent fault scarp crossing fluvial terrace on Momance River east of Fayette. Fault trace marked by push-pins labeled “EPG flt”.

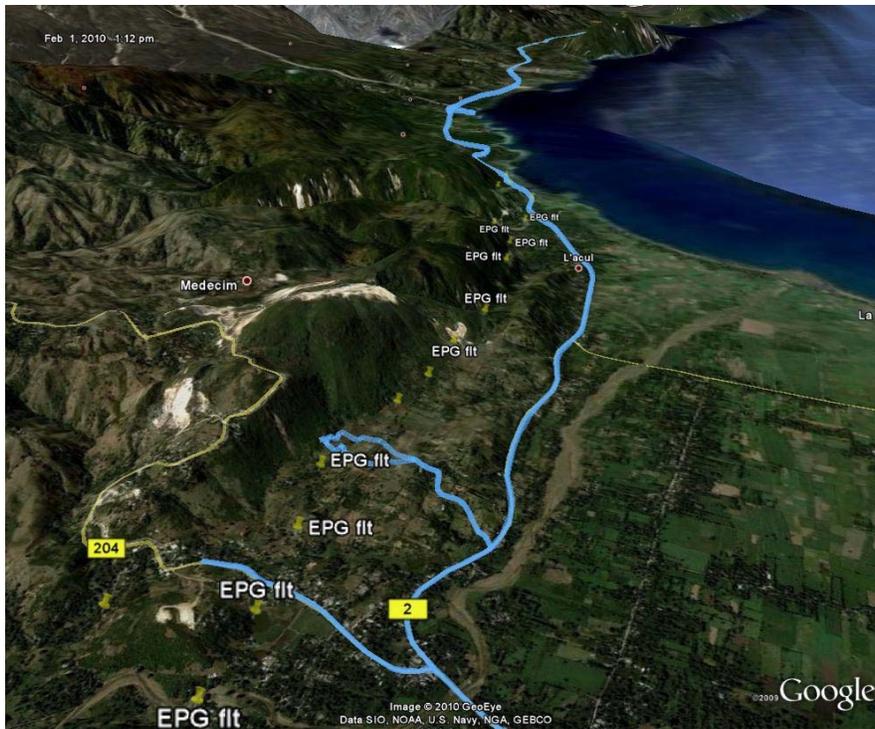
Dr. Mann and Dr. Koehler identified several locations near Dufort where the location of the EPG fault was well constrained and accessible, and the combined team visited these sites on February 1. These sites are located along Road 204 (Jacamel Road) and west of Road 204 (Figure 4.3). Road 204 passes south from the intersection with Road 2 across the plain and up the slope of the east-west trending mountain range. The EPG fault lies along the base of the range, at a prominent break-in-slope from the plains to the lower part of the range. The team confirmed that Road 204 is not displaced where it crosses the fault and range front. A distinct linear valley and shutter ridge occur at the base of the hills about 0.75 km west of Road 204, providing a well-constrained location of the active trace of the EPG fault. The team inspected the fault over a distance of several hundred meters across the small valley, along several transects extending across the shutter ridge and through the valley bottom to bedrock areas exposed on the hillslope above the valley. The fault is constrained to lie at the prominent break-in-slope at the base of the hill or within a few tens of meters east in the valley bottom (Figure 4.4). South of this valley, the EPGFZ is marked by the prominent break-in-slope and a series of side-hill benches (Figure 4.5). The team observed minor cracking in the valley floor at one location, and a linear north-facing scarp at the base of the hillslope. It was concluded that the minor cracking in the valley floor likely represented effects of shrink-swelling in the soil and that the north-facing scarp was the result of hoeing/tilling for agricultural purposes (Figure 4.6). Therefore, the team concluded that the fault did not rupture at the ground surface through the small valley.

**Figure 4.3.** View southwest along EPG fault west of Dufort. Reconnaissance track marked in blue shows location of fault traverses on and west of Road 204. Fault trace marked by push-pins labeled “EPG flt”.

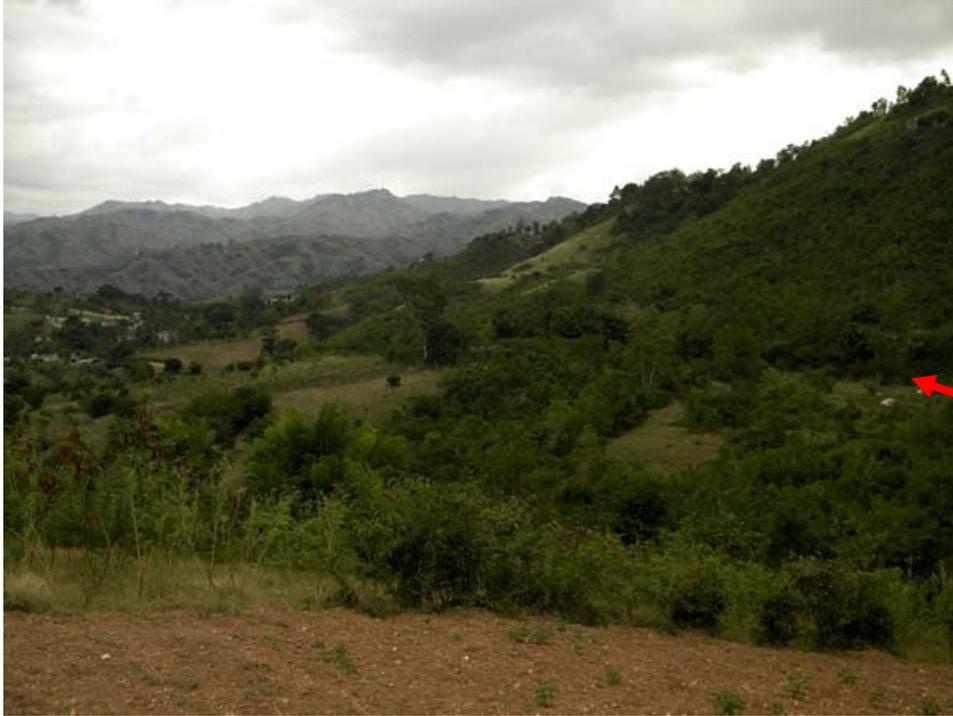
**Figure 4.5.** View east along trace of EPG fault from hill above linear valley west of Road 204 (along red arrow) (N18.445819, W72.6431718).

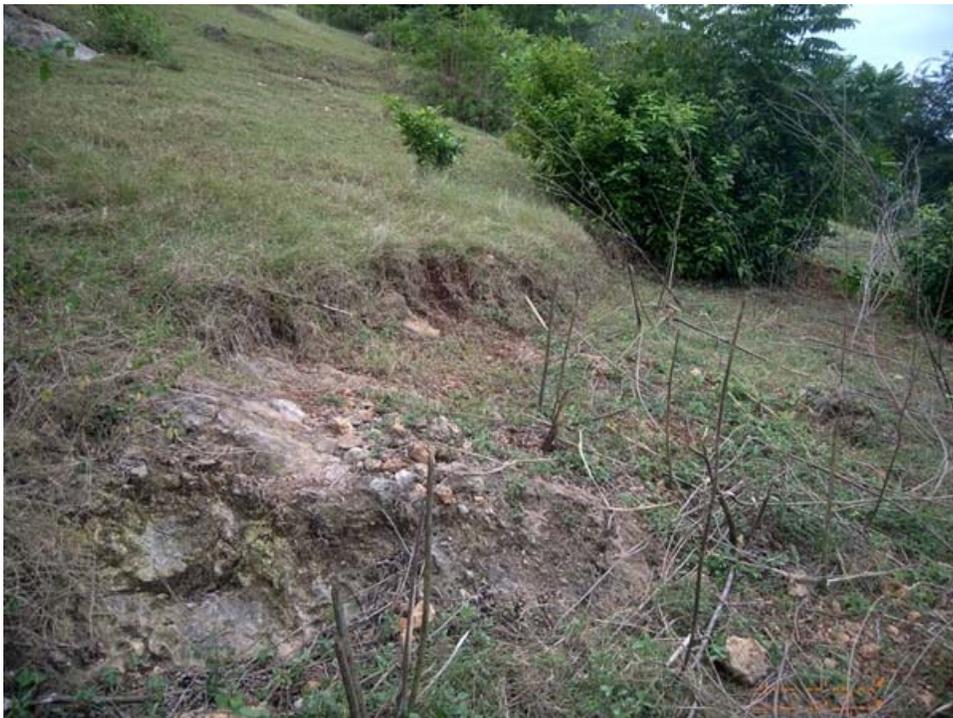
**Figure 4.6.** View west along agricultural scarp in linear fault valley west of Road 204 (N18.444527, W72.643777).

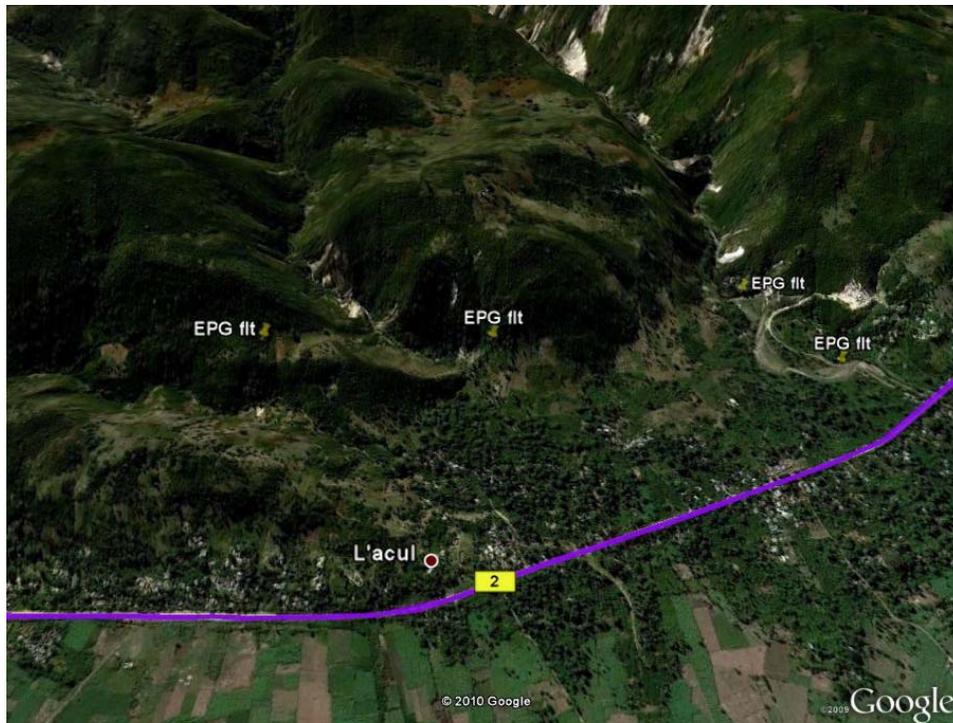
**Figure 4.7.** View south of shutter ridge blocking drainage (center) and offset stream channel (center right) along fault south of L’acul. Fault trace marked by push-pins labeled “EPG flt”.

The GEER team traversed Road 2 west of Road 204, where Road 2 is parallel to and crosses over the EPGFZ near L’acul, on several occasions between February 1 and 4 during additional reconnaissance investigations (Figure 4.7). No evidence of lateral road displacements or equivocal shear cracks was found on the roads across the fault crossing areas. However, a number of cracks and areas of settlement were observed along the road. These features were evaluated and we concluded to be the result of settlement of the road fill/embankment settlement over soft subgrade soils (see Section 8.0 Road Fill Performance), and possibly in some cases due to localized liquefaction. None of these features were found to represent surface fault rupture.

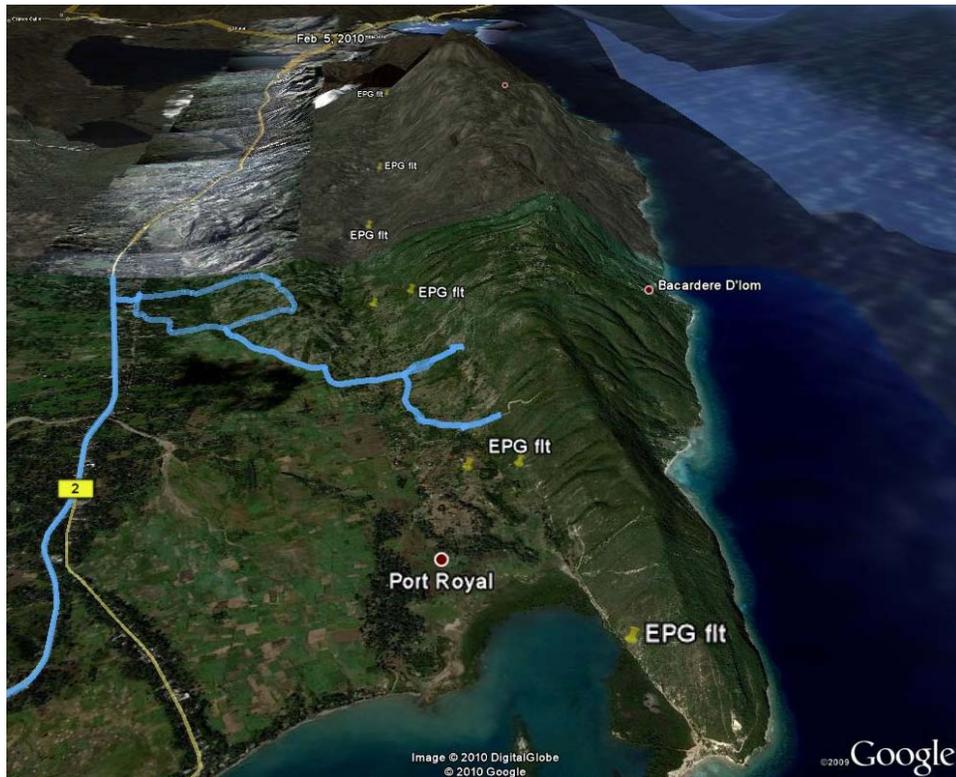
With the assistance of a local resident to guide the team along un-improved cart and horse paths off the paved road, the GEER team conducted traverses across the fault on February 4 at two locations in the area north and west from Port Royal (Figure 4.8). At the two sites, which were located along about a  $\frac{3}{4}$  km length of the range front, two parallel fault traces are marked by prominent side hill benches, offset drainages, and a sharp steeply dipping contact between colluvium and limestone bedrock (Figures 4.9 to 4.11). The team traversed footpaths that extended north upslope across the fault at both sites. No fracturing or evidence for fault rupture

was observed at the bedrock-colluvial contact (a northern fault trace) or along the base of the side-hill benches and alignment with diverted drainages (a southern fault trace). When asked whether and where they had observed any ground cracking, several local residents described ground failures due to landsliding on slopes on the opposite side of the valley, and one location of ground cracking on the coast east of Port Royal. We were not able to travel to the coast to evaluate the ground cracks because of impending darkness, but based on the description of the cracks as being near the water, and due to the prevalence of lateral spreading along the coast, it is likely that these fractures were due to ground failure rather than fault rupture. Thus, based on our observations and the information from the local residents, the team concludes that the EPGFZ did not rupture at the surface where it extends onshore from Petit Goâve Bay.

**Figure 4.8.** View west of prominent parallel west-southwest trending fault traces along south-facing slope of hills west of Petit Goâve Bay and Port Royal. Reconnaissance track marked in blue shows location of fault traverses west of Port Royal. Fault trace marked by push-pins labeled “EPG flt”.

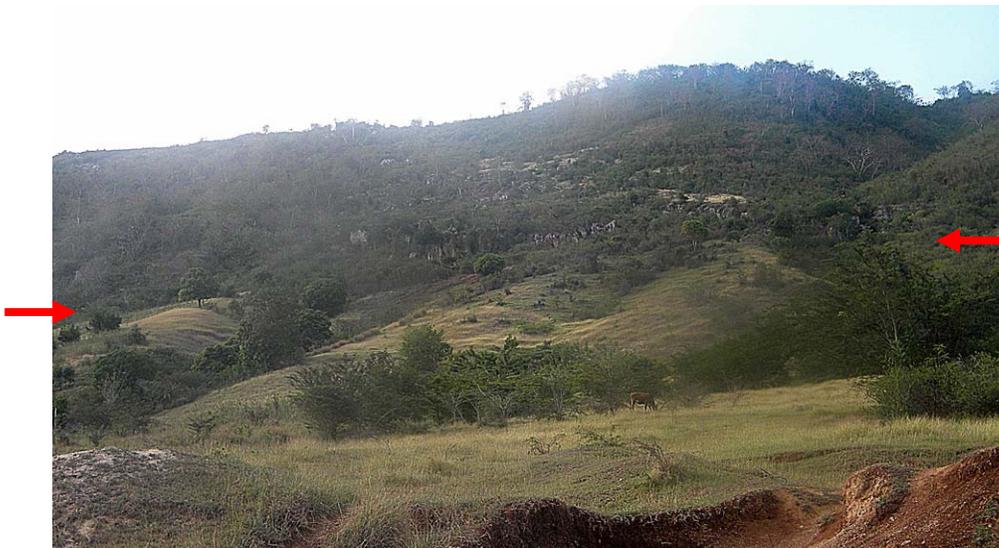
**Figure 4.10.** View north across fault (at upper break in slope) west of Port Royal. Side-hill bench and blocked drainages at center of photograph (between red arrows) (N18.439666, W72.916444).

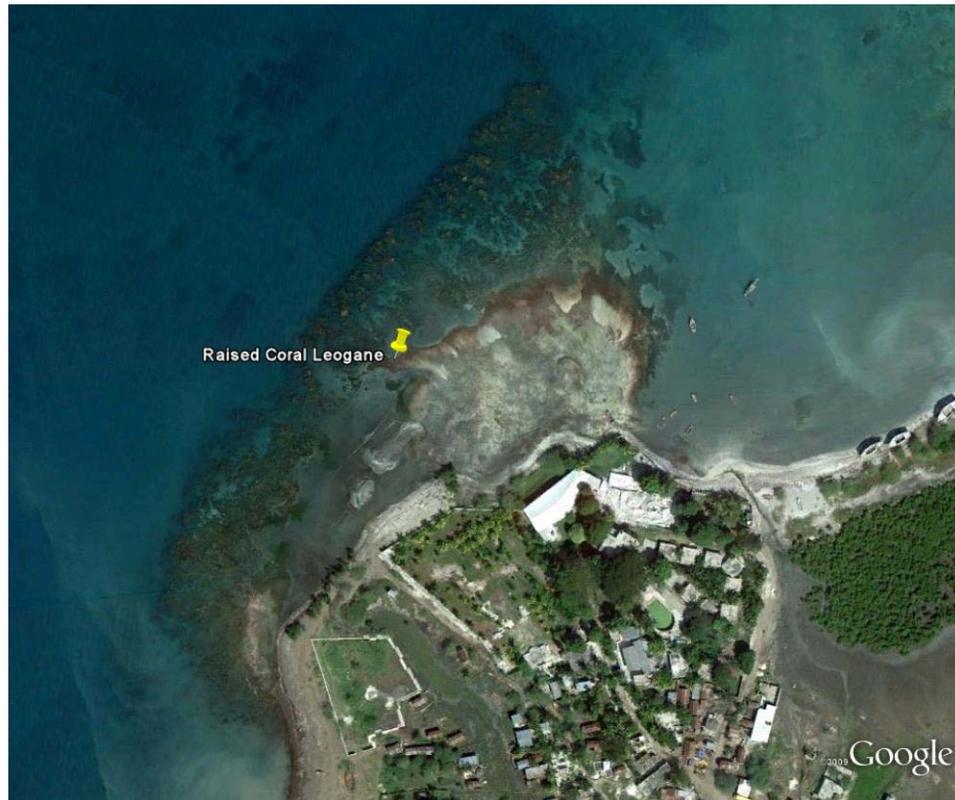
Interpretation of aerial imagery and reports from Haitians in the coastal area of Léogâne indicated that several areas along the coast were uplifted as a result of the 12 January earthquake. The GEER team traveled to the Ca Ira area west of Léogâne on 1 February to observe one area where coastal uplift had been observed. At this site, the team observed an area of exposed coral and subtidal Turtle grass extending for more than 100 m seaward from the shoreline (Figure 4.12). Key observations from this area are as follows.

The estimated uplift resulting from 12 January earthquake is on the order of 50 centimeters based on elevational differences between pre-event high tide marks on a seawall (interpretation by Rich Briggs), tidal records for the date and time of the field visit, elevation of current high tide debris strandline, presence of living coral exposed in the coral head above the water (Figure 4.17), the height (length) of the exposed grasses, and reports on water level/tidal changes by local villagers.

**Figure 4.12** Aerial view of coastal uplift in Ca Ira, near Legwane.  
(See GEER Haiti Report.kmz for location)

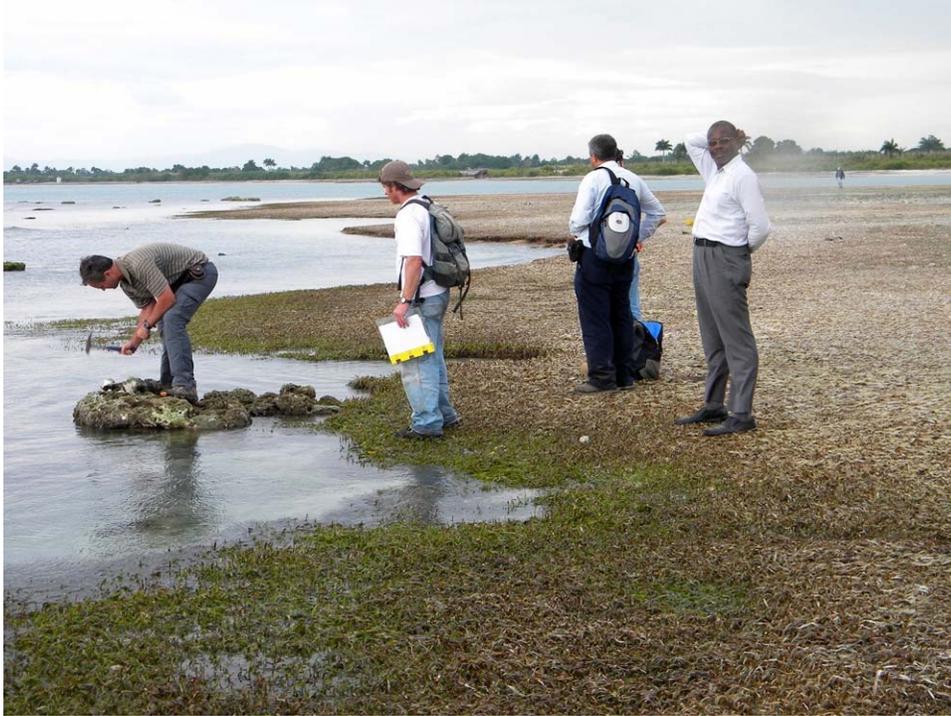
Turtle grass is a subtidal plant, and apparently does not grow in areas exposed at low tide. As observed during our reconnaissance, an extensive area of this grass was exposed above the water level (which was at or close to low tide during our reconnaissance). Much of the exposed grass was brown and appeared to be dying as a result of exposure to air/direct sunlight (Figure 4.13). The length of the grasses was about 10 cm, possibly indicating the minimum submergence depth at low tide prior to the 12 January earthquake.

**Figure 4.13.** Reconnaissance team inspecting exposed grass and coral at Ca Ira, Léogâne. An extensive area of mud flats, grasses, and coral was exposed at low tide. (18.525333°N, 72.652008°W).

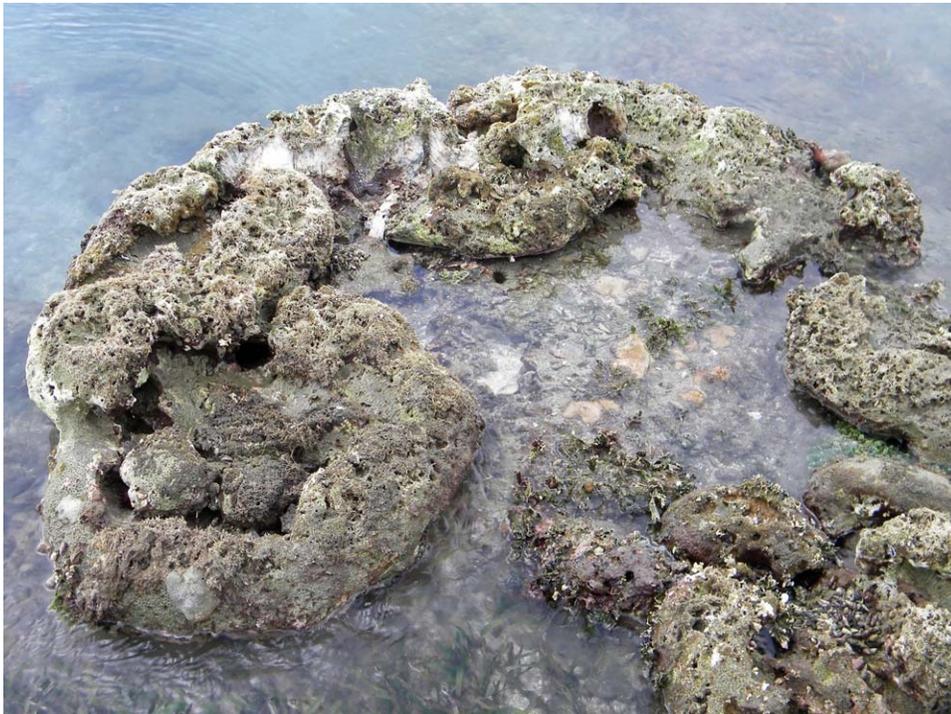
The coral reef exposed at low tide consisted of largely dead coral heads (Figure 4.14), with small areas of new living coral at the top of the heads (Figure 4.15). The outer coral head is dead, which appears to indicate that uplift occurred previously at this site, followed by submergence and growth of new coral. The minimum subtidal depth at which coral grows is dependent on the specific coral species and other factors, but may be on the order of several tens of centimeters.

**Figure 4.14** Coral head (~1.0 m diameter) with living coral at center exposed at low tide at Ca Ira, Léogâne (N18.525333, W72.652008).

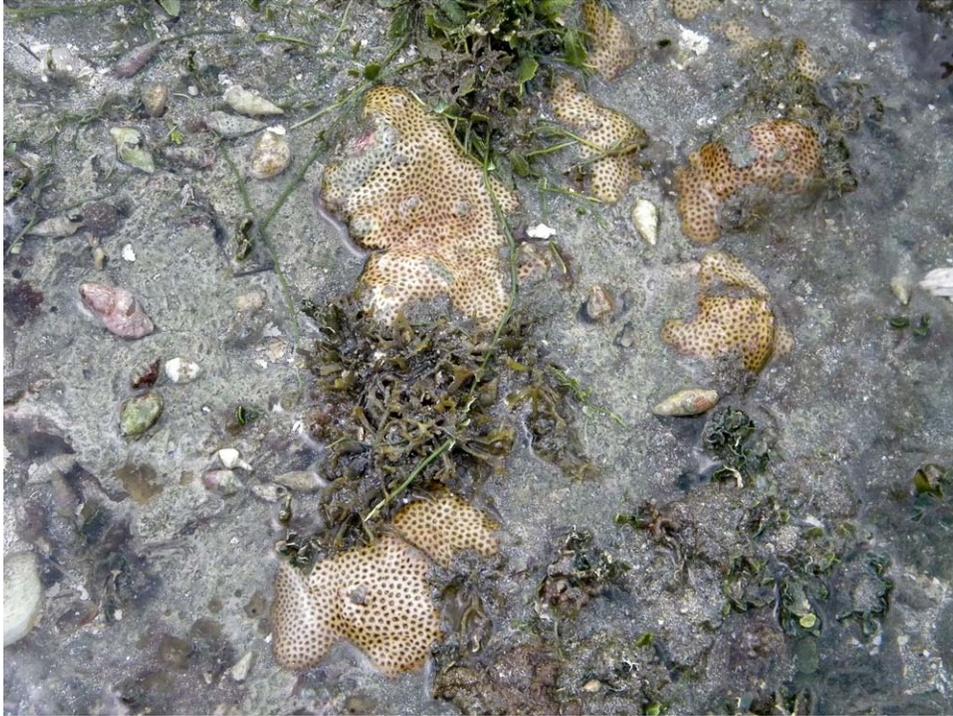
**Figure 4.15** Living coral in coral head exposed at low tide at Ca Ira, Léogâne. (N18.525333, W72.652008)

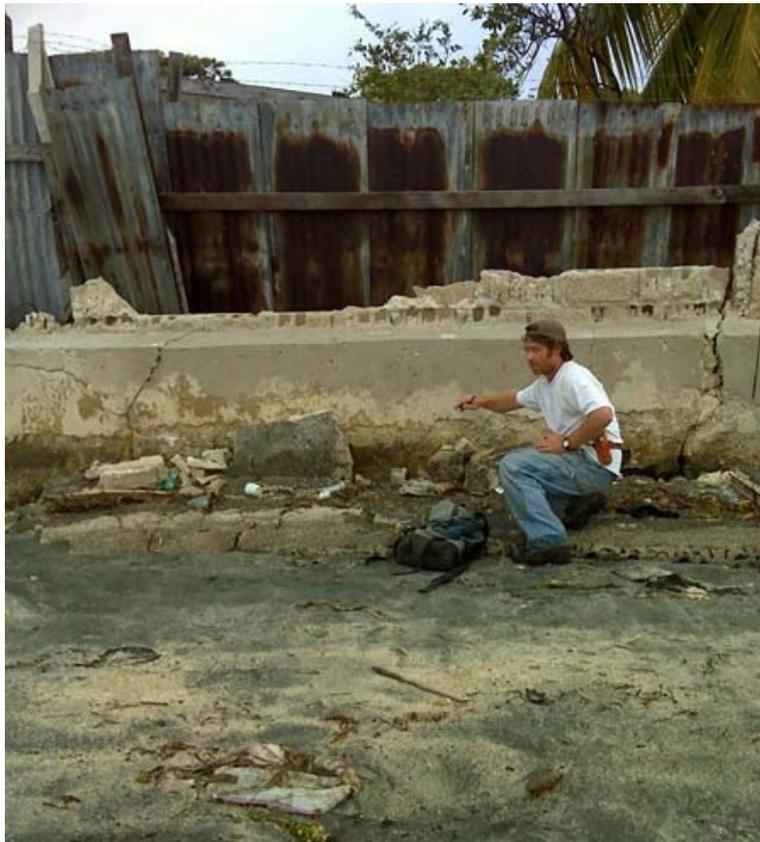
Local villagers indicated that the grasses and mud flats were not exposed at low tides prior to the 12 January earthquake, and that the high tides no longer extended to the sea wall as indicated by the water marks on these walls (Figure 4.16). The current tide chart for Port-au-Prince indicates the tidal range typically is about 0.4 to 0.6 m.

**Figure 4.16.** Water mark for high tides on sea wall at Ca Ira, Léogâne. Residents indicate high tides no longer extend up the wall to the former high tide level (N18.524924, W72.650871)

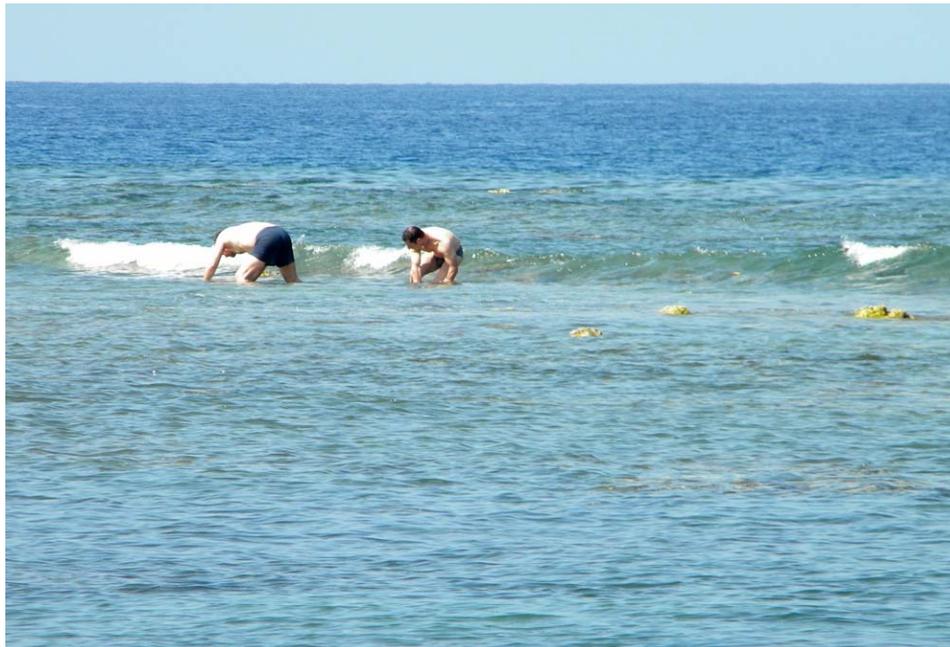
**Figure 4.19** GEER team members inspecting uplifted coral reef near L'acul Coral heads are exposed above water at right, approximately one hour prior to high tide. (N18.446463, W72.688354).

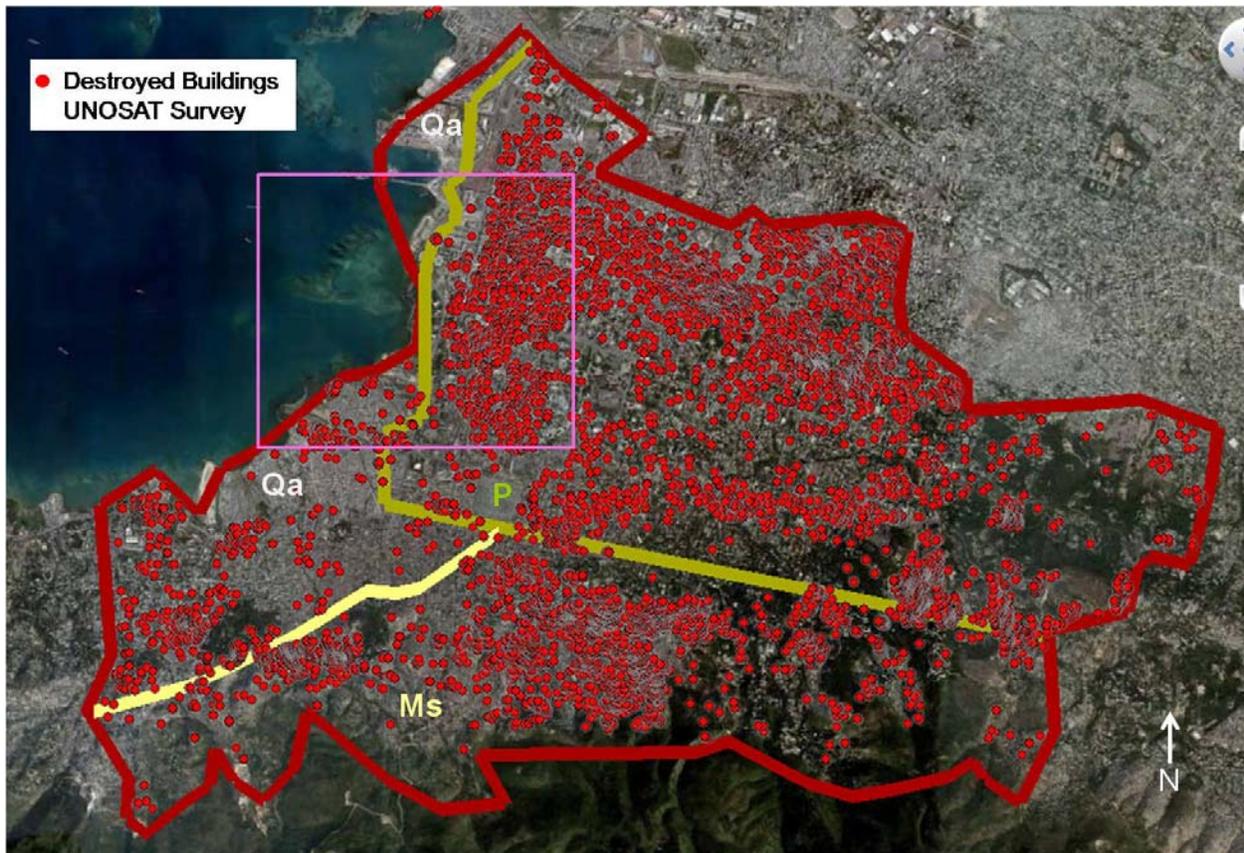
Figure 5.6 shows the buildings categorized as Destroyed in the UNOSAT survey relative to the Quaternary (Qa), Pliocene (P) and Miocene (Ms) deposits discussed in Section 5.2. It is evident from this broad view that many buildings were destroyed in each of these three deposits (however, recall that the geologic boundaries are somewhat uncertain). However, the picture is skewed somewhat because only the Destroyed buildings are shown (approximately 10,000 points). When one zooms in on the damage, certain patterns begin to emerge. The following discussion will focus on the area boxed in pink in Figure 5.6.

**Figure 5.6** Buildings classified as Destroyed in the UNOSAT survey relative to the three geologic units (Quaternary = Qa, Pliocene = P and Miocene = Ms) underlying the survey area. Note that the destroyed buildings shown in this figure only represent about 10% of the more than 90,000 total buildings categorized in the UNOSAT survey (refer to the text for more detail).

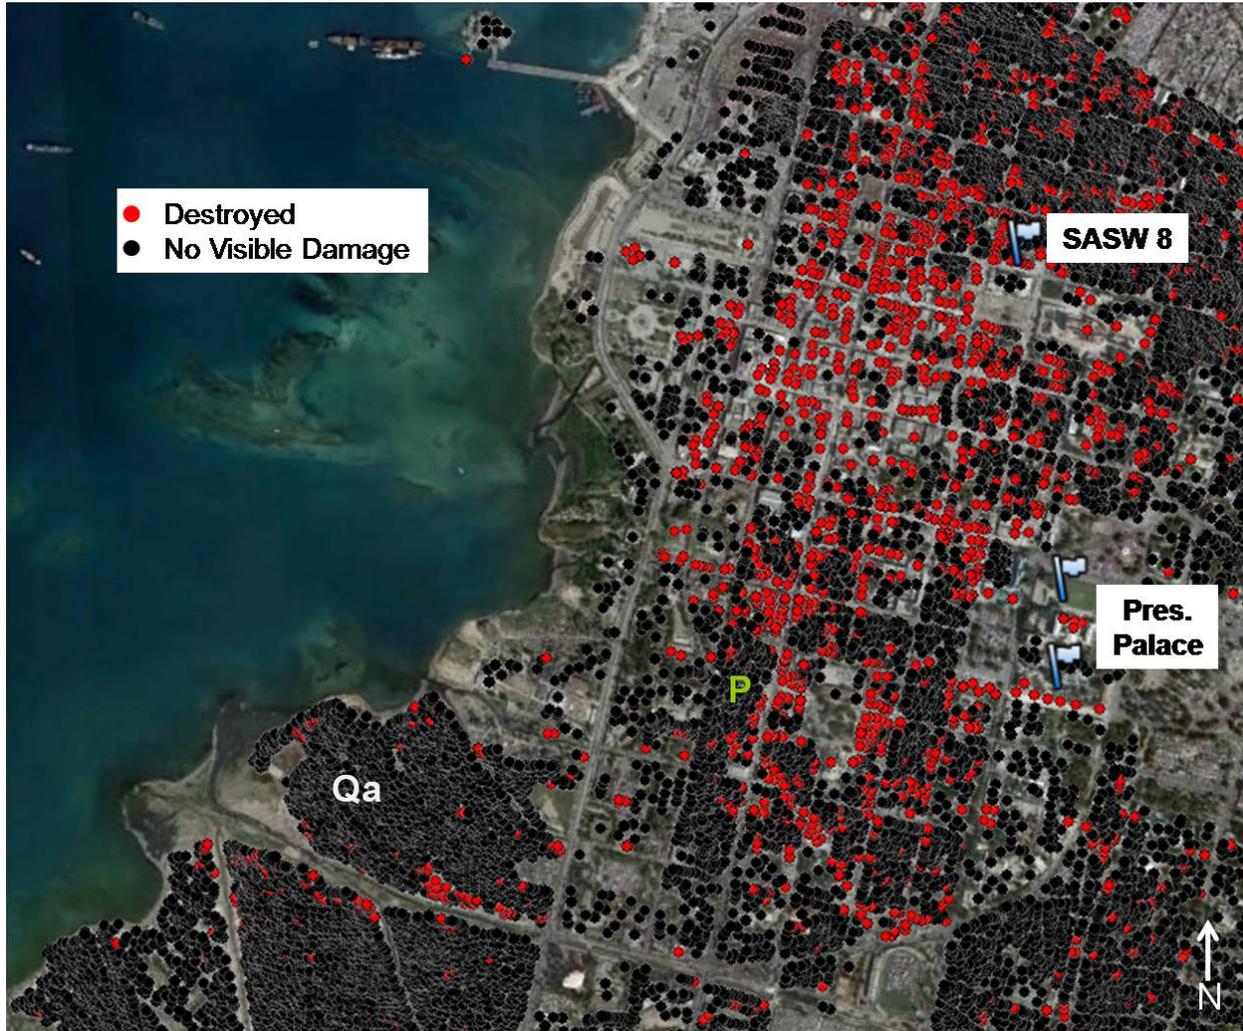
One intensely damaged zone noticed on the GEER reconnaissance was an area located due west and north of the Presidential Palace. This area is boxed in pink in Figure 5.6 and shown in Figure 5.7 along with the buildings that were categorized as either Destroyed (red dots) or No Visible Damage (black dots) in the UNOSAT survey. Also shown are three flag markers where Spectral Analysis of Surface Waves (SASW) testing was performed to investigate the near-surface soil layering and stiffness in the area. It is clear that nearly every building on some of these blocks was completely destroyed (particularly just west and south of SASW 8). However, it is also clear that other areas nearby (e.g. the extreme left-hand bottom corner of Figure 5.7) had very few destroyed buildings. Interestingly, according to the published geologic map, the heavily damaged area lies on Pliocene deposits, while the lightly damaged area lies on younger (presumably softer) Quaternary deposits. However, the revised interpretation of the Quaternary/Pliocene contact (see Section 5.2) would place both of these areas within Quaternary alluvium. One reason for these differences in damage may be building type. Most of the buildings in the heavily damaged zone were larger, multi-story, reinforced concrete structures, while most of the buildings in the lightly damaged area were smaller, densely packed Shanty's with tin roofs (note the difference in density of black dots in the two areas). Several pictures of the type of structures and damage encountered in the heavily damaged zone near SASW 8 are shown in Figure 5.8.

**Figure 5.7** Buildings classified as No Visible Damage and Destroyed in the UNOSAT survey for the boxed area specified in Figure 5.6. Notice the heavily damaged zone lying on P deposits to the north and west of the Presidential Palace and the lightly damaged zone lying on Qa deposits in the lower left-hand corner. Most of the buildings in the heavily damaged zone were larger, multi-story, reinforced concrete structures, while most of the buildings in the lightly damaged area were smaller, densely spaced Shanty's with tin roofs (refer to the text for more detail).

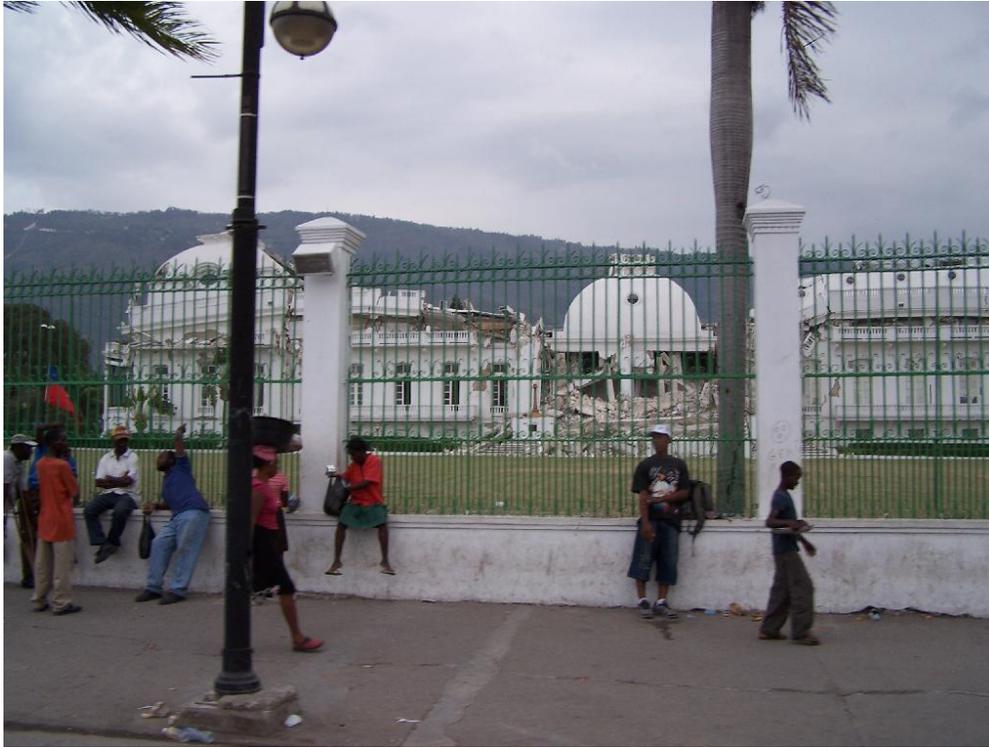
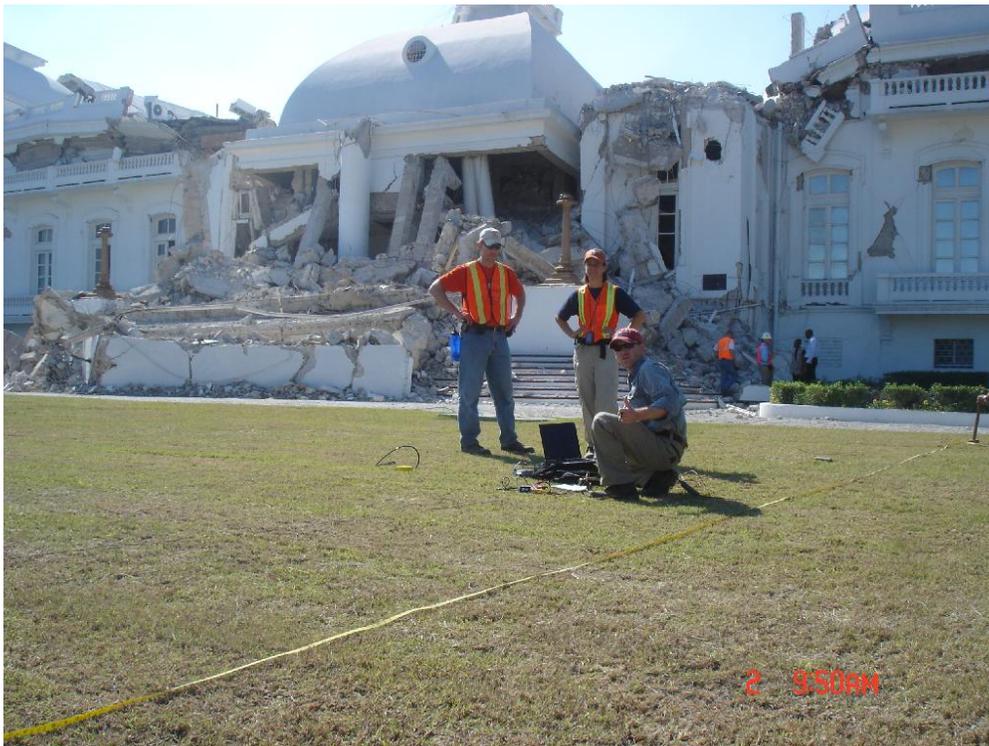
The Presidential Palace also lies on the eastern edge of this heavily damaged zone. The damage to the Presidential Palace (Figure 5.9) was documented by many news crews covering the aftermath of the earthquake due to its symbolism for the widespread, devastating destruction throughout the city. The GEER team conducted two SASW tests (SASW 6 and SASW 7) and one H/V Spectral Ratio test on the grounds of the Presidential Palace. These results have not been fully processed yet, but will be made available as soon as they are complete.

**Figure 5.9** The Presidential Palace lies within the heavily damaged zone noted above. Two SASW tests and one H/V Spectral Ratio test were conducted here (N 18.543633°, W - 72.338905°).

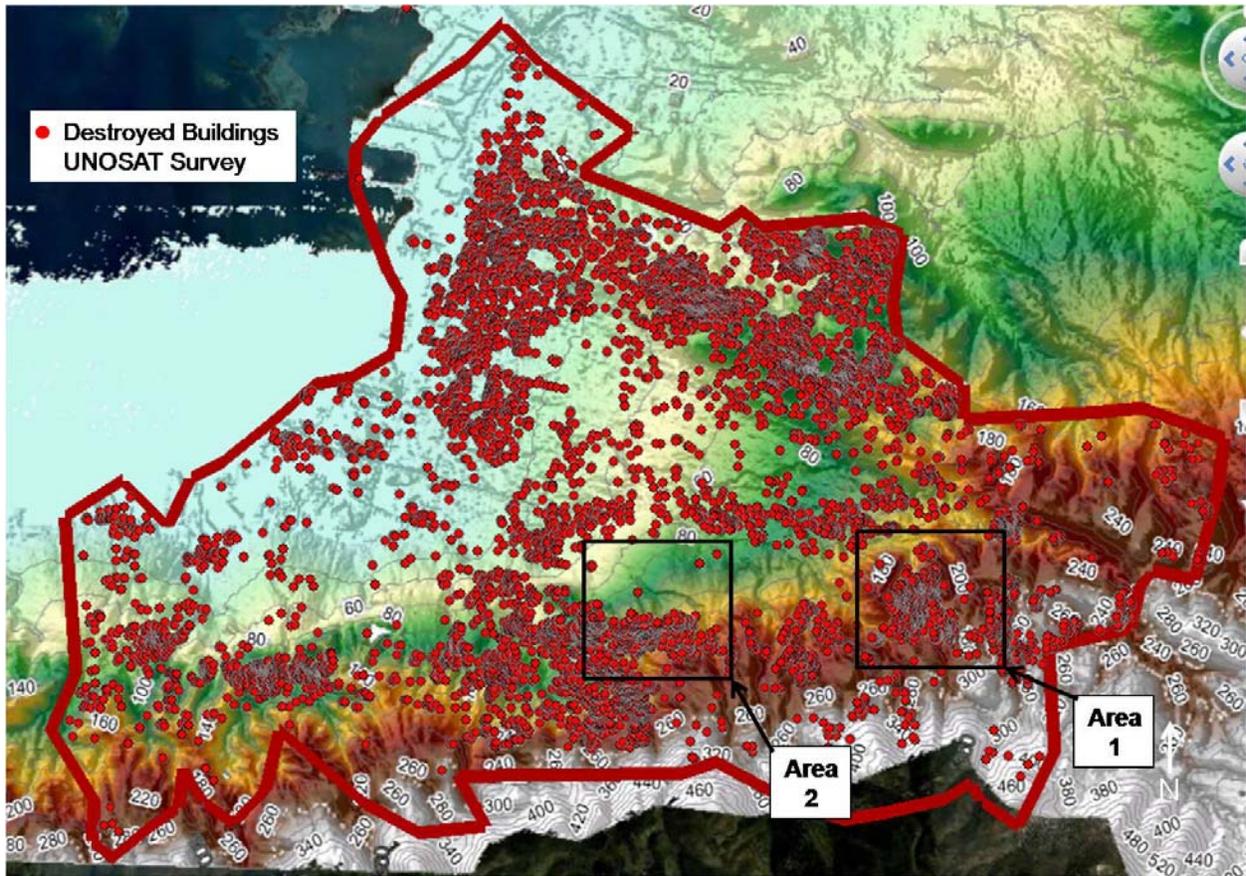
Figure 5.10 shows the buildings categorized as Destroyed in the UNOSAT survey relative to a color-shaded topographic map of the Port-au-Prince area. These 20-m, color-shaded contours were generated by personnel from CAST using LiDAR data processed by Chris Crosby at OpenTopography ([http://opentopo.sdsc.edu/files/Haiti/WorldBank\\_Haiti\\_lidar\\_hs\\_v1.kmz](http://opentopo.sdsc.edu/files/Haiti/WorldBank_Haiti_lidar_hs_v1.kmz)). As was the case with the varied geologic deposits shown in Figure 5.6, it is evident that many buildings were destroyed in all types of topography. However, when one zooms in on the damage, certain patterns begin to emerge. The following discussion will focus on the two areas labeled in Figure 5.10.

**Figure 5.10** Buildings classified as Destroyed in the UNOSAT survey relative to topography in the Port-au-Prince area. Note that the destroyed buildings shown in this figure only represent about 10% of the more than 90,000 total buildings categorized in the UNOSAT survey (refer to the text for more detail).

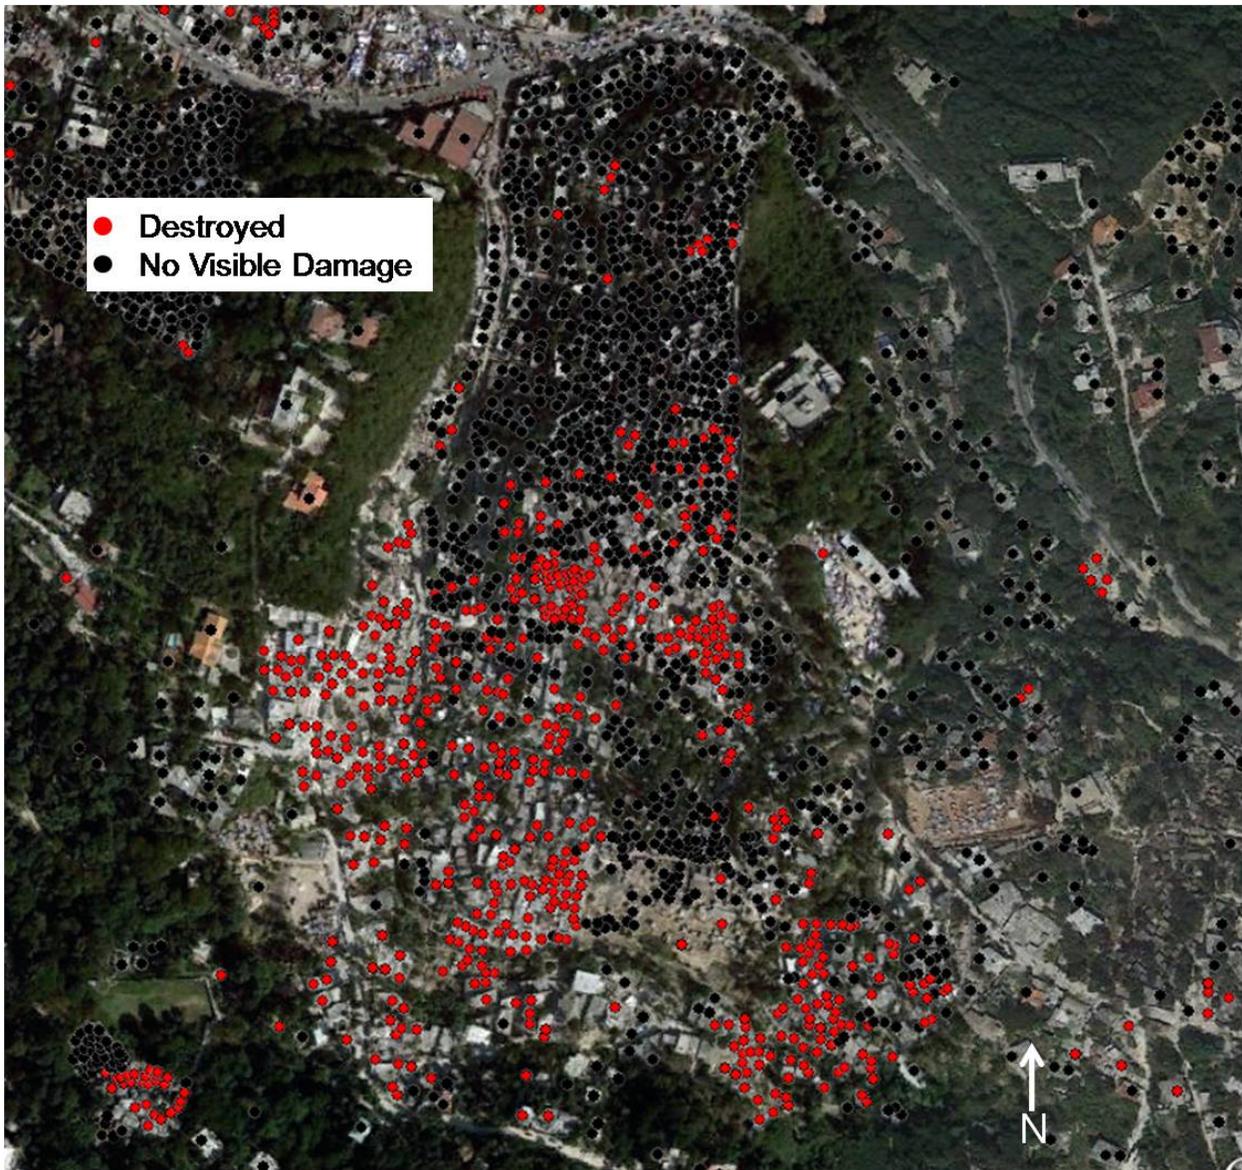
One interesting area lying on steep topography is shown in Figure 5.11 along with the buildings that were categorized as either Destroyed (red dots) or No Visible Damage (black dots) in the UNOSAT survey. This zone is labeled as Area 1 in Figure 5.10. There is almost a distinct line that could be drawn from east-to-west that separates heavy damage to the south from almost no visible damage to the north. When one zooms in on this area there appears to be no significant difference in the type of structures. All of them appear to be densely packed Shanty-type buildings. It is possible that the steepness of the slope affected this pattern, but no conclusive evidence is known at this time.

**Figure 5.11** Buildings classified as No Visible Damage and Destroyed in the UNOSAT survey for the boxed area labeled as Area 1 in Figure 5.10. Notice the clear north-south separation between no visible damage and destroyed buildings that bisects the ridgeline east-to-west. All of these buildings appear to be Shanty-type structures with similar construction (refer to the text for more detail).

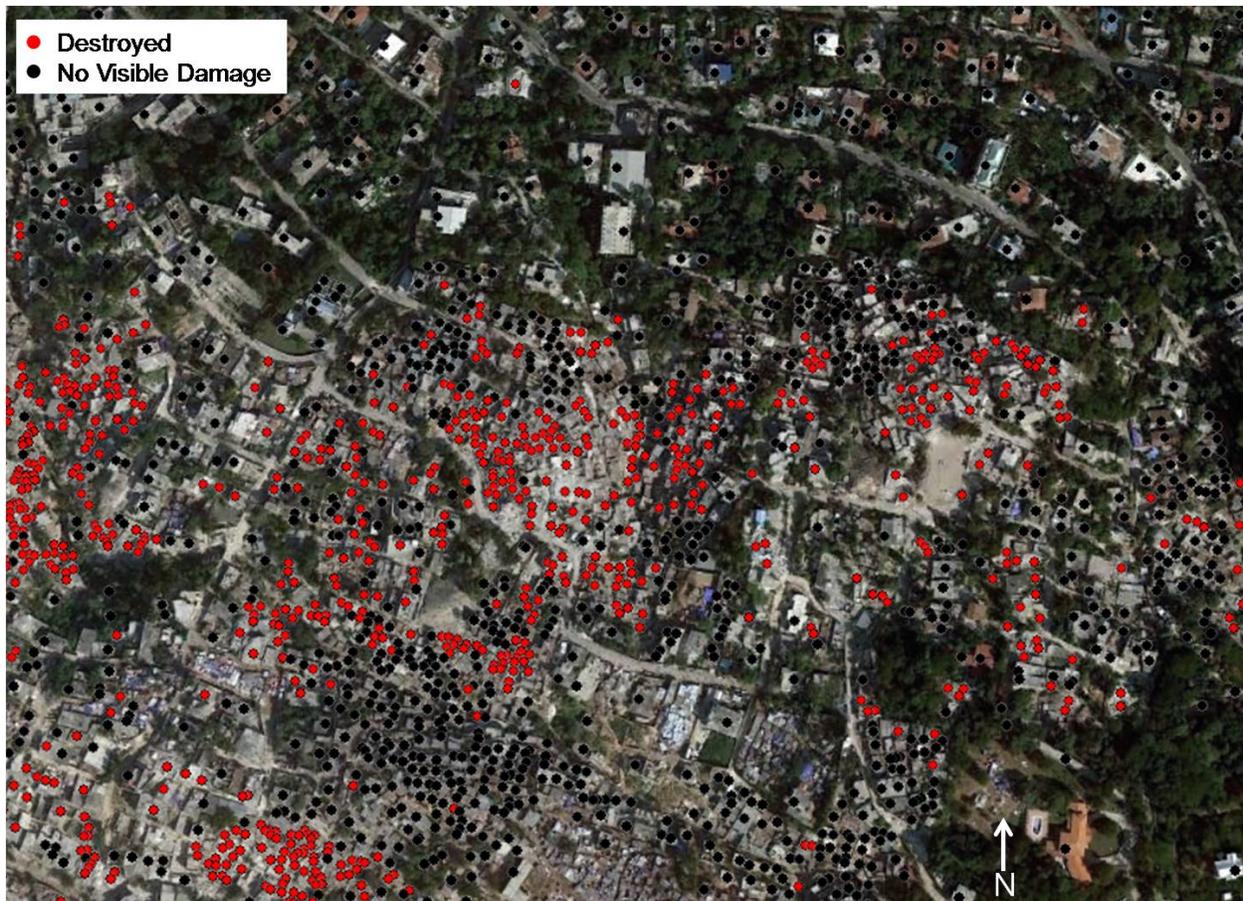
Another interesting area lying on a transition from moderate to steep topography is shown in Figure 5.12. This zone is labeled as Area 2 in Figure 5.10. Once again, there is almost a distinct line that can be drawn from east-to-west that separates heavy damage to the south from no visible damage to the north. However, in this case there is both a distinct difference in the type of structure (and likely quality of construction) and type of topography. The structures to the north are larger buildings that appear to be nice homes (some with swimming pools). They are also constructed on more gradual topography. Very few of these homes were damaged. The structures to the south are Shanty-type structures, and the ones that are damaged most severely are located near the top of the hillsides/ridges. This could be evidence of ridge-top focusing of seismic energy. Conversely, the line of Shanty's where no visible damage is noted (bottom center of Figure 5.12) are constructed in a valley.

**Figure 5.12:** Buildings classified as No Visible Damage and Destroyed in the UNOSAT survey for the boxed area labeled as “Area for Fig. 10” in Figure 3.8. Notice the clear north-south separation between no visible damage and destroyed buildings that bisects this area from east-to-west. The undamaged buildings to the north are larger homes that appear to be well constructed. Furthermore, they also sit on more moderate topography. The destroyed buildings appear to be Shanty-type structures that sit near the top of the hillsides/ridges (refer to the text for more detail).
