# GEOTECHNICAL ENGINEERING RECONNAISSANCE OF THE 2010 HAITI EARTHQUAKE

Version 1: February 22, 2010

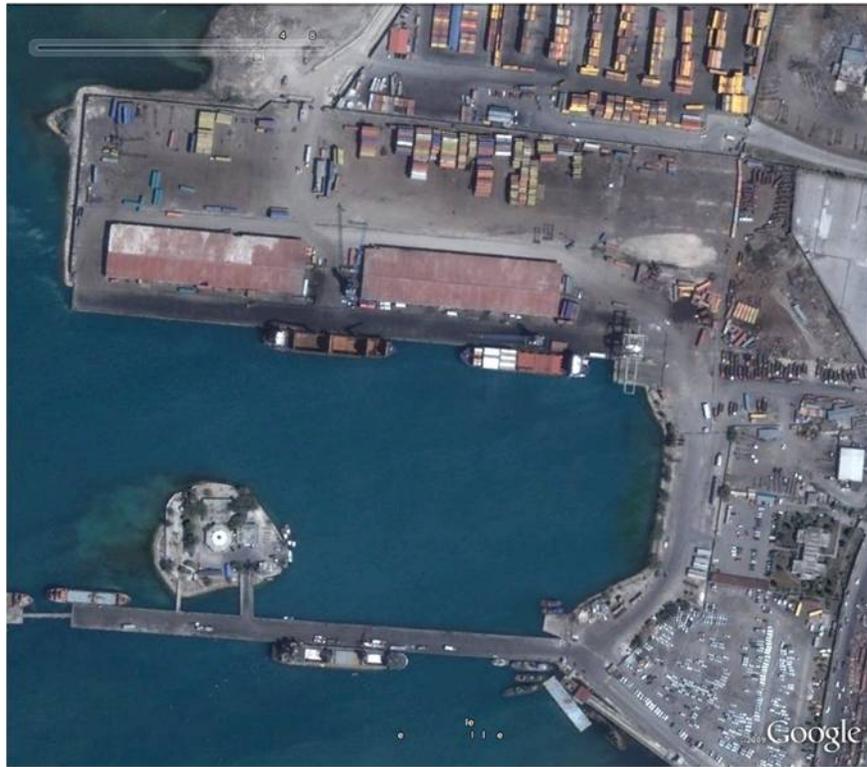
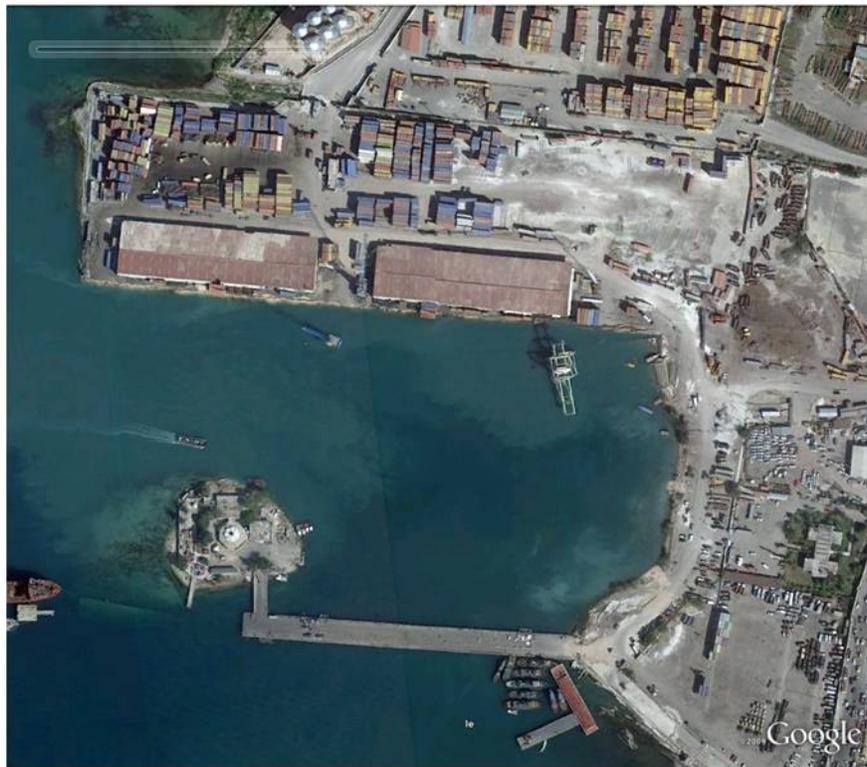
Pre- and post-earthquake aerial images of the port are shown in Figure 6.2, and these images clearly show evidence of liquefaction and lateral spreading, failure of the North Wharf, and collapse of portions of the South Pier. The photo of the port shown in Figure 6.3 (unknown photographer) is circa 1962, and shows one long pier that extends from the main coastal road. This pier is located along the southern margin of the current port (Figure 6.4), which suggests that the present port facility is constructed on fill, likely un-engineered and of unknown origin. Also, from field reconnaissance, it is clear that the fill material extends to the North (to the left and out of view of the photo shown in Figure 6.3), demarcated by dashed lines in Figure 6.4. The port suffered extensive damage during the earthquake (Figure 6.5), inhibiting the delivery of relief supplies to areas affected by the earthquake. Light-colored areas on the ground surface in Figure 6.4 are sand boils/ejecta and can be seen in the eastern half of the container storage yard and behind and between the two warehouses. The locations where large lateral spreading fissures were observed are also shown in Figure 6.5.

**Figure 6.2** Pre- and post-earthquake satellite/aerial imagery (top and bottom, respectively) of the port at Port-au-Prince, Haiti (N18.555058°, W72.351144°). Imagery courtesy of Google Earth.

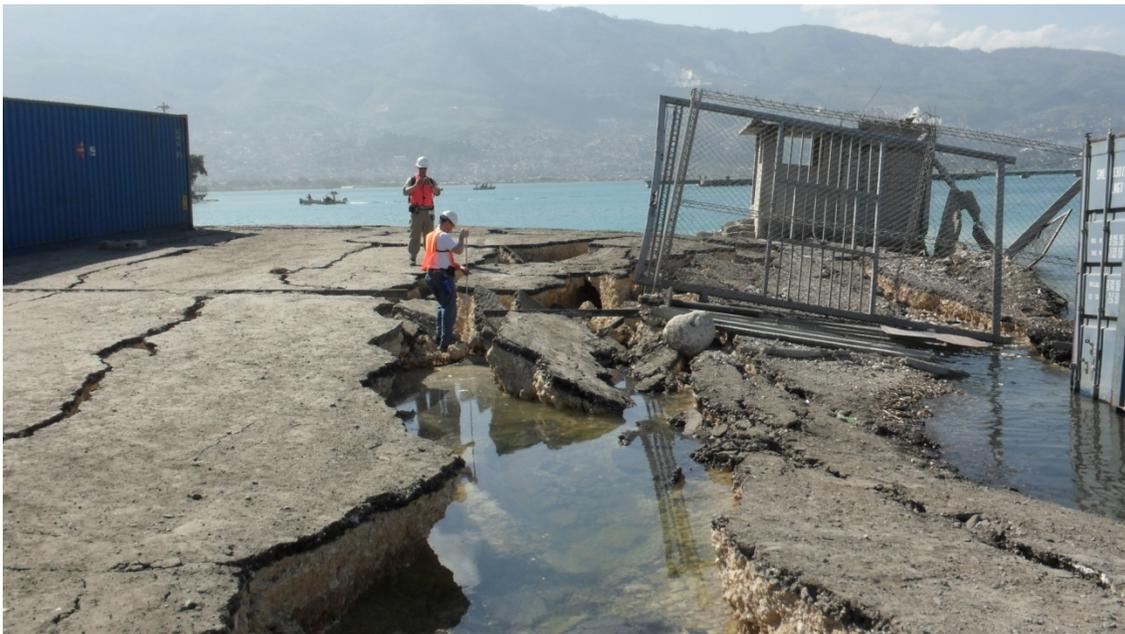
**Figure 6.9** Lateral spreading west of the two metal warehouses. Photo taken facing south with the metal warehouses to the left. (N18.557075, W72.352045)

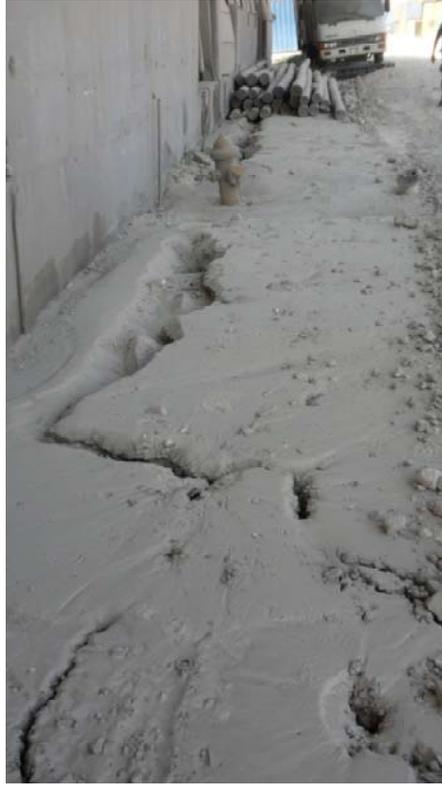
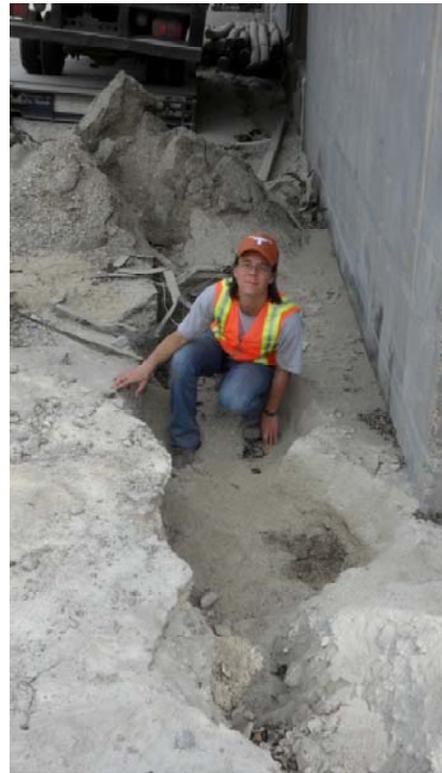
**Figure 6.10** Liquefaction and lateral spreading adjacent to the north side of the metal warehouses. Photo on top taken facing west, photo on bottom taken facing east. (N18.556961, W72.349751)

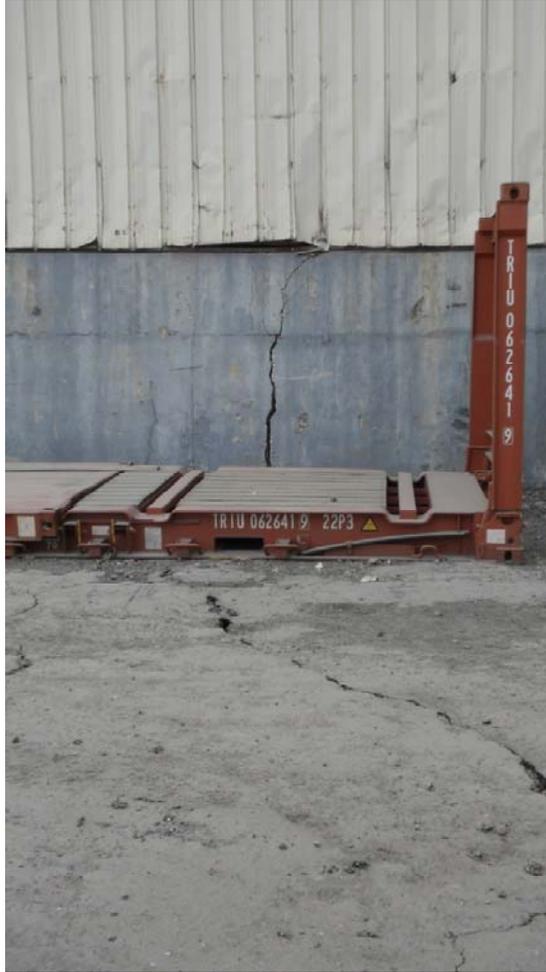
**Figure 6.11** Lateral spreading crack extending into the western foundation wall of the west warehouse. Photo taken facing east. (N18.55721, W72.35179)

The warehouses suffered severe damage as a result of the lateral spreading and settlement, and will likely have to be torn down. As shown in Figure 6.11, lateral spreading cracks running in the East-West direction cut through each warehouse foundation wall. A detailed survey of the relative elevations and lateral movements of the west warehouse slab is shown in Figure 6.14. The interior slab consisted of 14 separate slabs, two abreast and seven long. Due to lateral spreading, the south wall (adjacent to the shoreline) moved approximately 0.7 to 1.4 m laterally towards the shoreline (i.e., the width of the warehouses increased). The relative elevations across the slab are more difficult to interpret because it was clear that the slab was constructed with a significant slope and/or curvature towards the seaward edge. Without knowledge of the relative elevation differences before the earthquake, these movements cannot be converted to relative settlements due to liquefaction. Nonetheless, the relative elevations across the interior were variable, with the some areas almost 1 m lower than others. It appeared that the

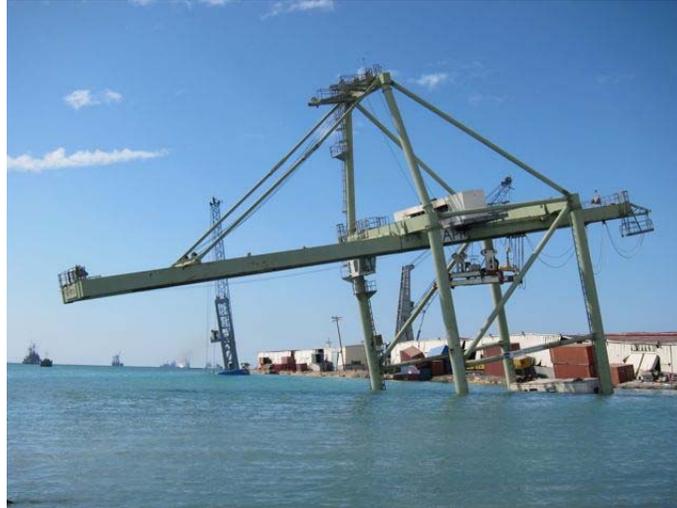
Two of the three cranes were apparently on the North Wharf at the time of the earthquake and are now partially submerged. Figure 6.12 shows the A-frame container crane in the foreground and a submerged mobile crane in the background. There was no obvious structural damage to the container crane. Interestingly, a photo taken by an unknown photographer (apparently aboard a ship docked at the eastern end of the wharf) immediately after the earthquake (Figure 6.13) shows that the landside legs of the A-frame crane were still above water, with the crane in its most eastwardly position. However, a U.S. Coast Guard photo taken during an overflight of the port at mid-day on January 13, 2010 shows the crane in the same position as in Figure 6.12 (i.e., moved westward about 60 m from its position in Figure 6.13) and with the base of the crane fully submerged. Also, the January 13 photo shows that additional subsidence occurred at the eastern end of North Wharf (i.e., the location of the crane in Figure 6.12). The National Earthquake Information Center reports no fewer than 45 aftershocks ranging from  $M_w$  4.0 to 6.0 following the main shock until 1:54 pm EST on January 13, 2010. This raises the likelihood that a portion of the observed permanent displacements caused by liquefaction occurred as a result of aftershocks. The second mobile crane was parked between the two warehouses and appears to be undamaged.

**Figure 6.12** Submerged 15-m gauge container crane (foreground) and mobile crane (background). Photo taken facing west. (N18.55598, W72.348564)

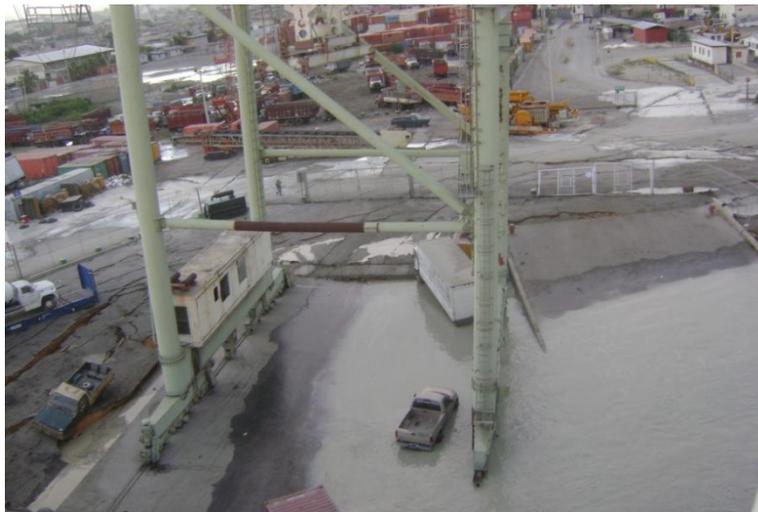
**Figure 6.13** Photo taken immediately after the earthquake with the crane in its most eastward position and with the landside legs of the crane above water. Photo taken facing east. Source: unknown (N 18.556056, W72.347981)

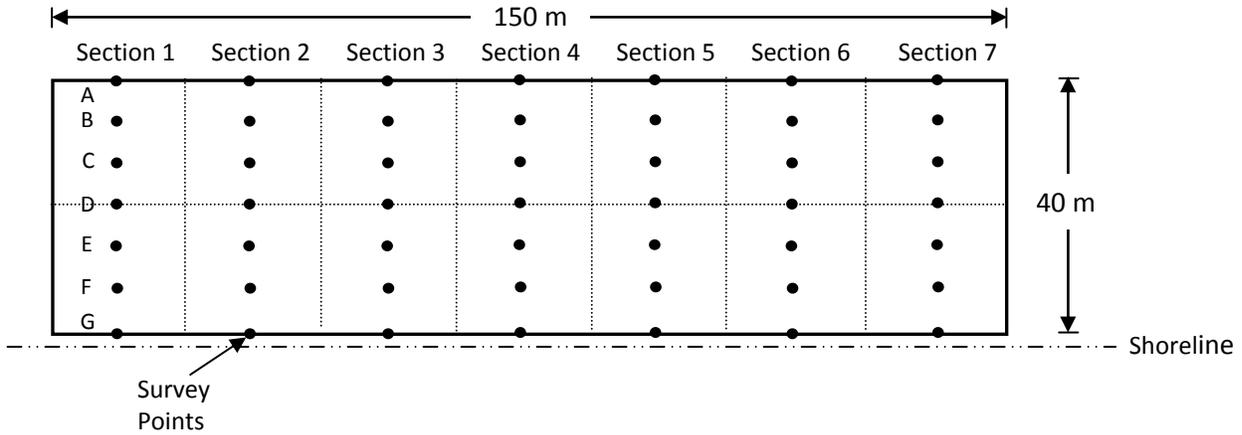
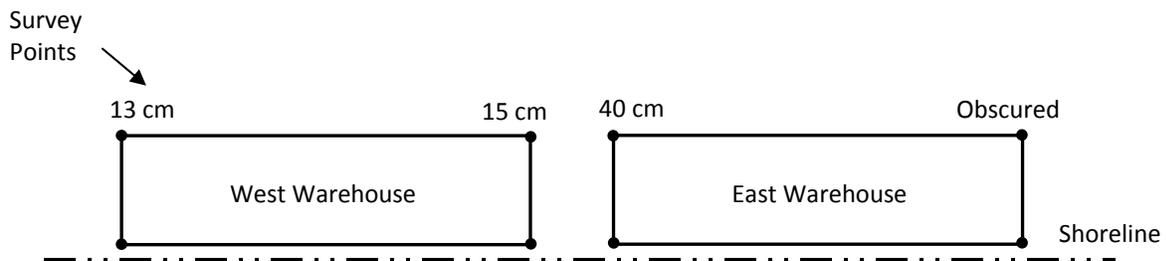
warehouses were founded on strip footings around their perimeters, which settled significantly. Settlements measured at the inland corners of the warehouses are also shown in Figure 6.14. The west warehouse appears to have settled approximately 15 cm relative to the ground surface, while the east warehouse settled more than 40 cm

**Figure 6.14** Results of a detailed survey of the relative settlements of the west warehouse slab, and the total settlements at the inland corners of the warehouses

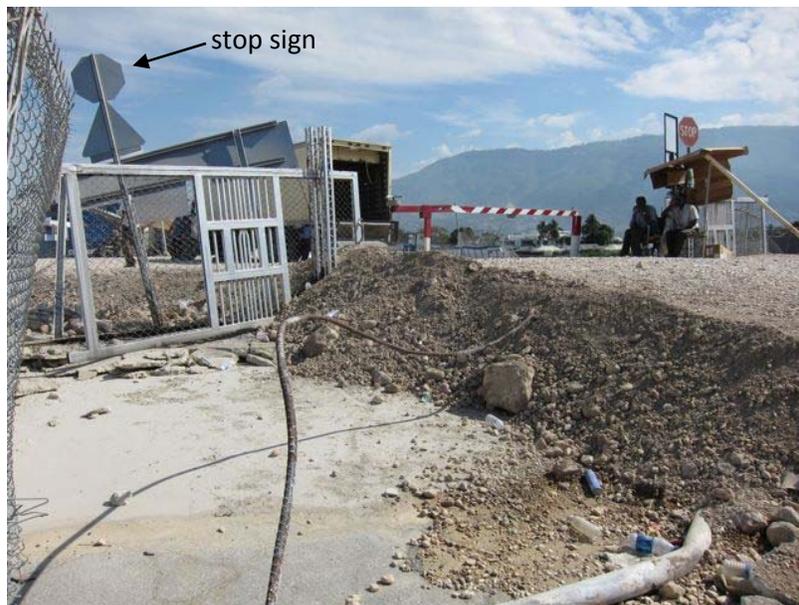
In addition to the damage to the piles supporting the South Pier, the abutment also experienced liquefaction-induced lateral and vertical displacements. Approximately 1 m of fill was required to re-level the approach to the pier as shown in Figure 6.15. Also, the piles supporting the small pedestrian bridge connecting the South Pier to the island could be readily observed. Figure 6.16 shows the damage to these piles, including the extensive damage to the landward row of piles.

**Figure 6.15** Approach to the South Pier immediately after the earthquake (top photo: Source unknown; photo taken facing South-East) and after approximately 1 m of fill was placed (bottom photo: photo taken facing West). (N18.554028, W72.348658)

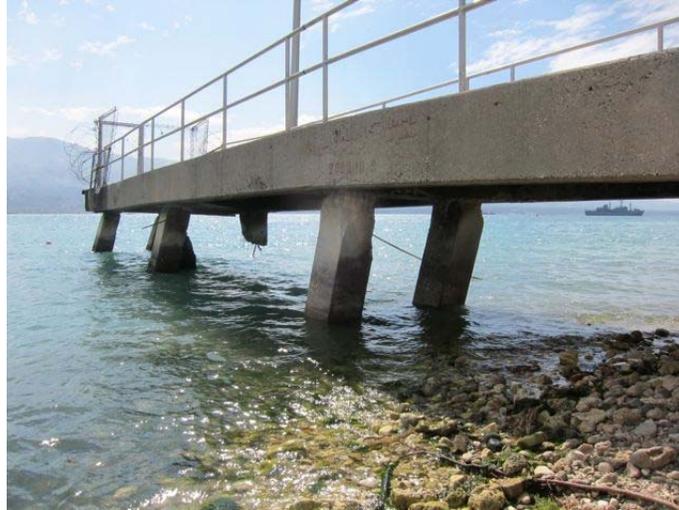
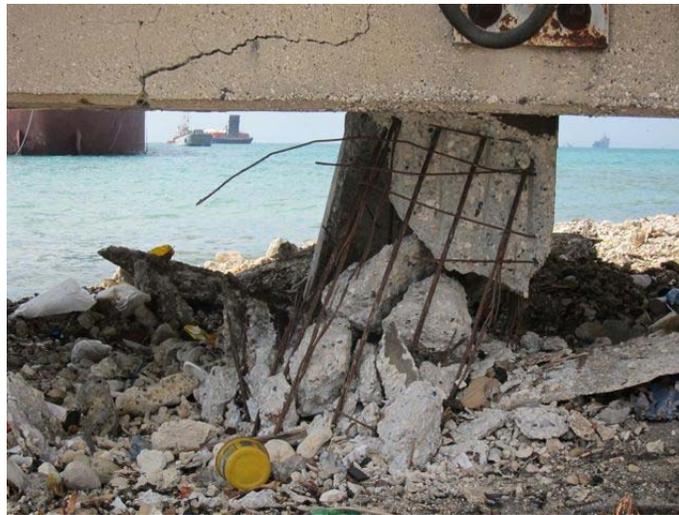
**Figure 6.16:** (top) Damage to piles supporting the pedestrian bridge connecting the South Pier to the island (photo taken facing South) and (bottom) extensive damage to the landward row of piles (photo taken facing West) (N18.554628, W72.351492)

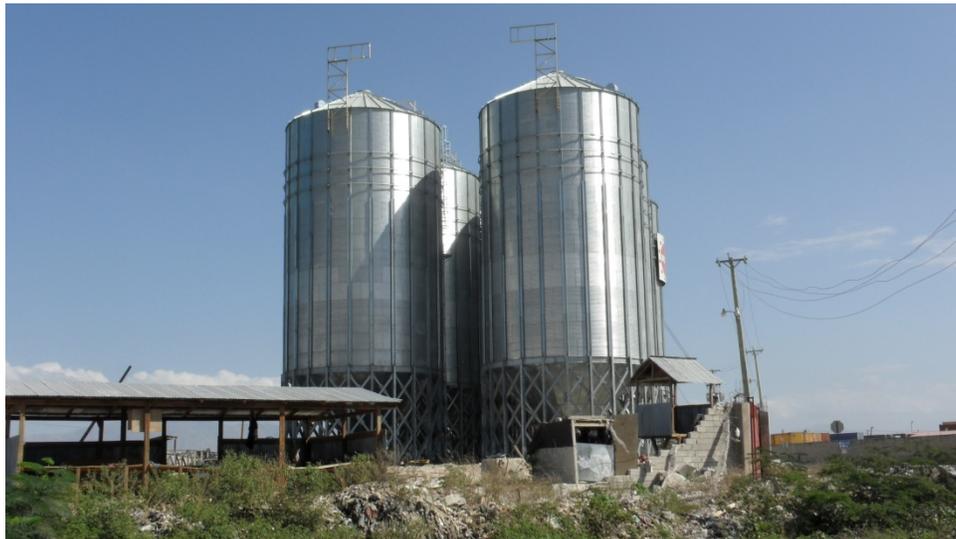
**Figure 6.19** Post-earthquake photo of steel grain hopper silos (photo taken facing North). The silos showed no visible signs of distress.  
(N18.558431, W72.350350)

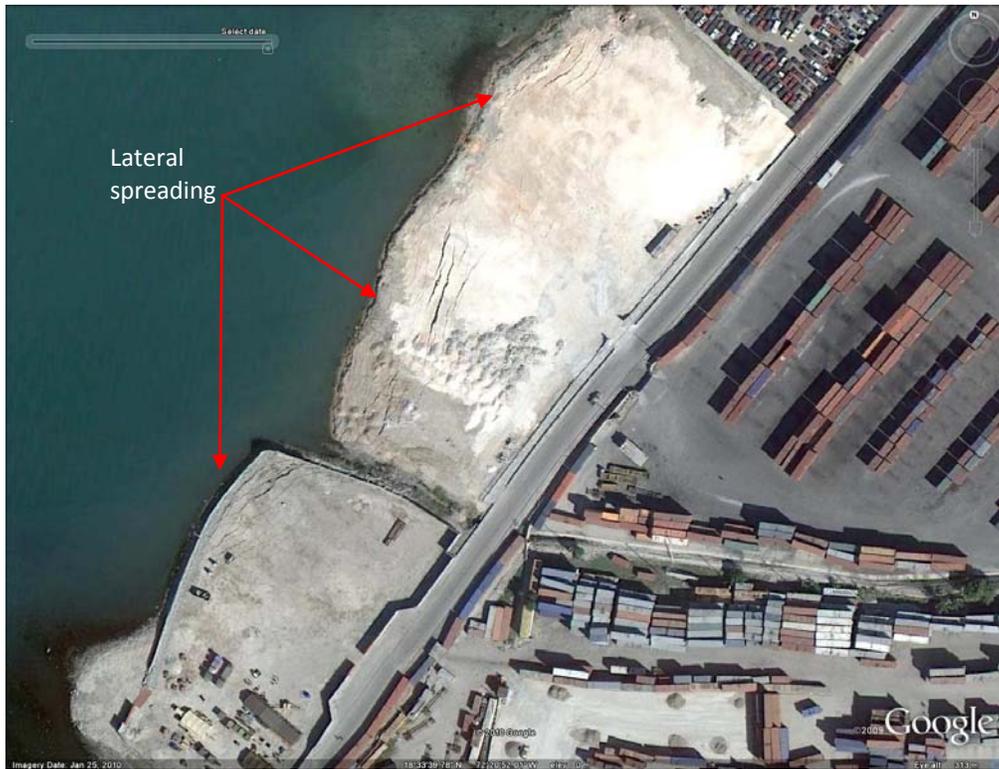
**Figure 6.20** Lateral spreading in the storage yards in the northern part of the port facility. Imagery courtesy of Google Earth. ( $18^{\circ}33'40.23''\text{N}$   $72^{\circ}20'52.33''\text{W}$ )

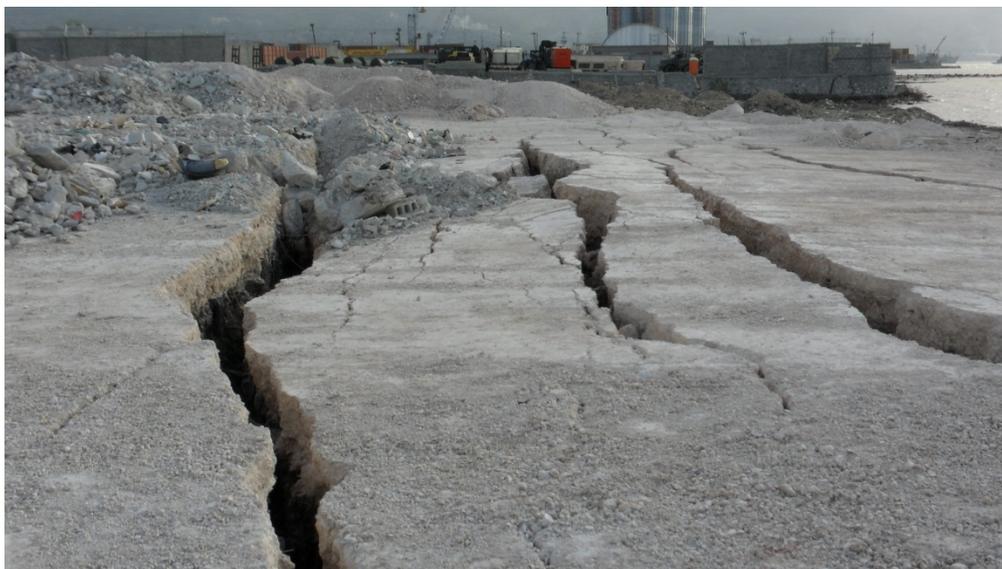
**Figure 6.21** Lateral spreading in the storage yards in the northern part of the port facility. Photo taken facing South. ( $18^{\circ}33'41.39''\text{N}$   $72^{\circ}20'52.51''\text{W}$ )

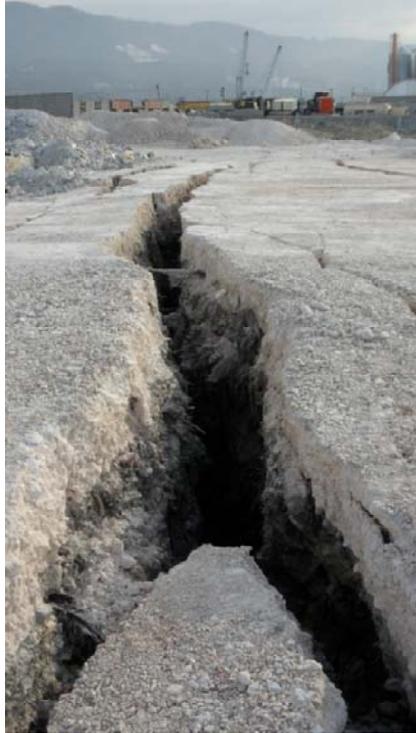
**Figure 6.22** Lateral spreading in the storage yards in the northern part of the port facility. Photo taken facing South. (18°33'41.76"N 72°20'52.25"W)

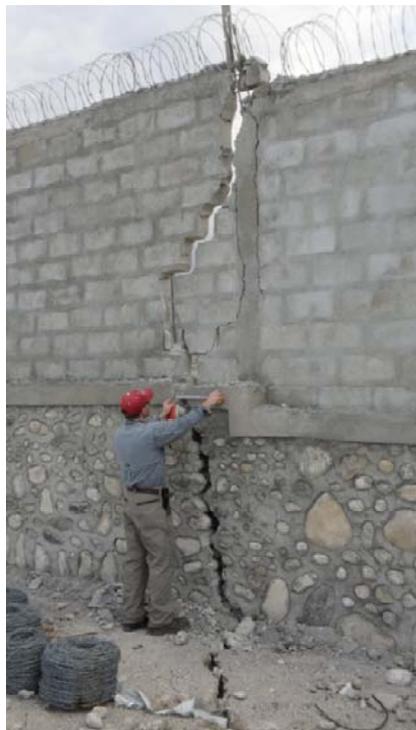
**Figure 6.23** Lateral spreading in the storage yards in the northern part of the port facility. Lateral spread crack passes through a stone/masonry wall. Photo taken facing South. (Approximate long. and lat. of photo: 18°33'35.15"N 72°20'56.18"W)

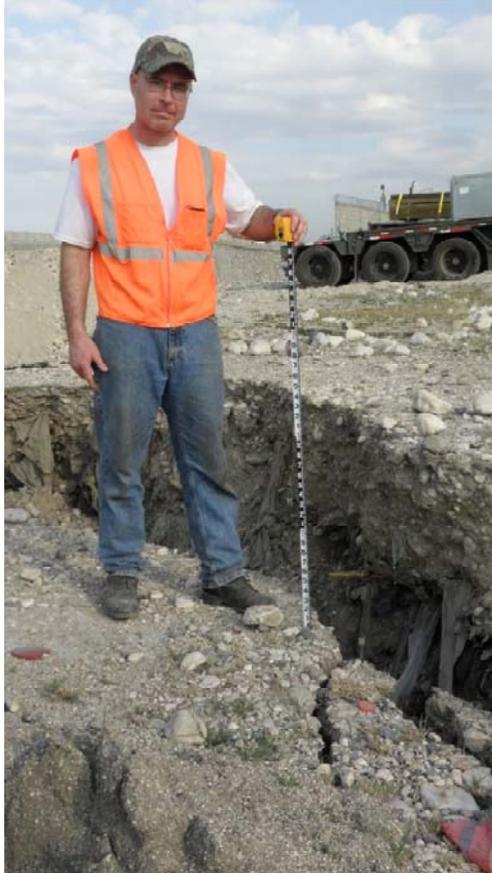
**Figure 6.24** Lateral spreading in the storage yards in the northern part of the port facility. A unique feature of this lateral spread is that the fill is garbage. However, it is believed that the liquefaction of the sand below garbage is the cause of the lateral spreading. Photo taken facing North-East. (Approximate long. and lat. of photo: 18°33'38.93"N 72°20'54.89"W)

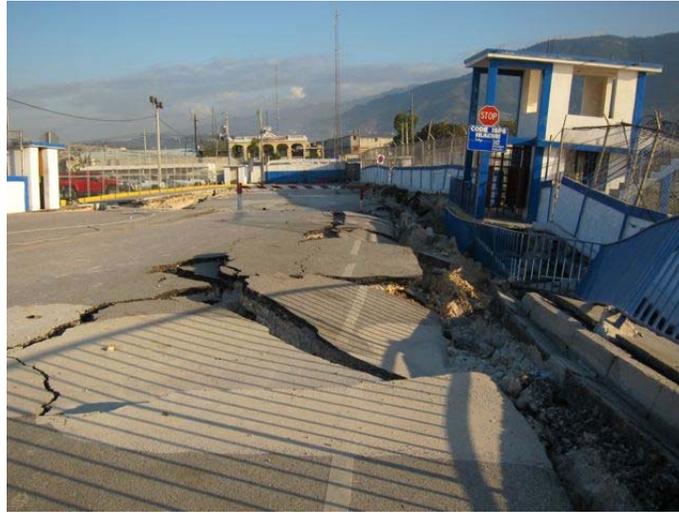
Finally, one of the main entrance roads to the port was heavily damaged by liquefaction-induced lateral spreading, as shown in Figure 6.25.

**Figure 6.25:** Damage to entrance road caused by lateral spreading. Photo taken facing South-East. (Approximate long. and lat. of photo: 18°33'11.61"N 72°20'52.50"W)

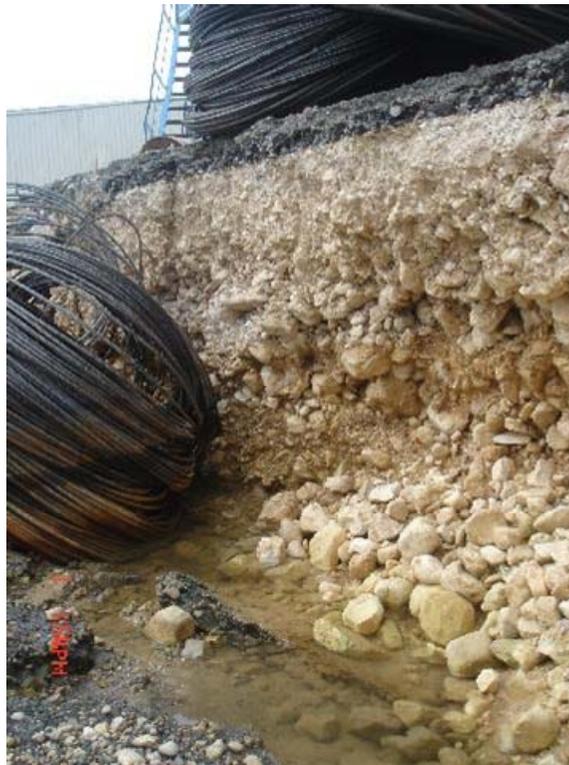
**Figure 6.29** Near-surface soil layering at the wharf as observed on the free-face of the lateral spread that collapsed the wharf deck. This picture was taken just south of SASW 1 (refer to Figure 6.26), facing East. (N18.556635°, W 72.350202°).

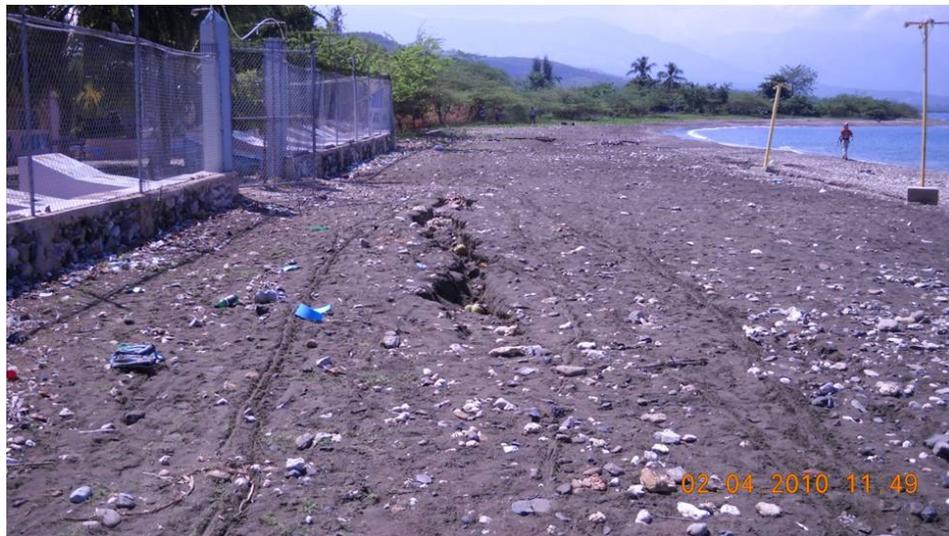
**Figure 7.5.** Ground cracking along coastline near village of L'Acul. (18°26'48.83"N, 72°41'11.39"W looking west).

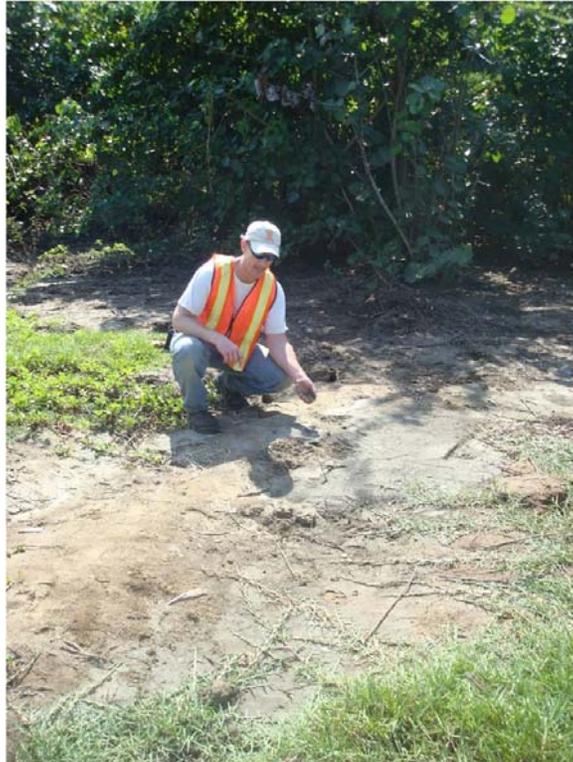
Based on the subparallel cracking, the formation of sand blows, and the results of the in-situ tests, the team attributed this failure to liquefaction and lateral spreading. Liquefaction likely occurred within the loose to medium dense sands below the watertable between depths of about 0.75 m and 2.3 m (2.5 to 7.5 ft). Below 2.3 m in the failed zone, the DCPT encountered much denser sands. The extent of the failure to the south was limited by the presence of fine-grained soils and peat overlying the denser marine sands.

**Figure 7.6.** Sand blow formation to the south of the main cracks along coast near village of L'Acuil. ( $18^{\circ}26'44.27''N$ ,  $72^{\circ}41'12.05''W$  looking south).

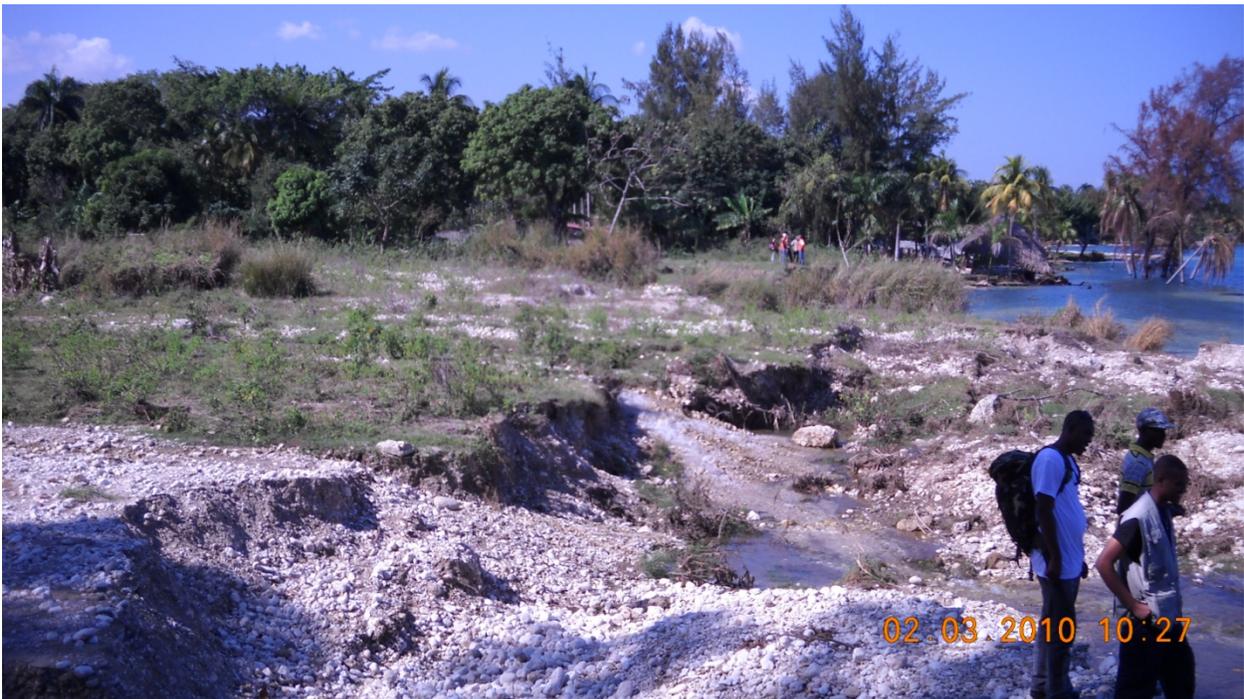
**Figure 7.10.** Scarp of coastal landslide near village of Fouche.  
( $18^{\circ}25'34.01''\text{N}$ ,  $72^{\circ}43'34.60''\text{W}$  looking westward).

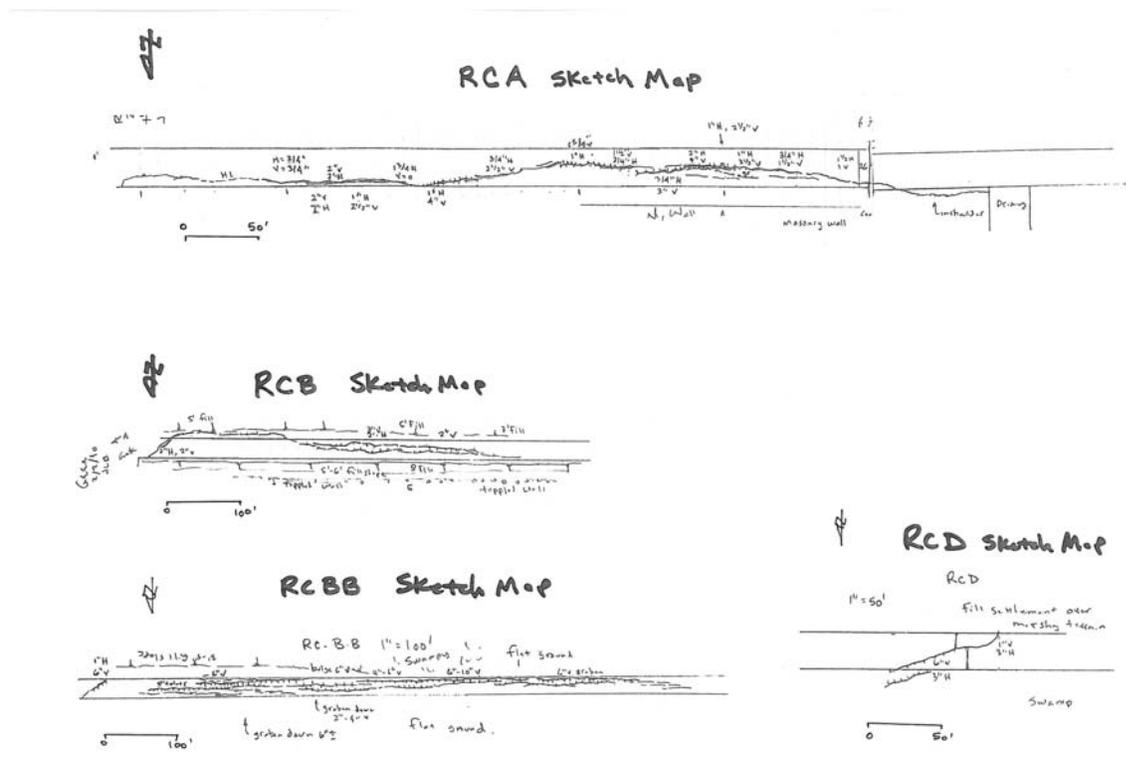
Five locations of poor road fill performance were investigated along Route 2 (Figure 8.1). Figures 8.2 and 8.3 are sketch maps of the crack patterns and fill failures for the investigated sites (note that RCD in Figure 8.2 represents RCC in Figure 8.1). These sketches will be improved in the next version of this report. At each location cracks and deformation extended completely through the asphalt pavement, which is typically 3 to 5 cm thick (Figure 8.4), and apparently through the compacted fill subbase and fill. Many of the road cracks exhibit an arcuate pattern typically associated with lateral spread or slump failures. Our team inspected the natural ground adjacent to the road/fill, and found no extension of cracks, liquefaction features, or cracks/deformation indicating global lateral spreading, deep-seated slumping, or major liquefaction. Rather, cracking appeared restricted to the road bed and adjacent fills, and reflects localized settlement and differential cracking/movement of the road fill and underlying subgrade soil. Most of the failures occur in areas where the road crosses small alluvial drainages/valleys and/or marshy areas. In some cases, the road is underlain by thick fill with steep fill slopes that underwent a degree of creep and possible discrete slumping. Based on observed conditions, the road failures appear to be the result of deformation of soft, organic and saturated alluvial and marsh soils. The magnitude of damage will require extensive regrading and paving to restore a stable and safe roadway.

Figure 8.2. Road fill failure sketch maps for sites RCA through RCD.

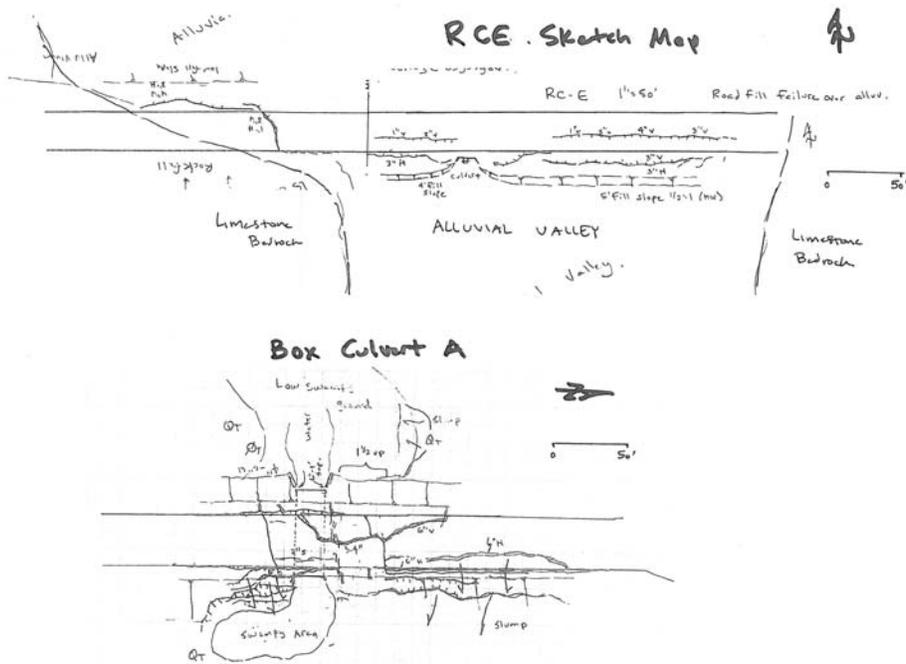
**Figure 8.3.** Road fill failure sketch maps for site RCE and BOXCLVTA.

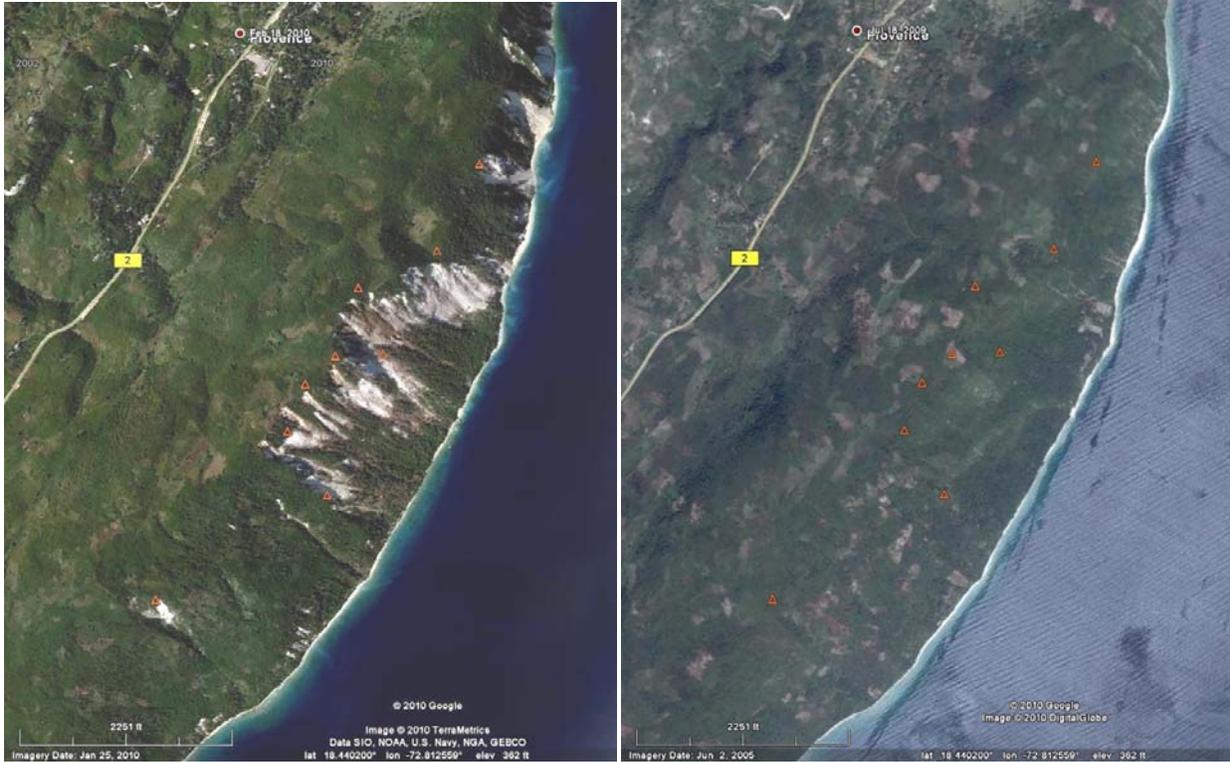
**Figure 9.2** Post-earthquakes denuded slopes due to landslides near Provence (left) along with pre-earthquake image (right). These are relatively steep ocean bluffs. (Scarp locations mapped by Ed Harp. Photos provided by Google Earth)

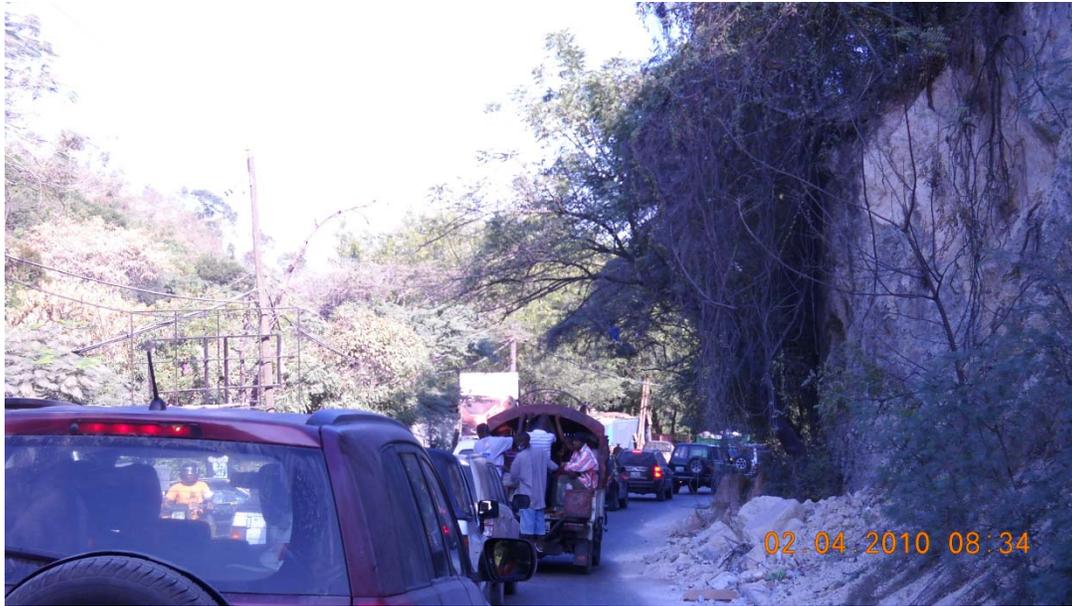
Numerous topples or falls were observed in over-steepened road cuts in weathered and sheared bedrock within the hills of Pétiion-Ville (Figure 9.5), an upland suburb to the southeast of Port-au-Prince. These over-steepened cut slopes had estimated inclinations of  $\frac{1}{4}H:1V$  or steeper; many were nearly vertical and some remaining un-failed cuts were actually locally overhanging. These slopes had estimated heights on the order of 1.5 to over 6 m. The falls generally included relatively slender slivers, typically involving 0.3 to 1.0 m thick of material. The material fell to the base of the slopes, forming a wedge on the roadside or sidewalk, and frequently encroaching onto the roadway.

**Figure 9.5** Vertical cut remaining relatively stable with minor rock fall/topples.

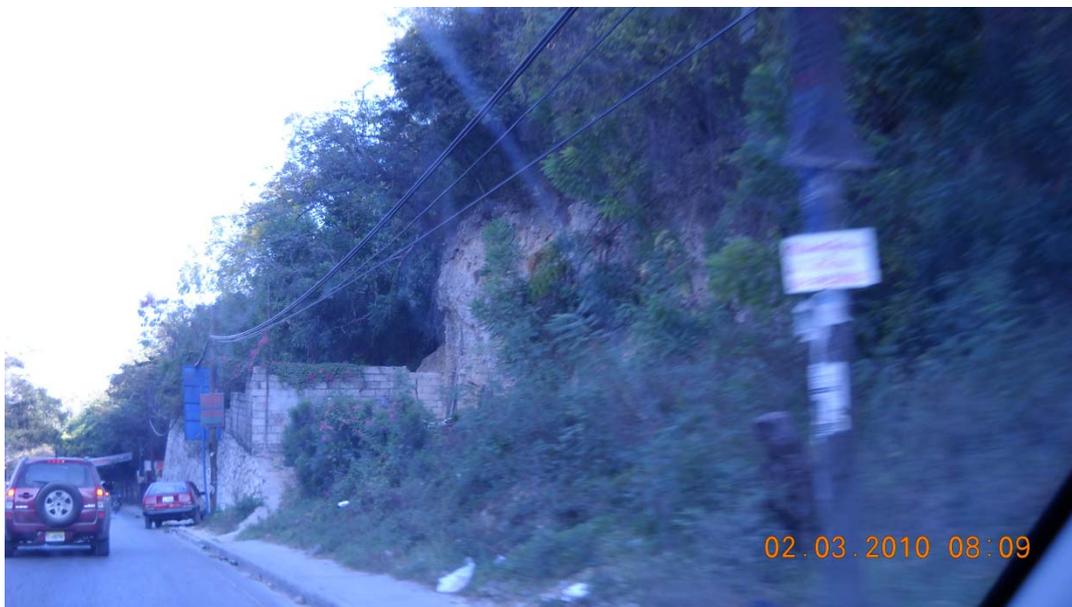
There were also many of these very steep road cuts that remained unfailed following the earthquake, as evidenced by the presence of vegetation, dust, and debris on the faces of the slopes (Figure 9.6). However, most of the unfailed slopes exhibited a wedge of raveled material at the base of the slope with established vegetation, suggesting the raveling had been occurring for some time and was not related to the recent earthquake, or with only minor toppling in the recent earthquake (e.g., Figure 9.5).

**Figure 9.6** Stable near-vertical road cut and masonry wall. (N18.531873, W72.313045).

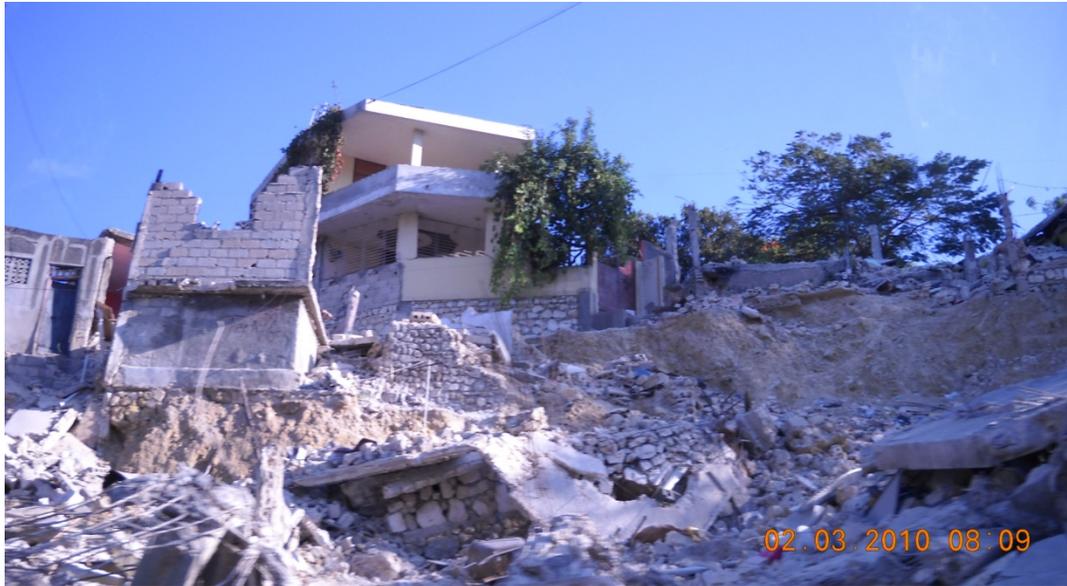
One area of more significant landslides was observed downhill from Petion-Ville along Rue Fernand. This landslide contained the rubble of several adjacent structures that had collapsed (Figure 9.7). There were scarp-like, near vertical surfaces near the top of slope, which could suggest that a rotational failure occurred beneath the now-collapsed structures. However, scarps of the observed height generated through a rotational failure would require a large volume of soil to be pushed out near the toe of slope. This volume of material did not appear to be present or to have been removed from the site. Furthermore, the soils are conglomeratic and likely have high friction angles, which would make the site an unlikely candidate for a rotational failure mechanism. It is more likely that the failure was initiated by basement/retaining walls for the overlying structures.

**Figure 9.7** Several buildings have collapsed in this location. Although there are scarp-like near vertical surfaces near the top of slope that may suggest the possibility of a deeper rotation failure, in our opinion the observed conditions are likely due movement of soils adjacent to failed walls, as discussed in the text. (N18.528406, W72.309920).

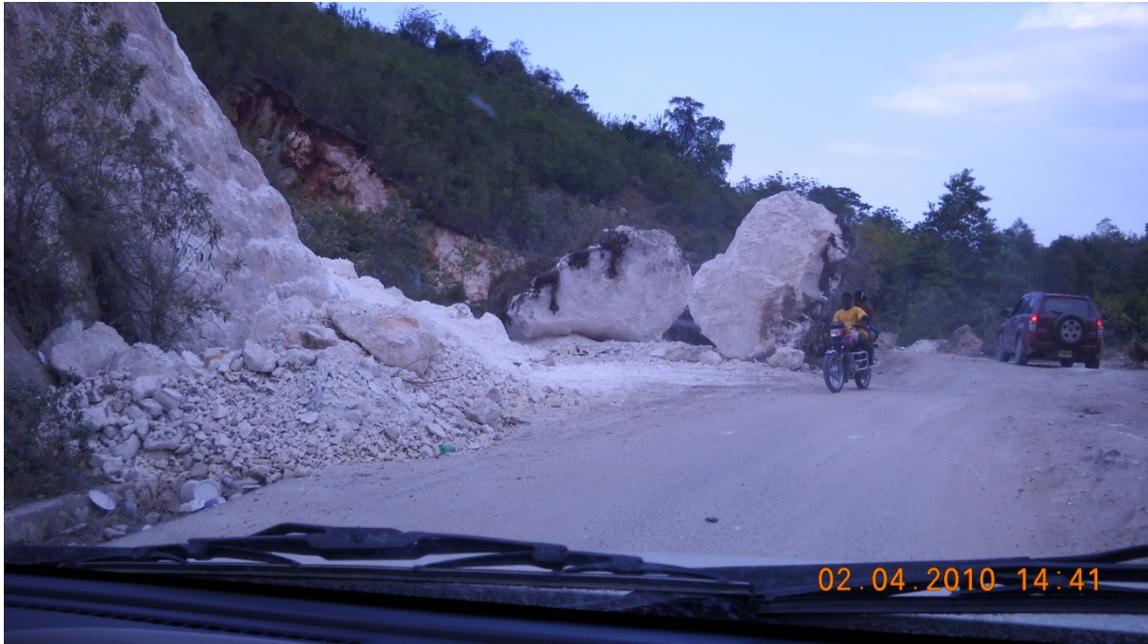
Some chalky limestone quarries (recent activity of the quarries was not checked) had moderately high steep slopes that also failed in rock topples or rock falls. Occasionally these resulted in large boulders rolling onto roadways (Figure 9.8). Similar failures occurred in over-steepened road cuts through chalky limestone.

**Figure 9.8** Topple or fall included several large boulders in this old quarry.  
(N18.439010, W72.646168).

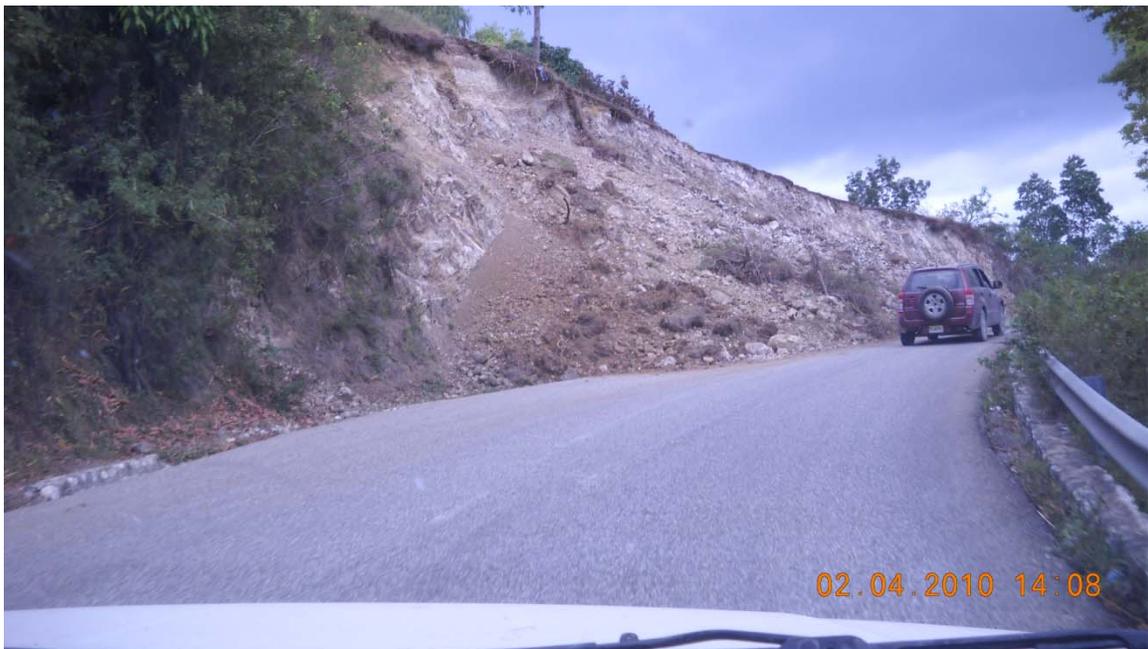
There were numerous rock falls, rock topples, and shallow rockslides in over-steepened road cuts along Highway 204 (e.g., Figures 9.8 through 9.12), although few of these were obvious in the aerial imagery. Many of these failures, as well as similar failures elsewhere, inhibited relief supplies from reaching many upland communities. The cut inclinations where the majority of the failures occurred are estimated to be on the order of about  $\frac{1}{4}H:1V$  to  $\frac{3}{4}H:1V$ , and ranged from a few meters high to over 10 m high. The failures were frequently in fractured, friable, blocky sedimentary materials. These blocks were stacked in a statically stable configuration that did not resist the seismic accelerations, and the blocky material simply deaggregated and cascaded to the bottoms of the slopes. In some locations rockslides occurred along bedding planes, but more often the exposed scarp revealed that the bedding was relatively level or dipping into the slope and the failed material pulled away from random discontinuous surfaces.

**Figure 9.9** Rock topple or rock fall from over-steepened road cut.  
(N18.412741, W72.638576).

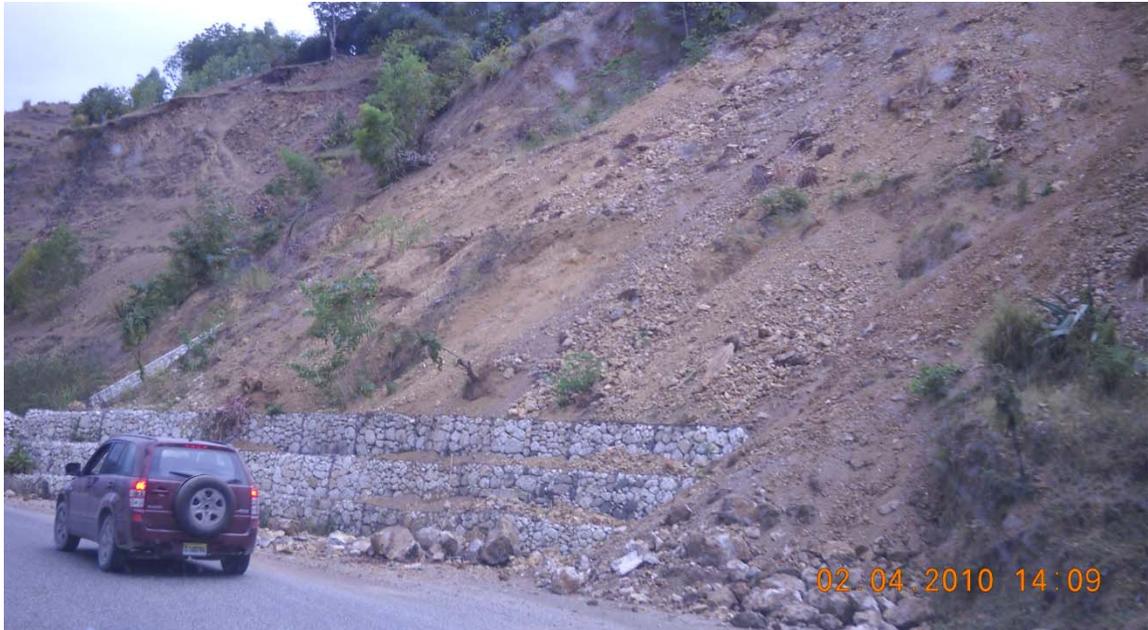
**Figure 9.10** Shallow rock topple or rock fall from over-steepened road cut. Debris slid over the top of stable gabions at the toe of the slope. (N18.409159, W72.638815).
