# GEOTECHNICAL ENGINEERING RECONNAISSANCE OF THE 2010 HAITI EARTHQUAKE

Version 1: February 22, 2010

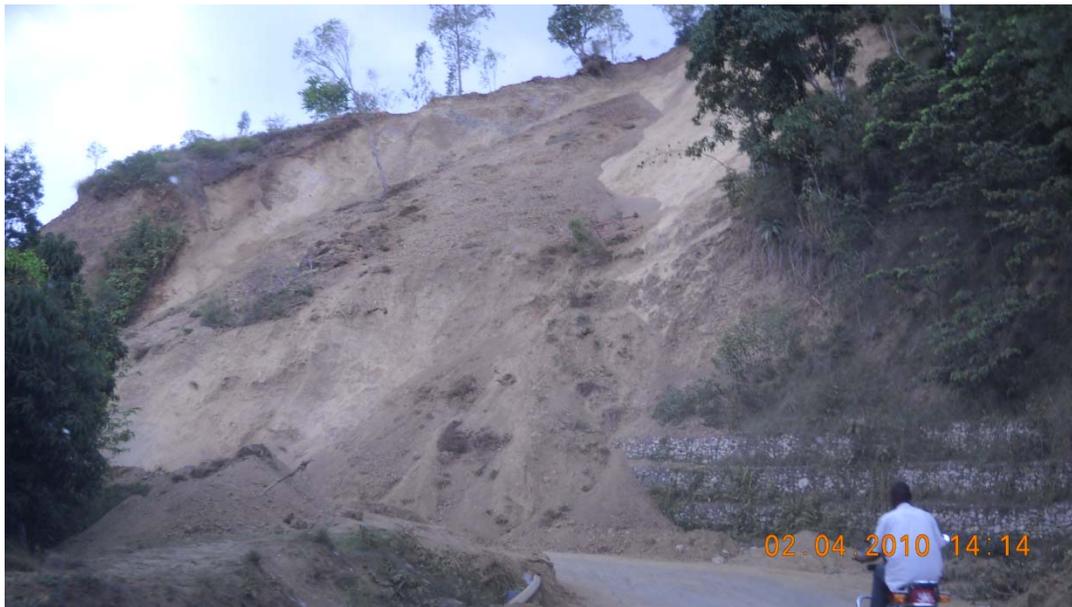
**Figure 9.11** Relatively shallow slip-out of regolith. Disaggregated material flowed over stable gabions and blocked over half the road. (N 18.409159, W72.638815).

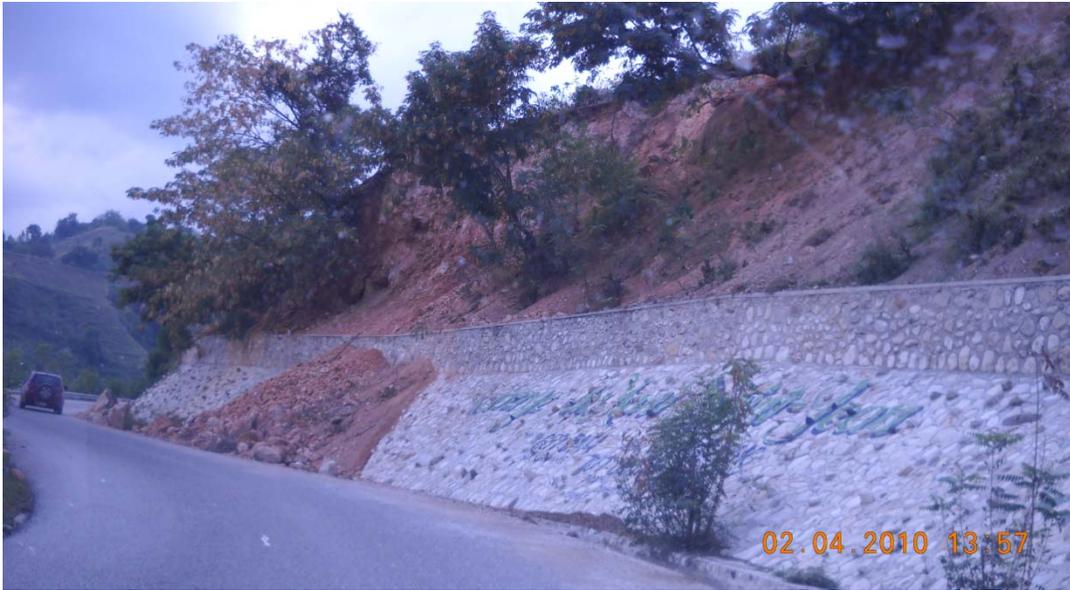
**Figure 9.12** Shallow slip-out of soil in upper road cut. Soil slid over the top of the surviving masonry wall and slope protection. (N18.440270, W72.636207).
