# **Modelli e tecniche nei progetti di intervento**

**Gaetano Manfredi**

# L'Aquila Earthquake: Structural damages

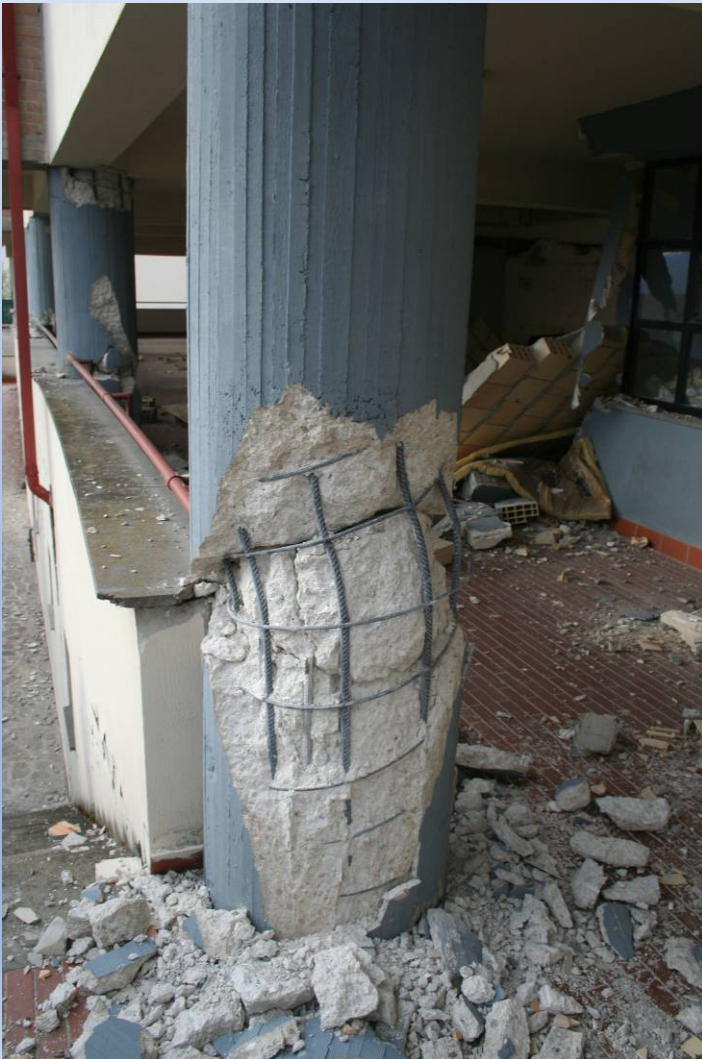
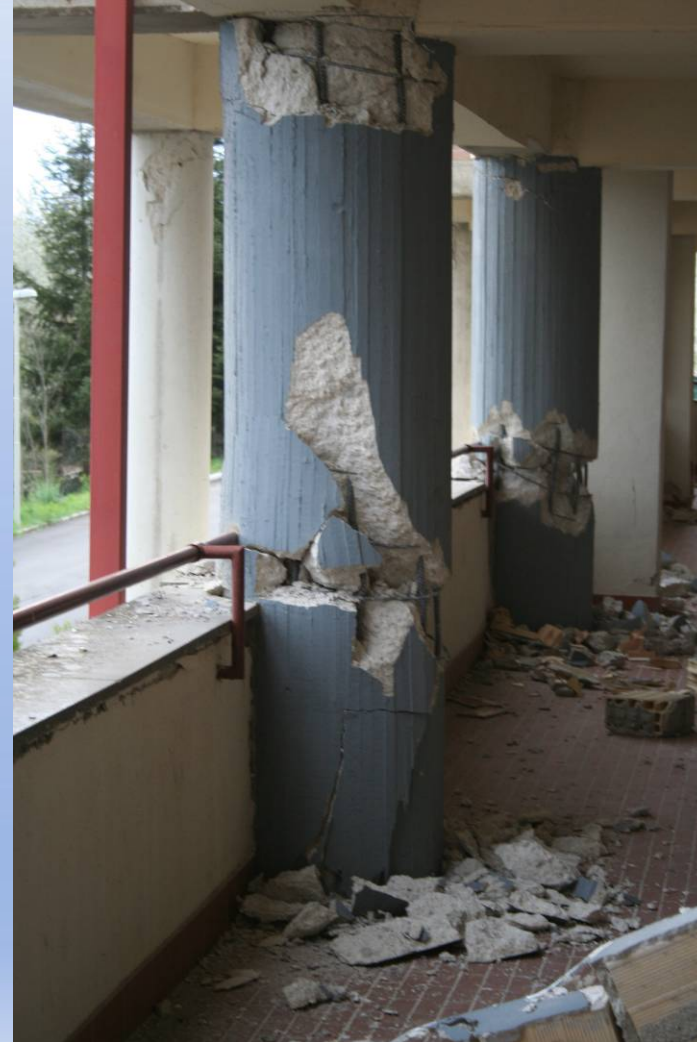
Shear Failure at the rectangular column end.

The stirrups spacing seems to be higher than 200mm.

Poor concrete quality

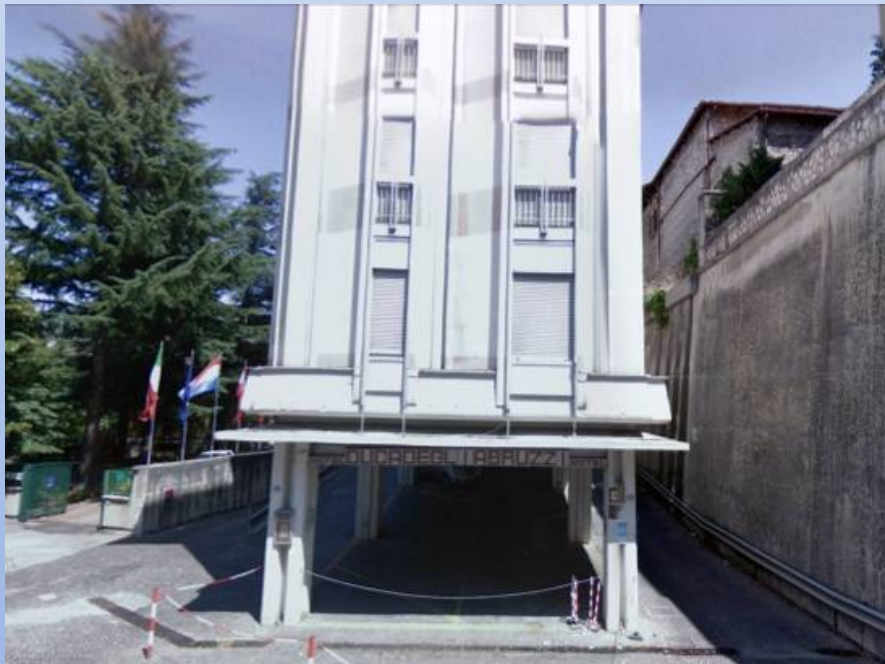
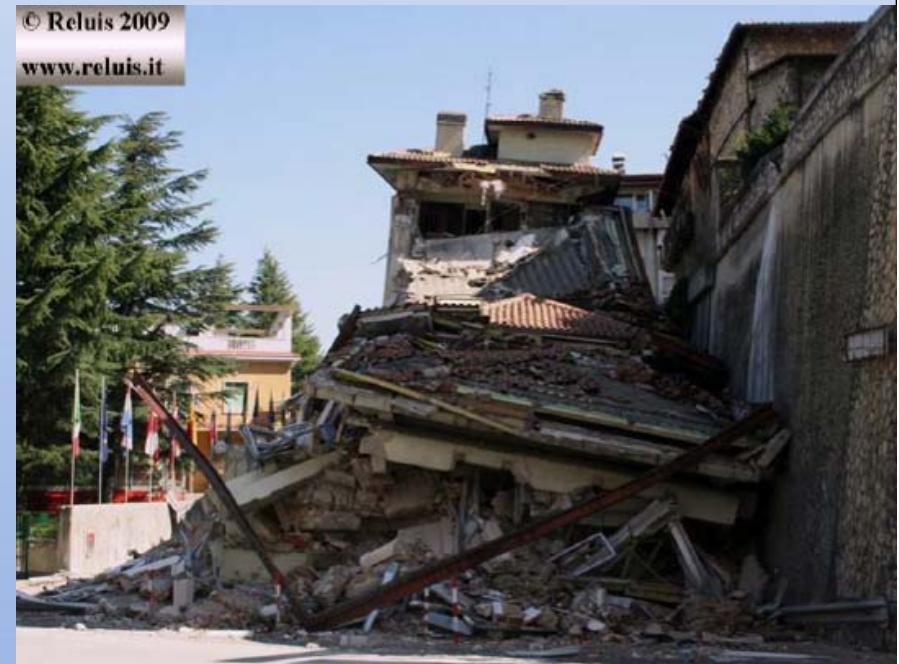
**Hotel Duca degli Abruzzi**

# L'Aquila Earthquake: Structural Collapses

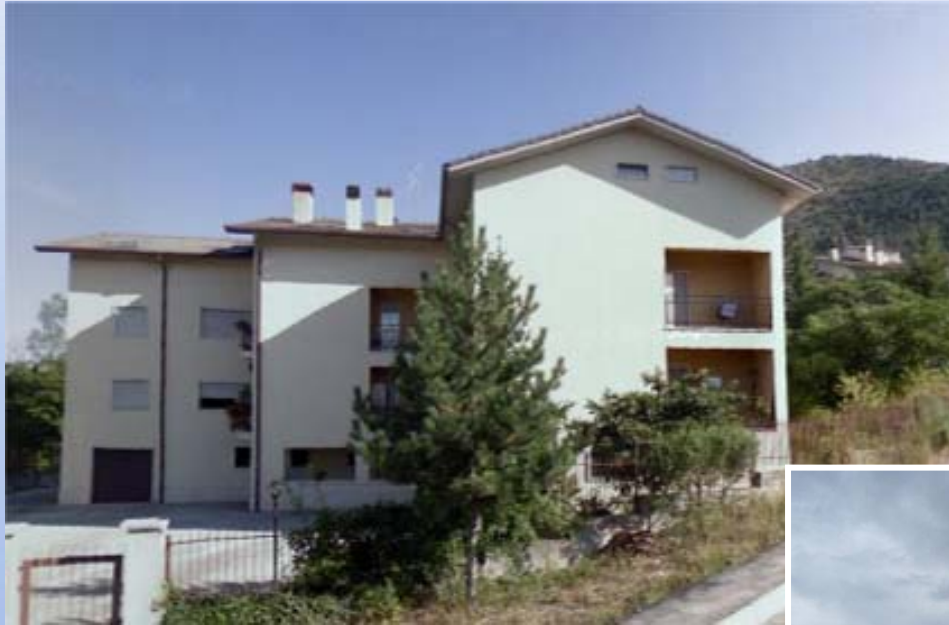
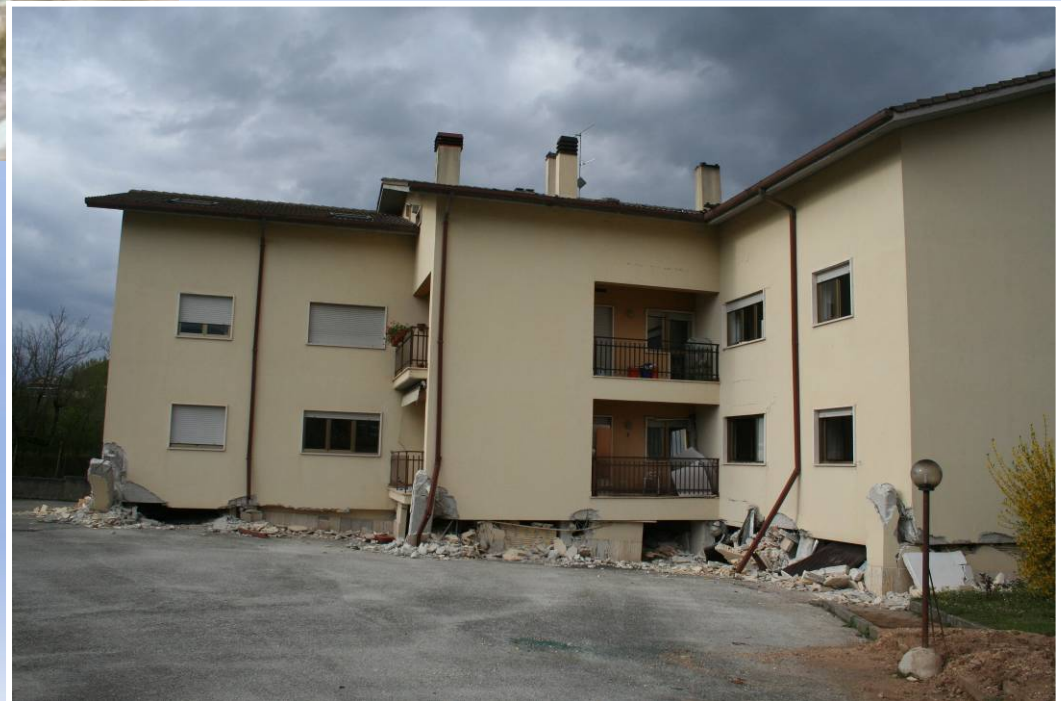
The buildings of "Pettino"

# L'Aquila Earthquake: Structural collapses

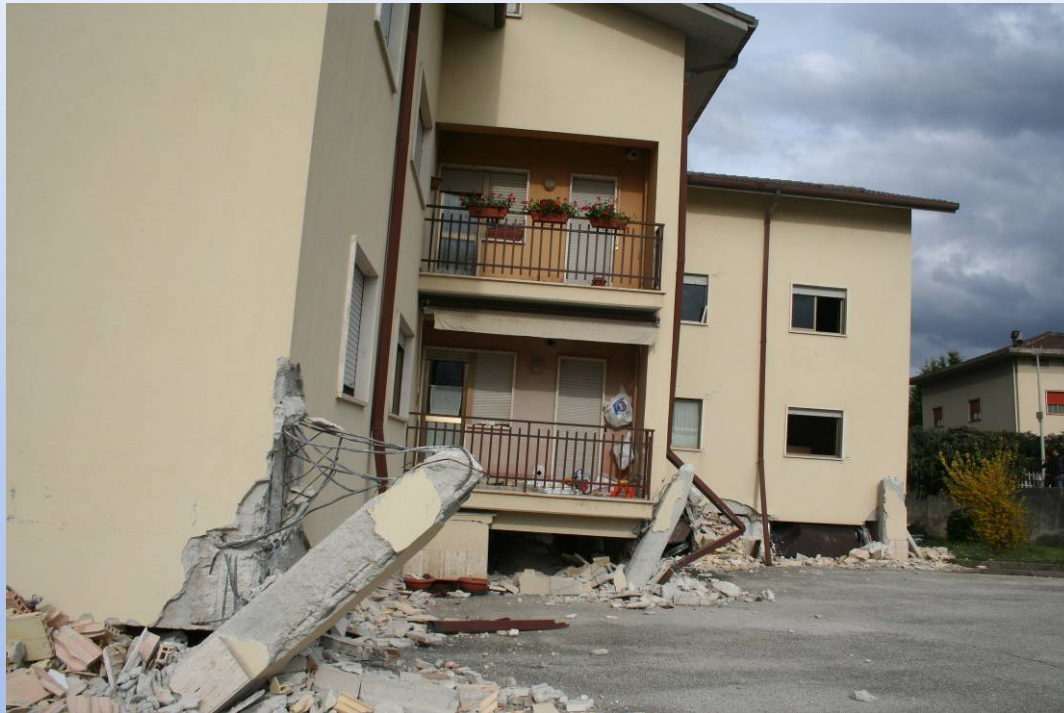
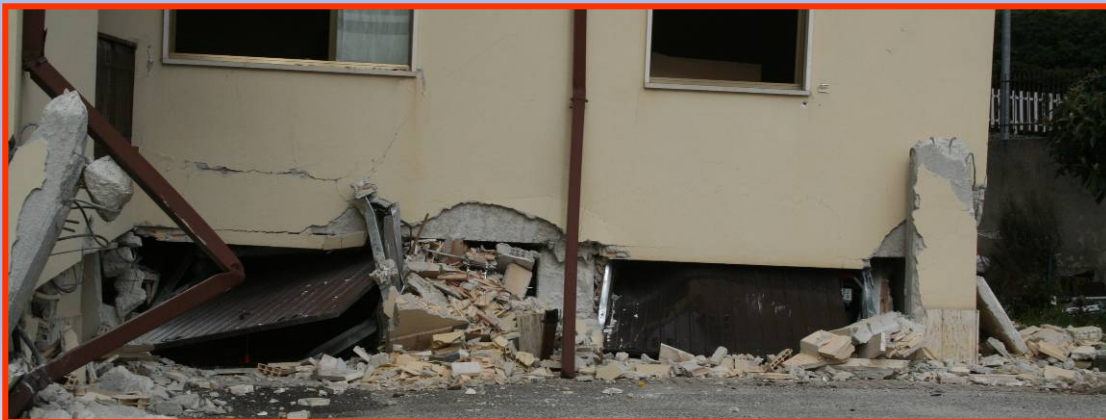
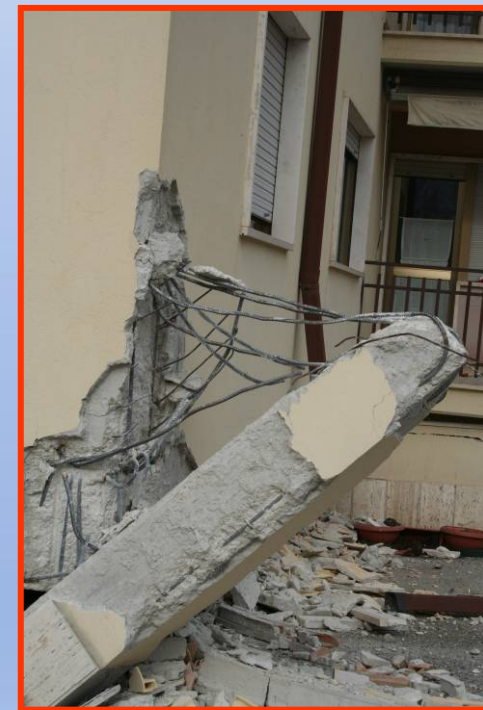
The buildings of  
"Pettino"

# L'Aquila Earthquake: Structural collapses

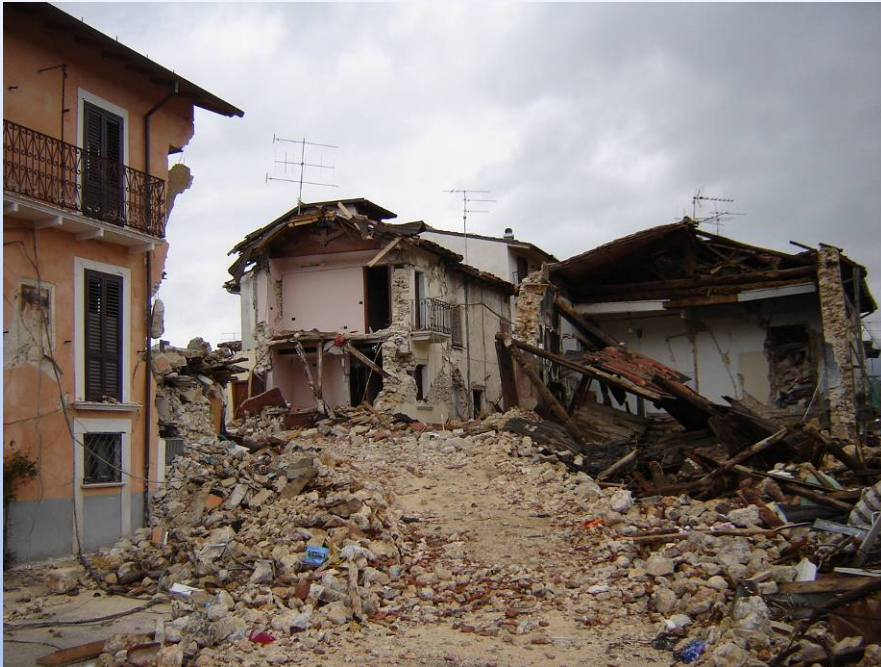
Tempera: collapse of head board buildings

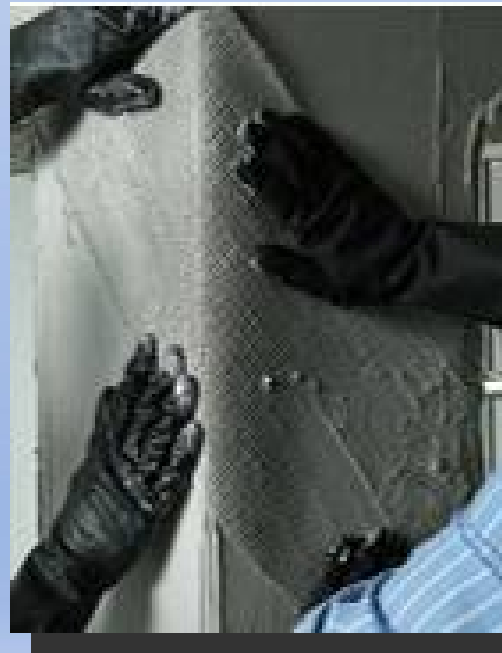
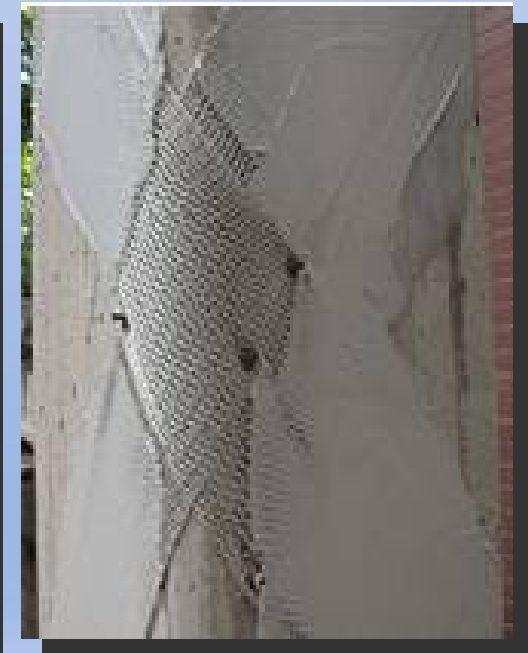
Cracks due to the actions provided by partition.  
**PSEUDO-HORIZONTAL CRACK** at column-joint panel interface.

**1. DIAGONAL UNIAXIAL STEEL SHEETS** designed to resist to partitions' actions .

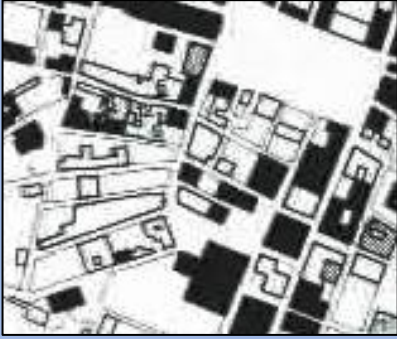
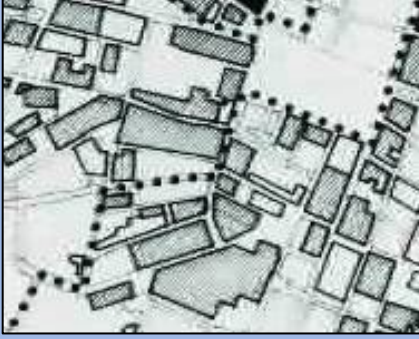
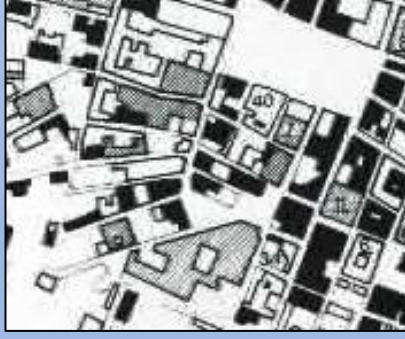
Historic View: I 1703.  
Damages due to seismic event

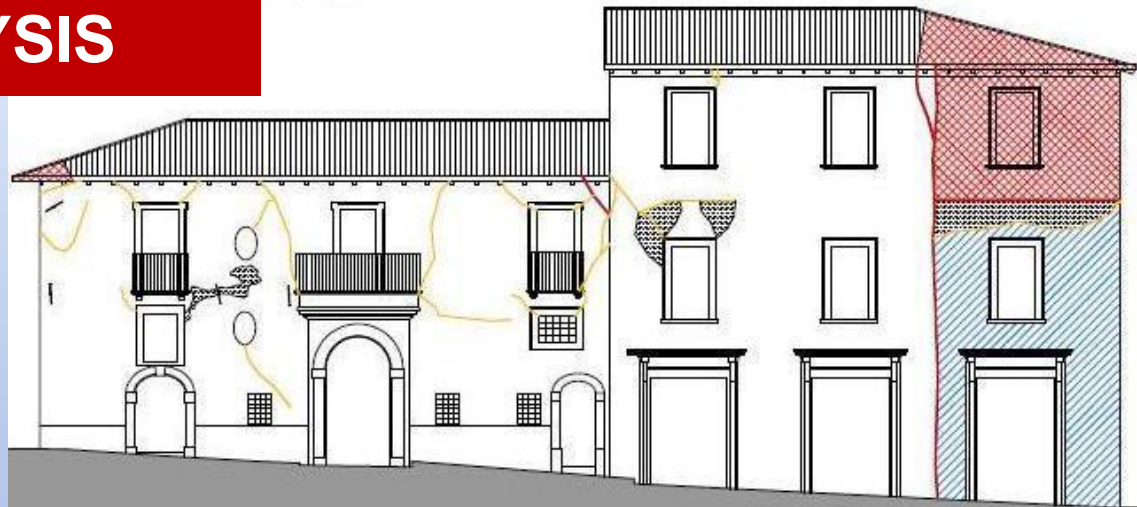
View p.zza Prefettura

lesione passante
 	lesione non passante
 	collo
 	meccanismo fuori piano attivato
 	distacco dell'intonaco
 	tiranti pre-esistenti

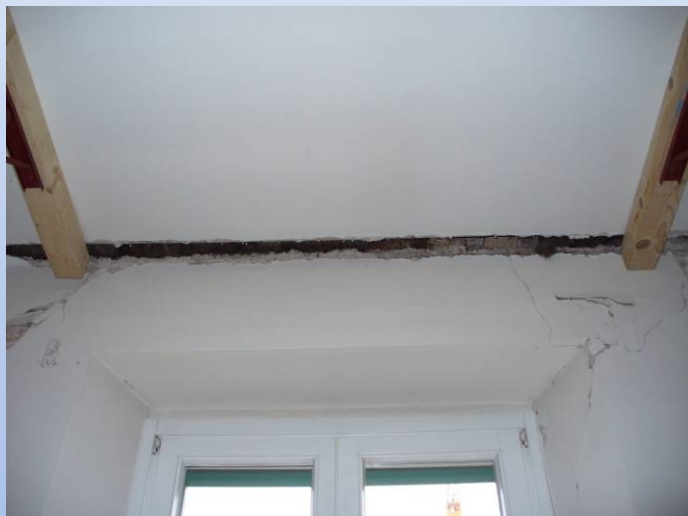
spanciamiento		crollo		fessure su pavimenti e volte
	lesione non passante		lesione al cantonale	TIRANTI	
	lesione passante		martello		
	lesione diffusa		incrocio		
	lesione a croce		lesione all'architrave

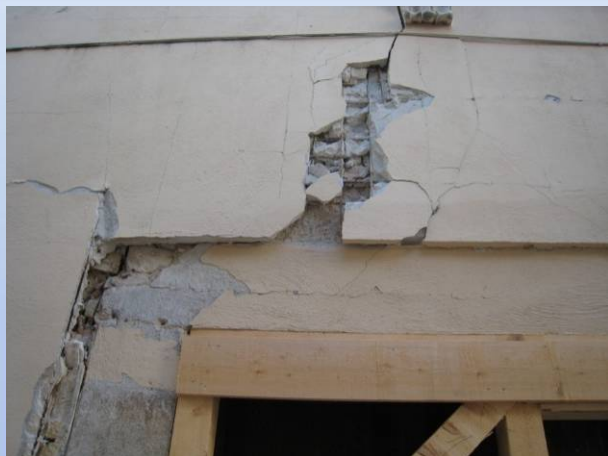
REINFORCED PLASTER

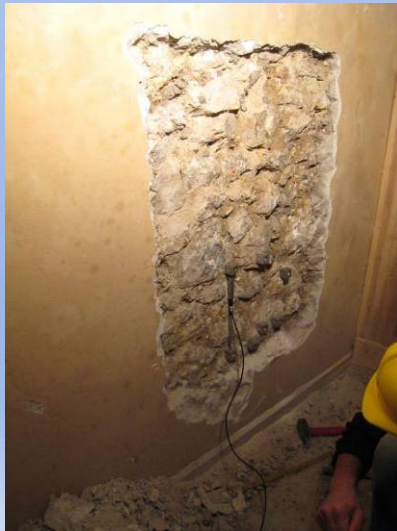
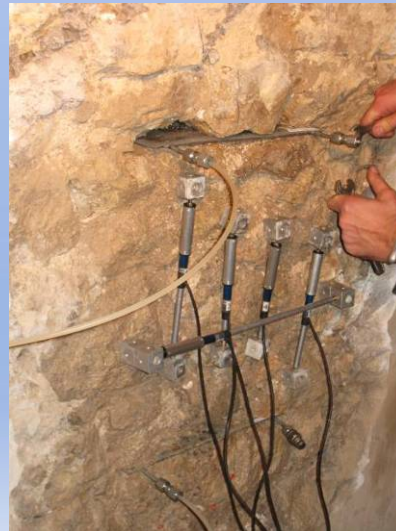
## FLAT JACKS

- SINGLE: stress in the masonry
- DOUBLE: elastic properties

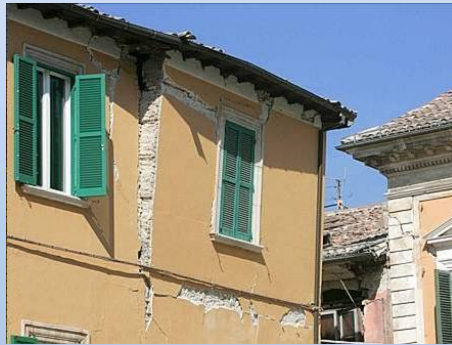
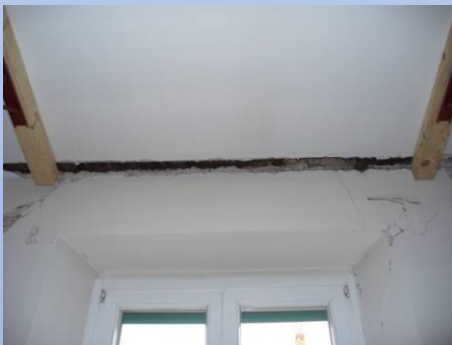
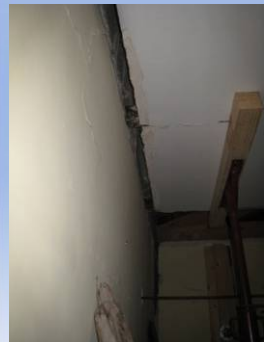
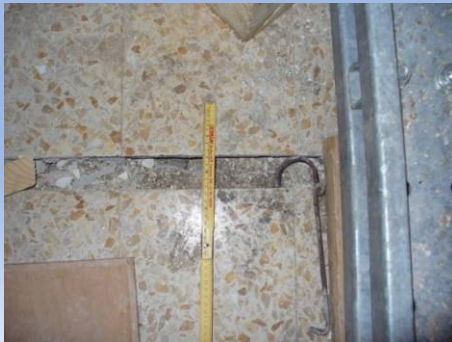
### OUT OF PLANE MECHANISMS: Facades' Overturning

### INSERTION OF TIES

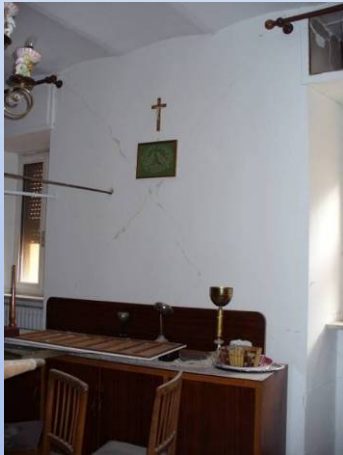
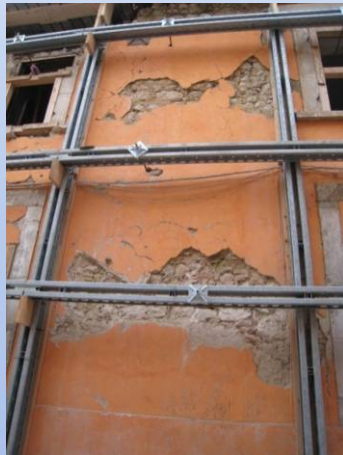
## SHEAR CRACKS

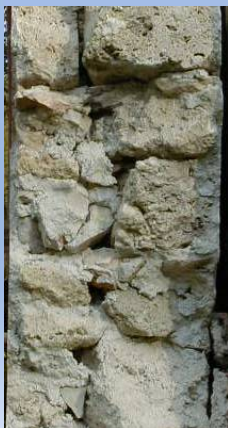
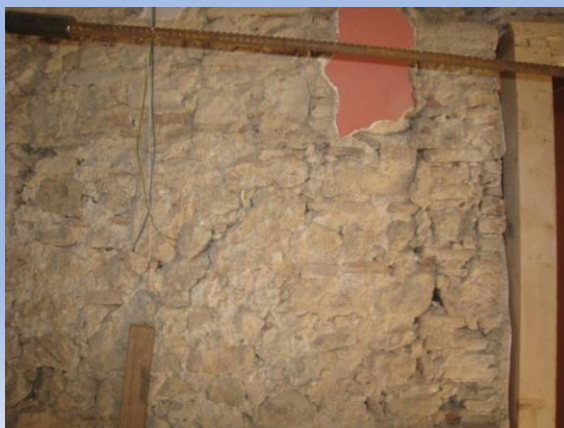
## LOW QUALITY OF RESISTING WALL

## MASONRY SUBSTITUTION WITH INTERLOCKING

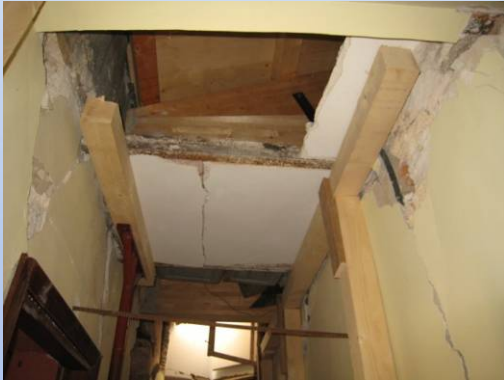
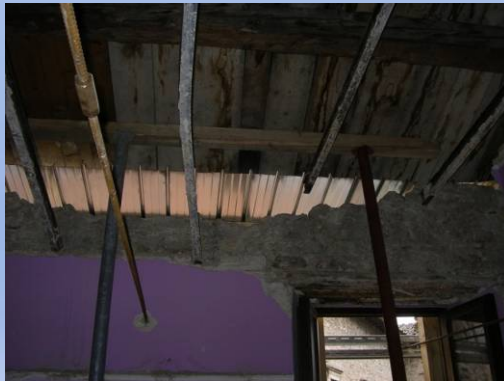
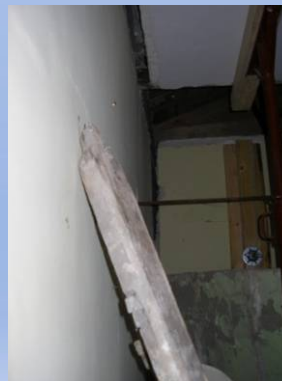
CRACKS AND PARTIAL OR TOTAL FLOOR SLABS COLLAPSE

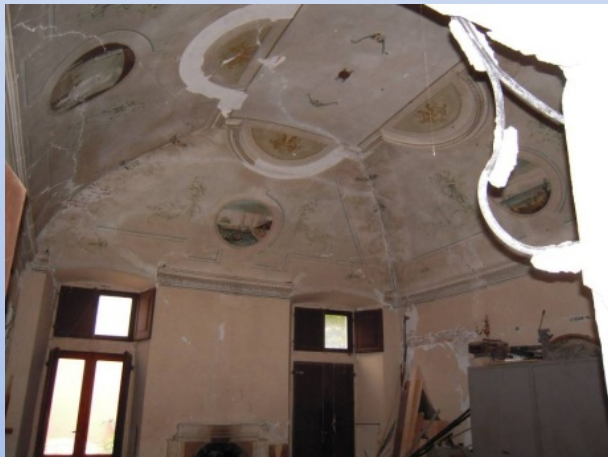
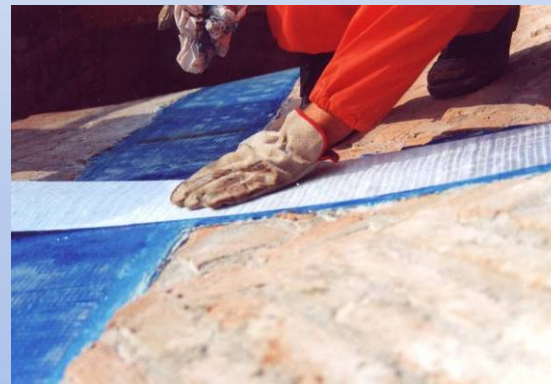
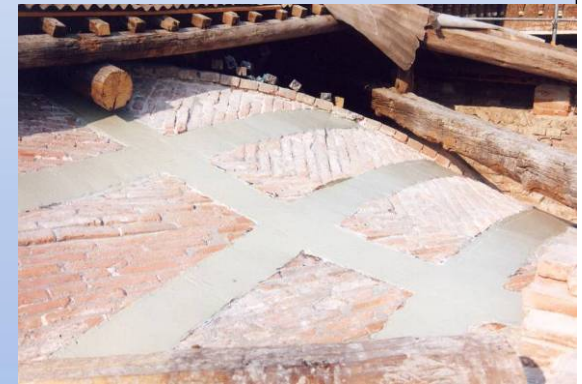
CRACKS OR PARTIAL COLLAPSE OF VAULTS

**Strengthening with composites (FRP)**
